Tighe and Bond, Inc. has been retained by the Town of East Hampton to conduct a Phase I Environmental Site Assessment (ESA) of the property located at 13 Watrous Street in East Hampton (the site). The purpose of this Phase I ESA is to evaluate the potential for contamination of soil, groundwater, and surface water resulting from current or historic site operations, use, and conditions at the site. This information will be used to determine if there is potential for current or historic releases of hazardous substances or petroleum products to the environment. This report is prepared for the exclusive use of the Town of East Hampton. This Phase I ESA was performed in general accordance with the requirements defined in the Connecticut Department of Environmental Protection (CTDEP) Transfer Act Site Assessment Guidance Document, dated June 1989, and revised November 1991 and the guidance for Phase I Site Assessments set forth in the June 12, 2000 Draft Site Characterization Guidance. This report also generally follows the standards of the American Society for Testing and Materials (ASTM) Standard Practice for Environmental Site Assessments (ASTM E1527-00 and E1528-00).

The site is loc

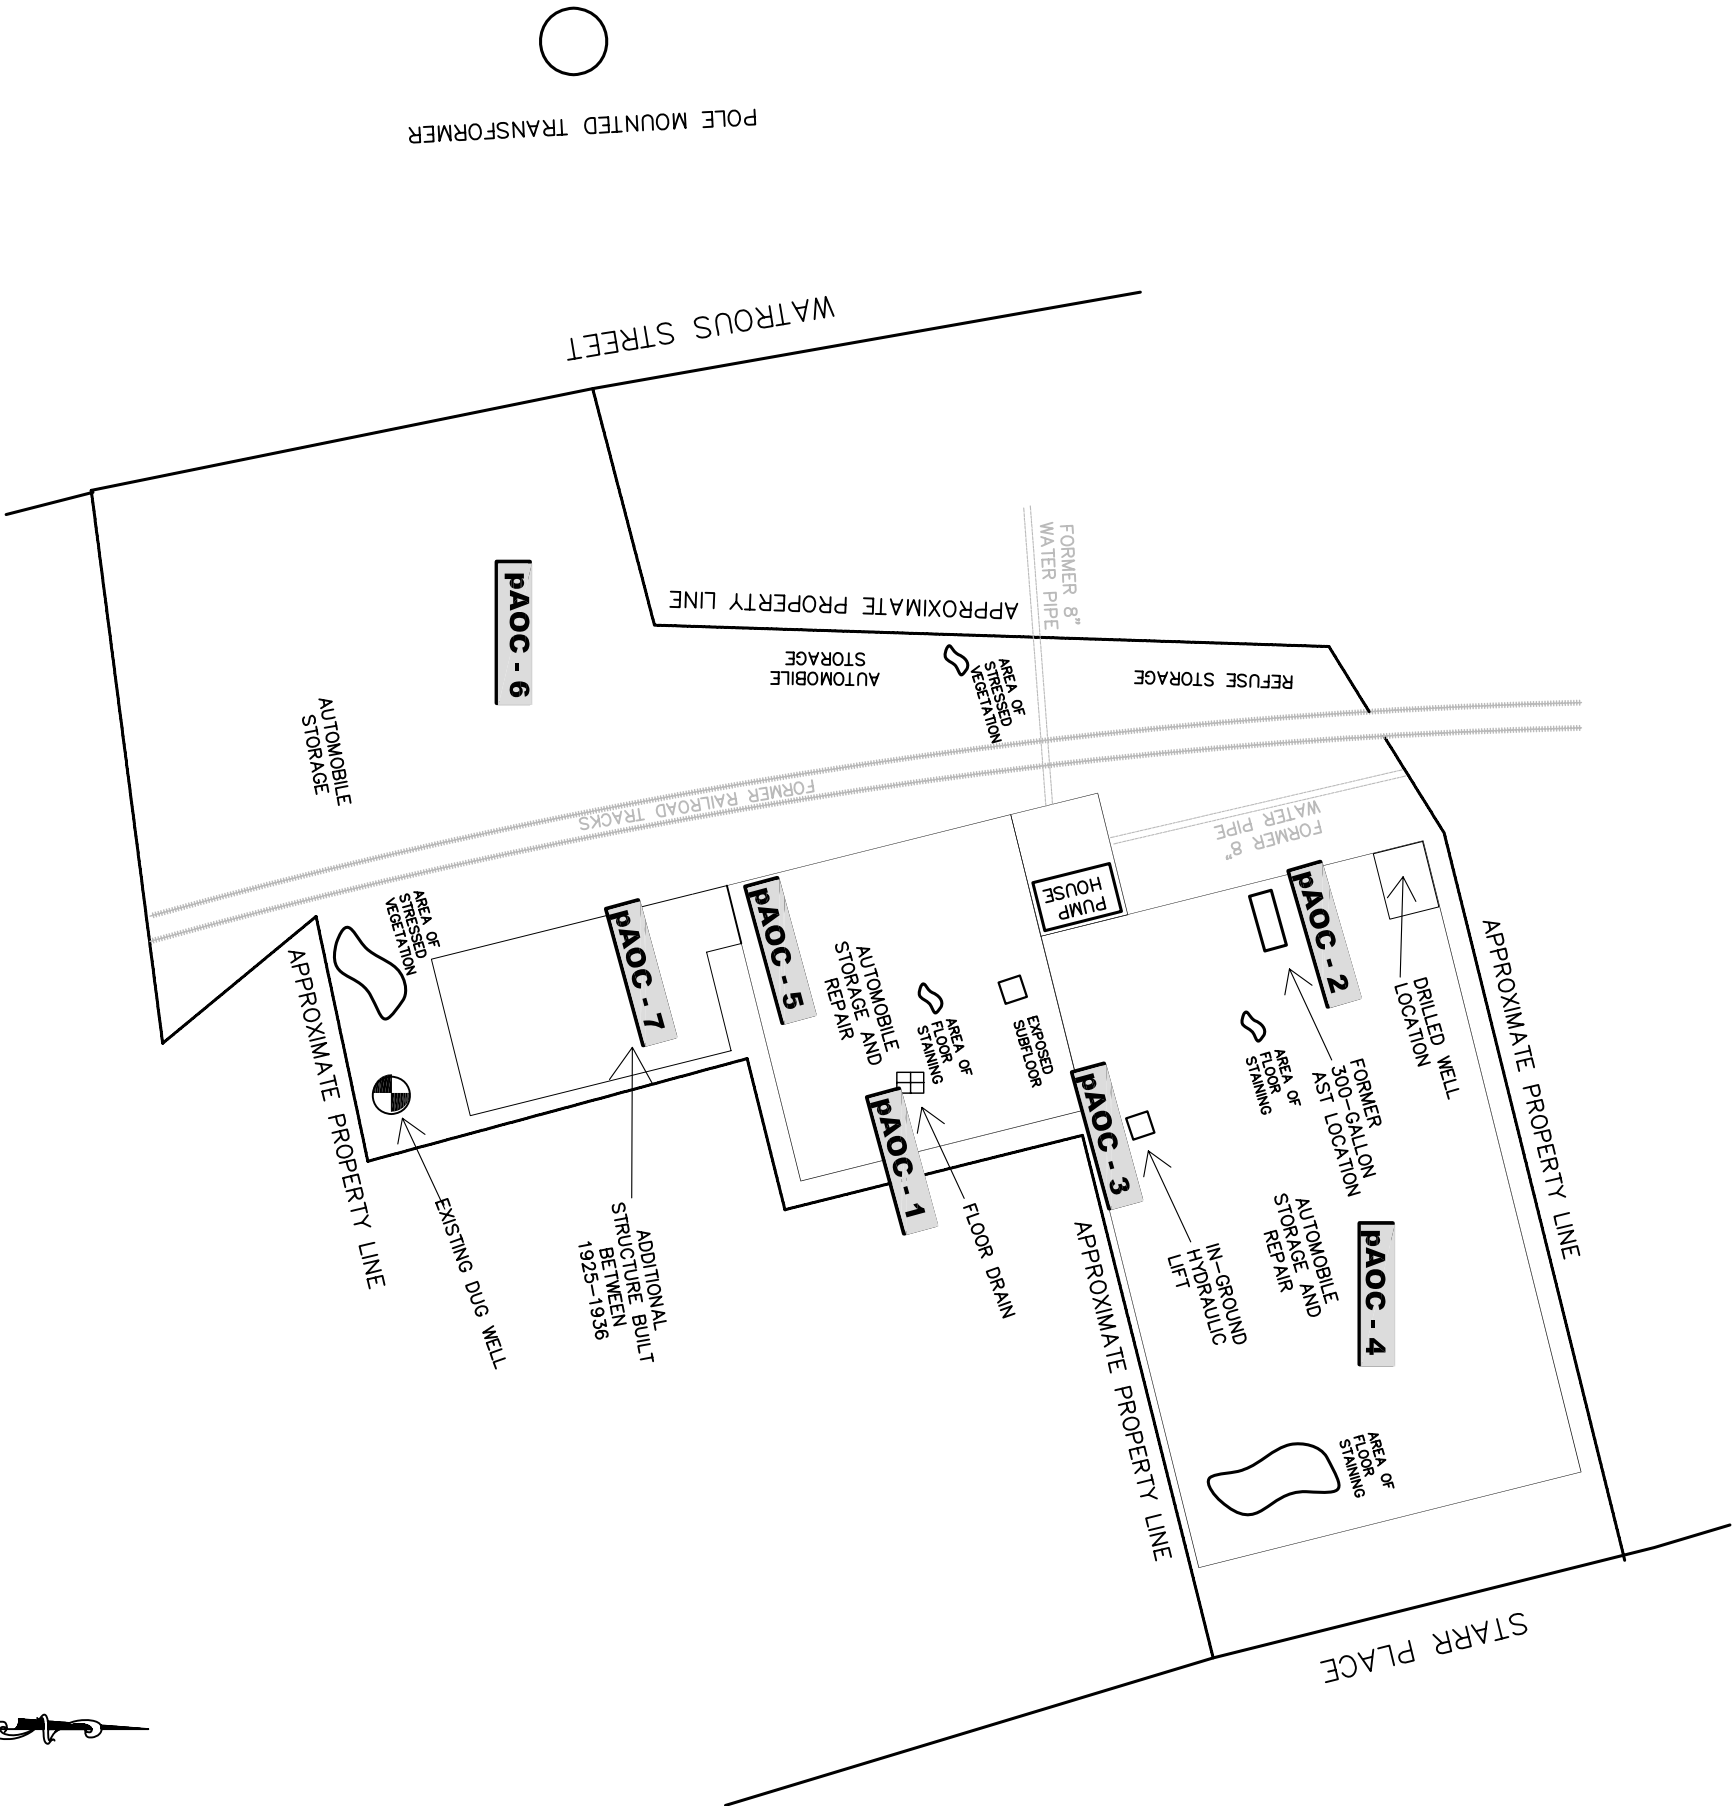
- **300-gallon AST Location:** Three 300-gallon tanks were contained in the northern section of the building. Minor floor staining was observed in the former AST storage location. The condition of the tanks is unknown but the potential exists that the one of the tanks has leaked and adversely affected soil or groundwater quality at the site. Potential COCs may include petroleum hydrocarbons and/or PAHs.

- **In-Ground Hydraulic Lift:** An in-ground hydraulic lift is located in the northern section of the site. The current tenant does not use the lift. However, the hydraulic fluids are still contained in the lift and present a potential environmental hazard. Potential COCs may include PAHs, and/or petroleum hydrocarbons.

- **Interior Floor Stained Areas:** Several areas of staining were documented during the site reconnaissance. Most notably, the northeast area of the building. Visibility of the floors was limited due to on-site automobile storage. Cracks in the concrete floor may provide a pathway for contaminants to migrate to the subsurface and environment. Potential COCs may include VOCs, PAHs, and/or petroleum hydrocarbons.

- **Exterior Areas of Stressed Vegetation and Soil Staining:** Current and historic site information suggests a potential for soil or groundwater contamination at the site perimeter. Automobile and refuse storage has historically occurred on the property exterior. In addition, a railroad track formerly traversed the western portion of the property. Stressed vegetation and soil staining has been documented during site reconnaissance. Potential COCs may include metals, VOCs, PAHs, and/or petroleum hydrocarbons.

Potential AOCs		
PAOC 1	Floor Drain	
PAOC 2	300-gallon AST Location	
PAOC 3	In-ground Hydraulic Lift	
PAOC 4	Former Coal Pocket Area	
PAOC 5	Interior Floor Stained Area	
PAOC 6	Exterior Soil Stained Area	
PAOC 7	Temporary Storage Area

Tighe & Bond, Inc. recommends that a Phase II ESA Scope of Work be developed and implemented to determine if a release has occurred from the PAOCs at the site. This investigation should, at a minimum, include the collection of soil and groundwater samples, particularly near stained areas inside and outside the site.
