## Application for Zoning Board of Appeals Variance

Beam Specification Letter August 11, 2022

Location: 12 Lakewood Roar

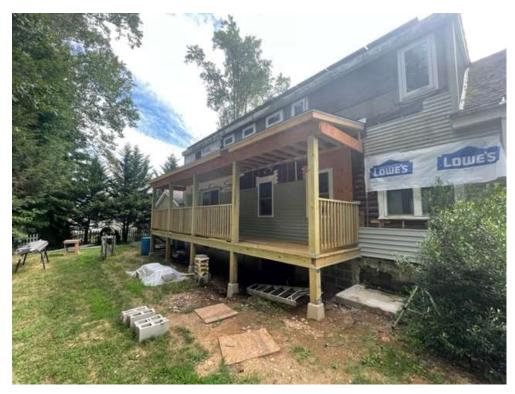
View of rear porch.

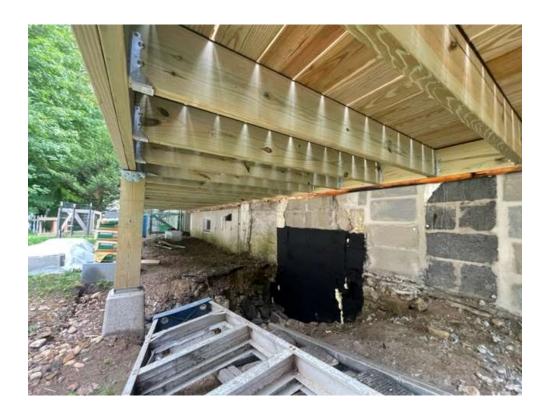
View of floor framing.

- 1. The 2x8 ledger attached to the house should have anchors spaced at 16" instead of 32". Additional anchors should be installed to establish this spacing.
- 2. There are no lateral deck ties installed to resists the lateral loads of the deck. These ties are Simpson DTT1-Z lateral ties and shall have at least four installed along the floor framing.

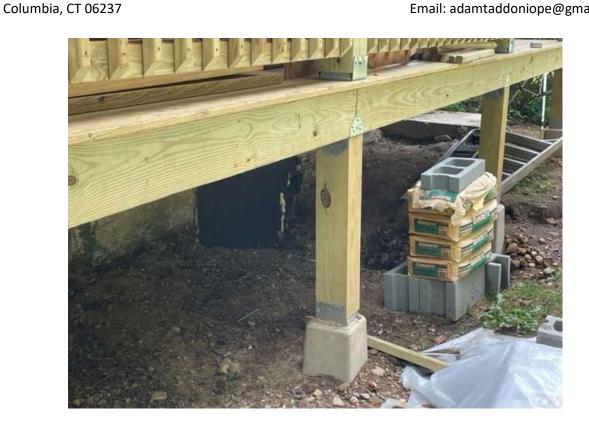
View of columns on precast piers.

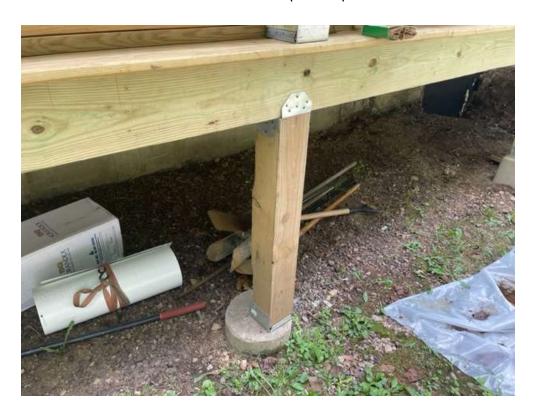
View of column on existing pier.

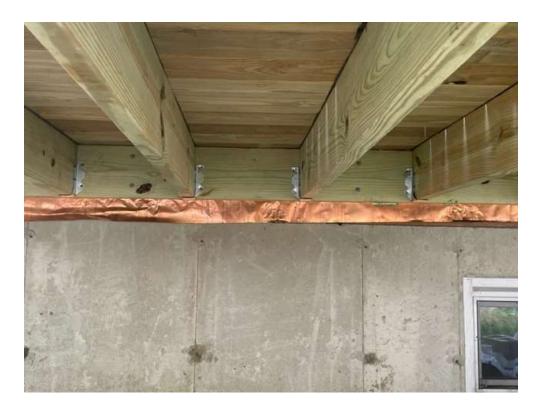
View of ledger with two rows of anchors @ 32".

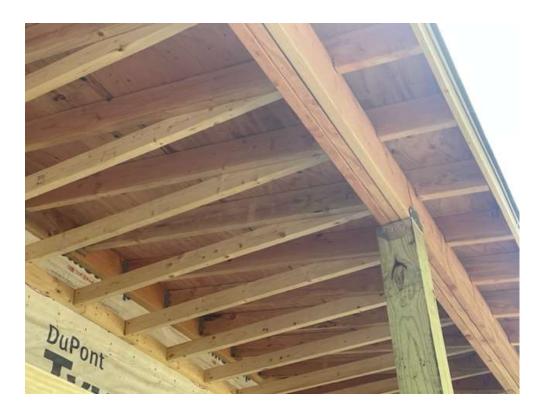
View of roof framing.

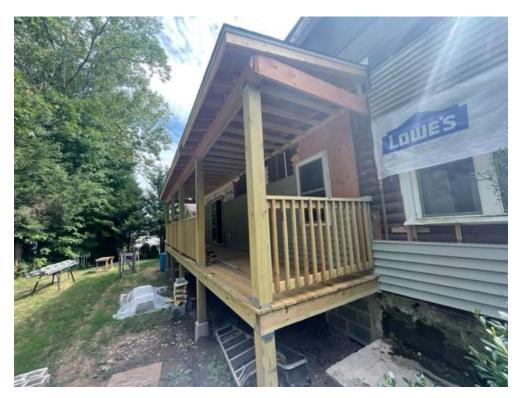
View of porch cross section.
