## 45 Meeks Point Rd Project Narrative

### Structural and Foundation Repairs

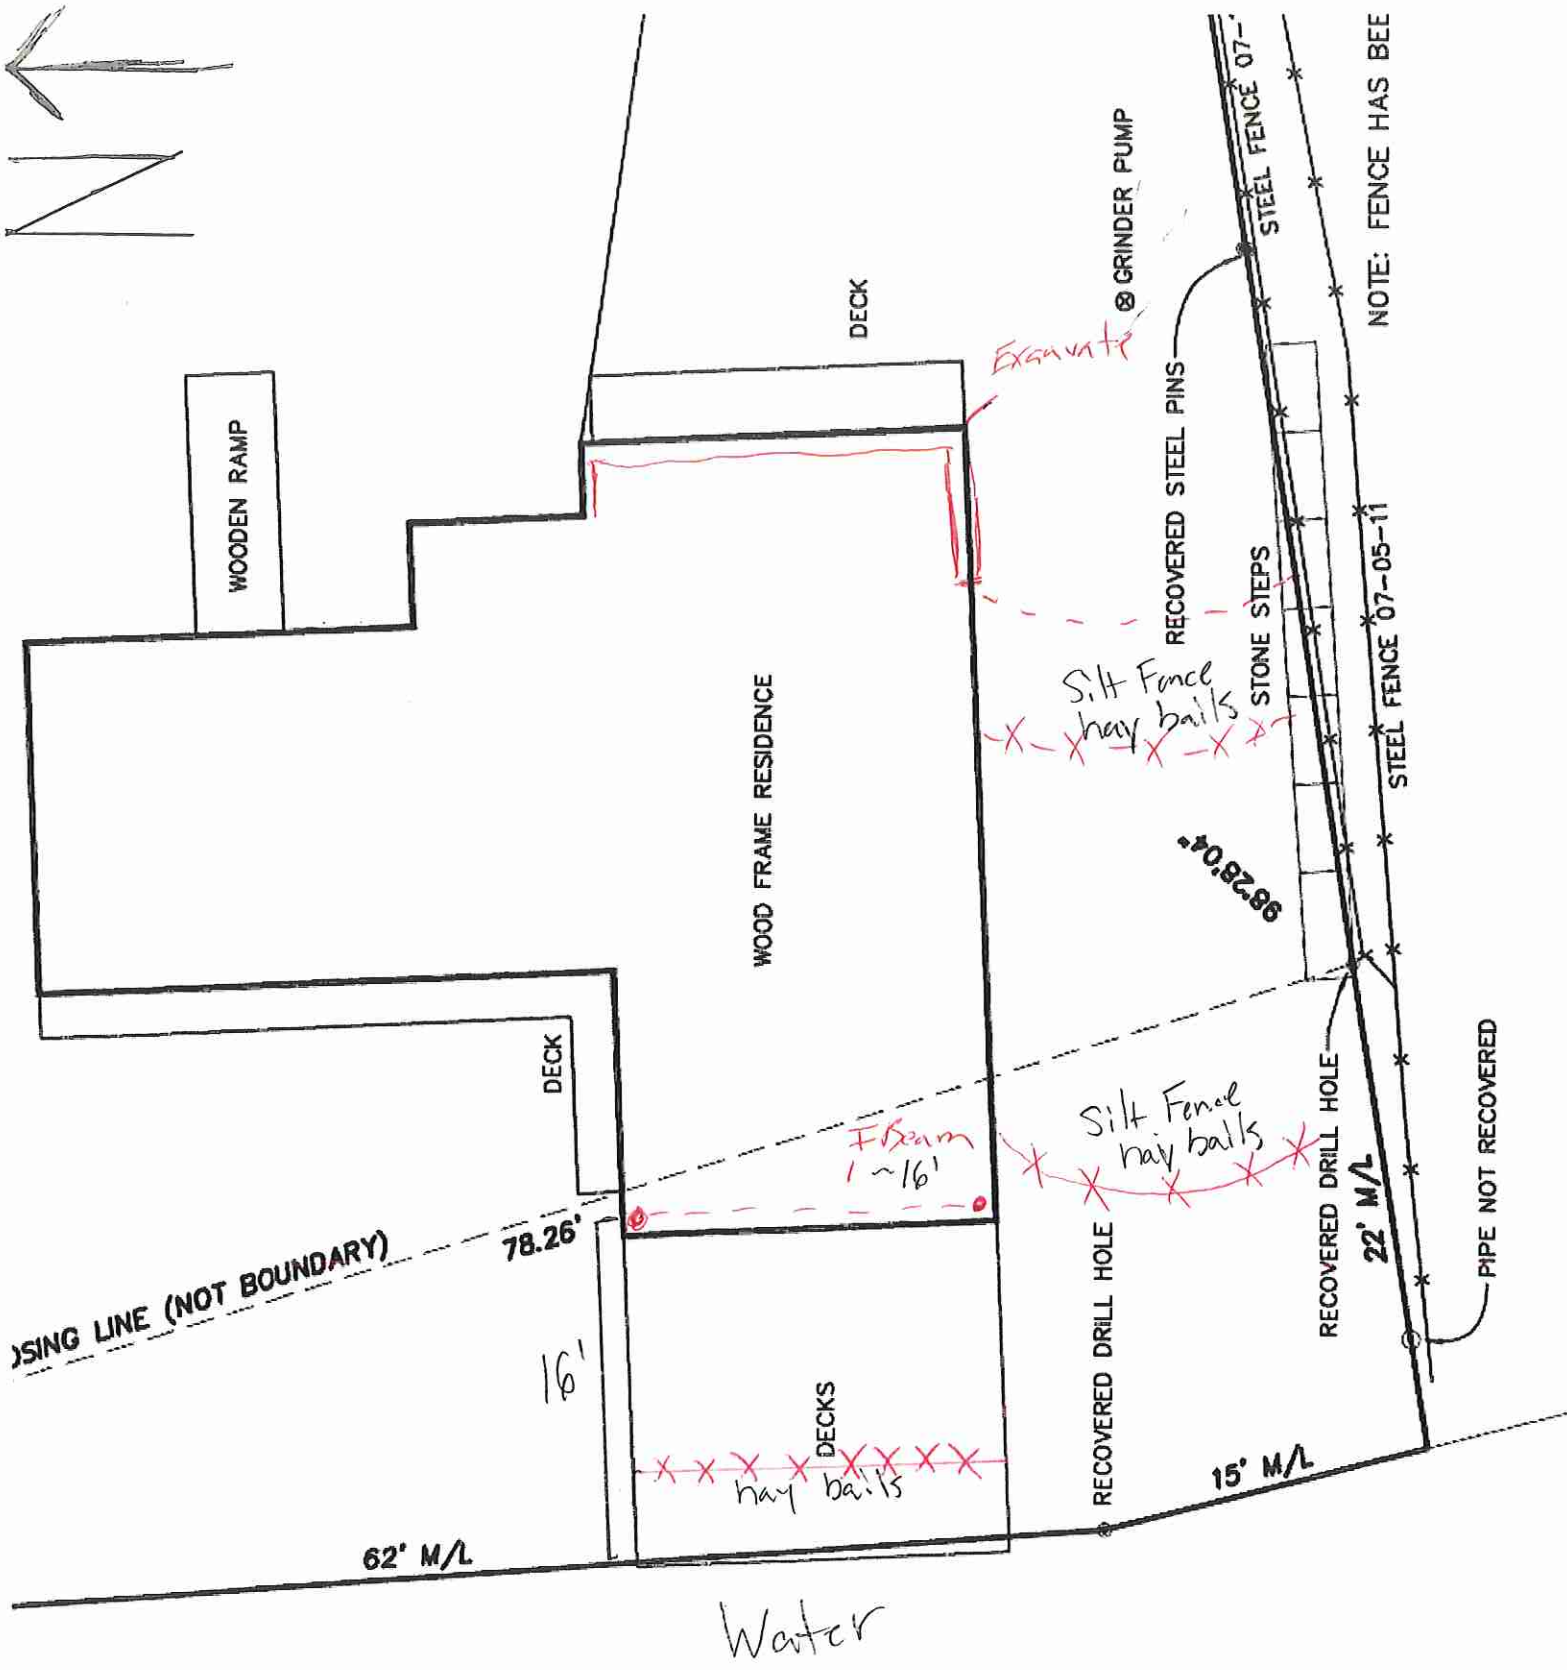
### Existing Lower Level Plan

1. Work Scope: Replace failing wooden I-beam that's sits on two concrete footings with steel I-beam. Raise home replace I-beam and level home. No excavation needed to make repair only replacement of existing beam. This portion of work will have no impact on surface water runoff. Hail bails will be below work zone in case of run off.
2. Excavate forty-one feet (41') by four (4') for 164 sqft around original homes foundation for remediation of water infiltration. Repair and water seal old foundation. Any unused excavated material will be transported away. Silt fences and hail bays will be used as indicated on site plan, two buffers for added protection.
