**RE: PRE-DEMOLITION HAZARDOUS MATERIALS SURVEY REPORT
1 WATROUS STREET, EAST HAMPTON, CONNECTICUT
(HRP#CTB4001.P2)**

PRE-DEMOLITION HAZARDOUS MATERIALS SURVEY REPORT

**1 Watrous Street
East Hampton, Connecticut**

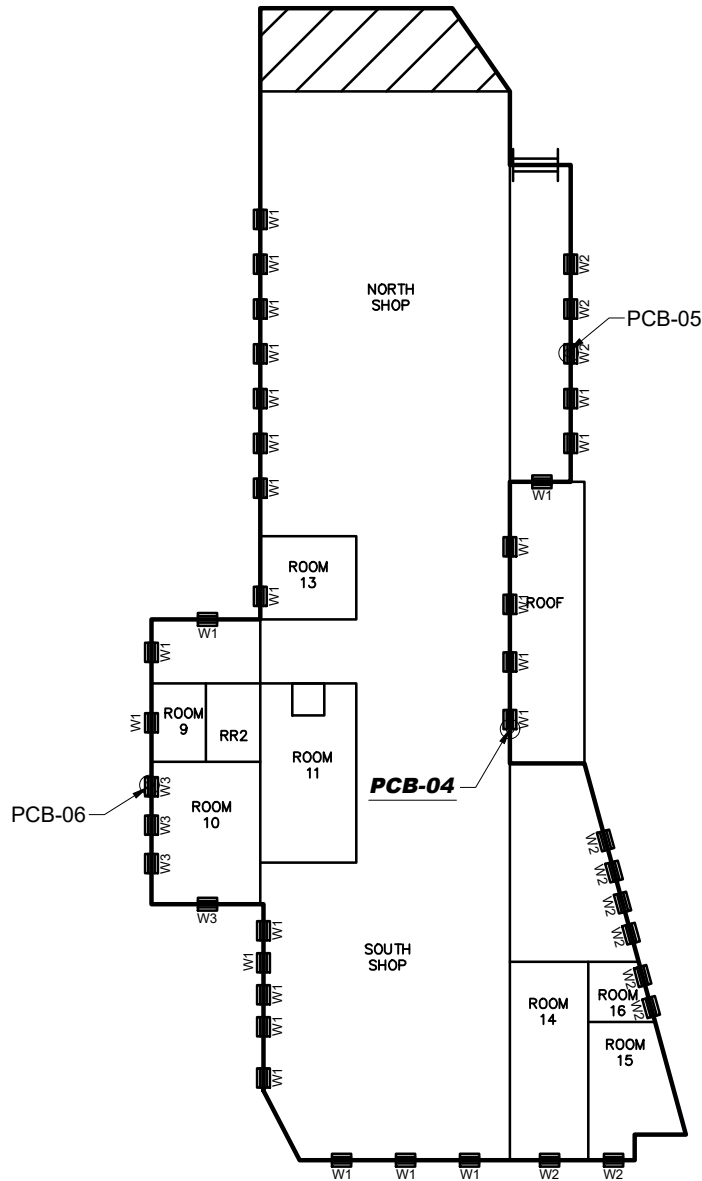
- PCB-01⊙ - PCB SAMPLE LOCATION
- PCB-02** ⊙ - DETECTION ABOVE CTDEEP STANDARD OF 1PPM (Mg/Kg)
