49 Bay Road
Seawall

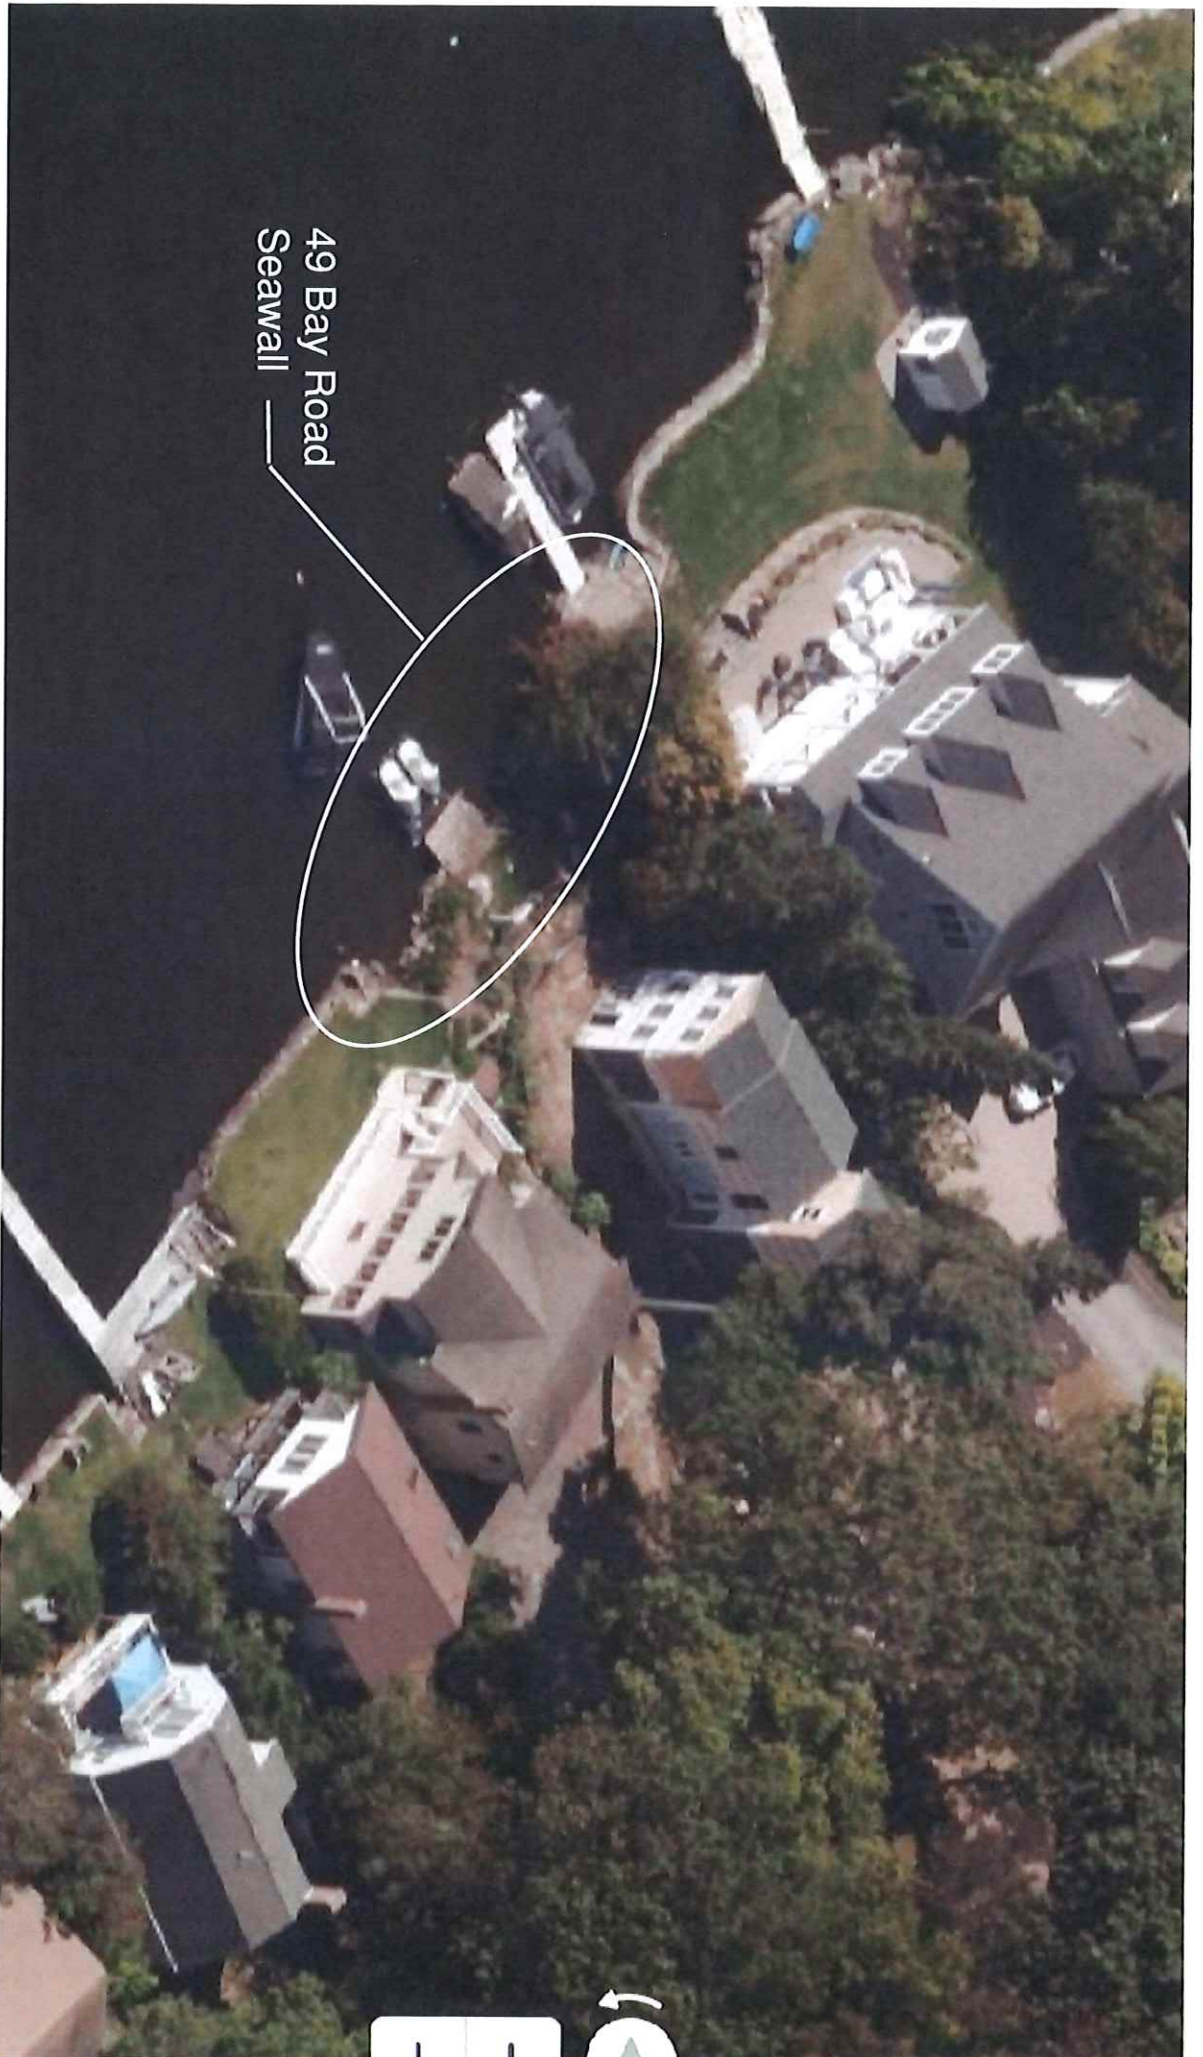
Aerial view of property showing neighboring wall conditions

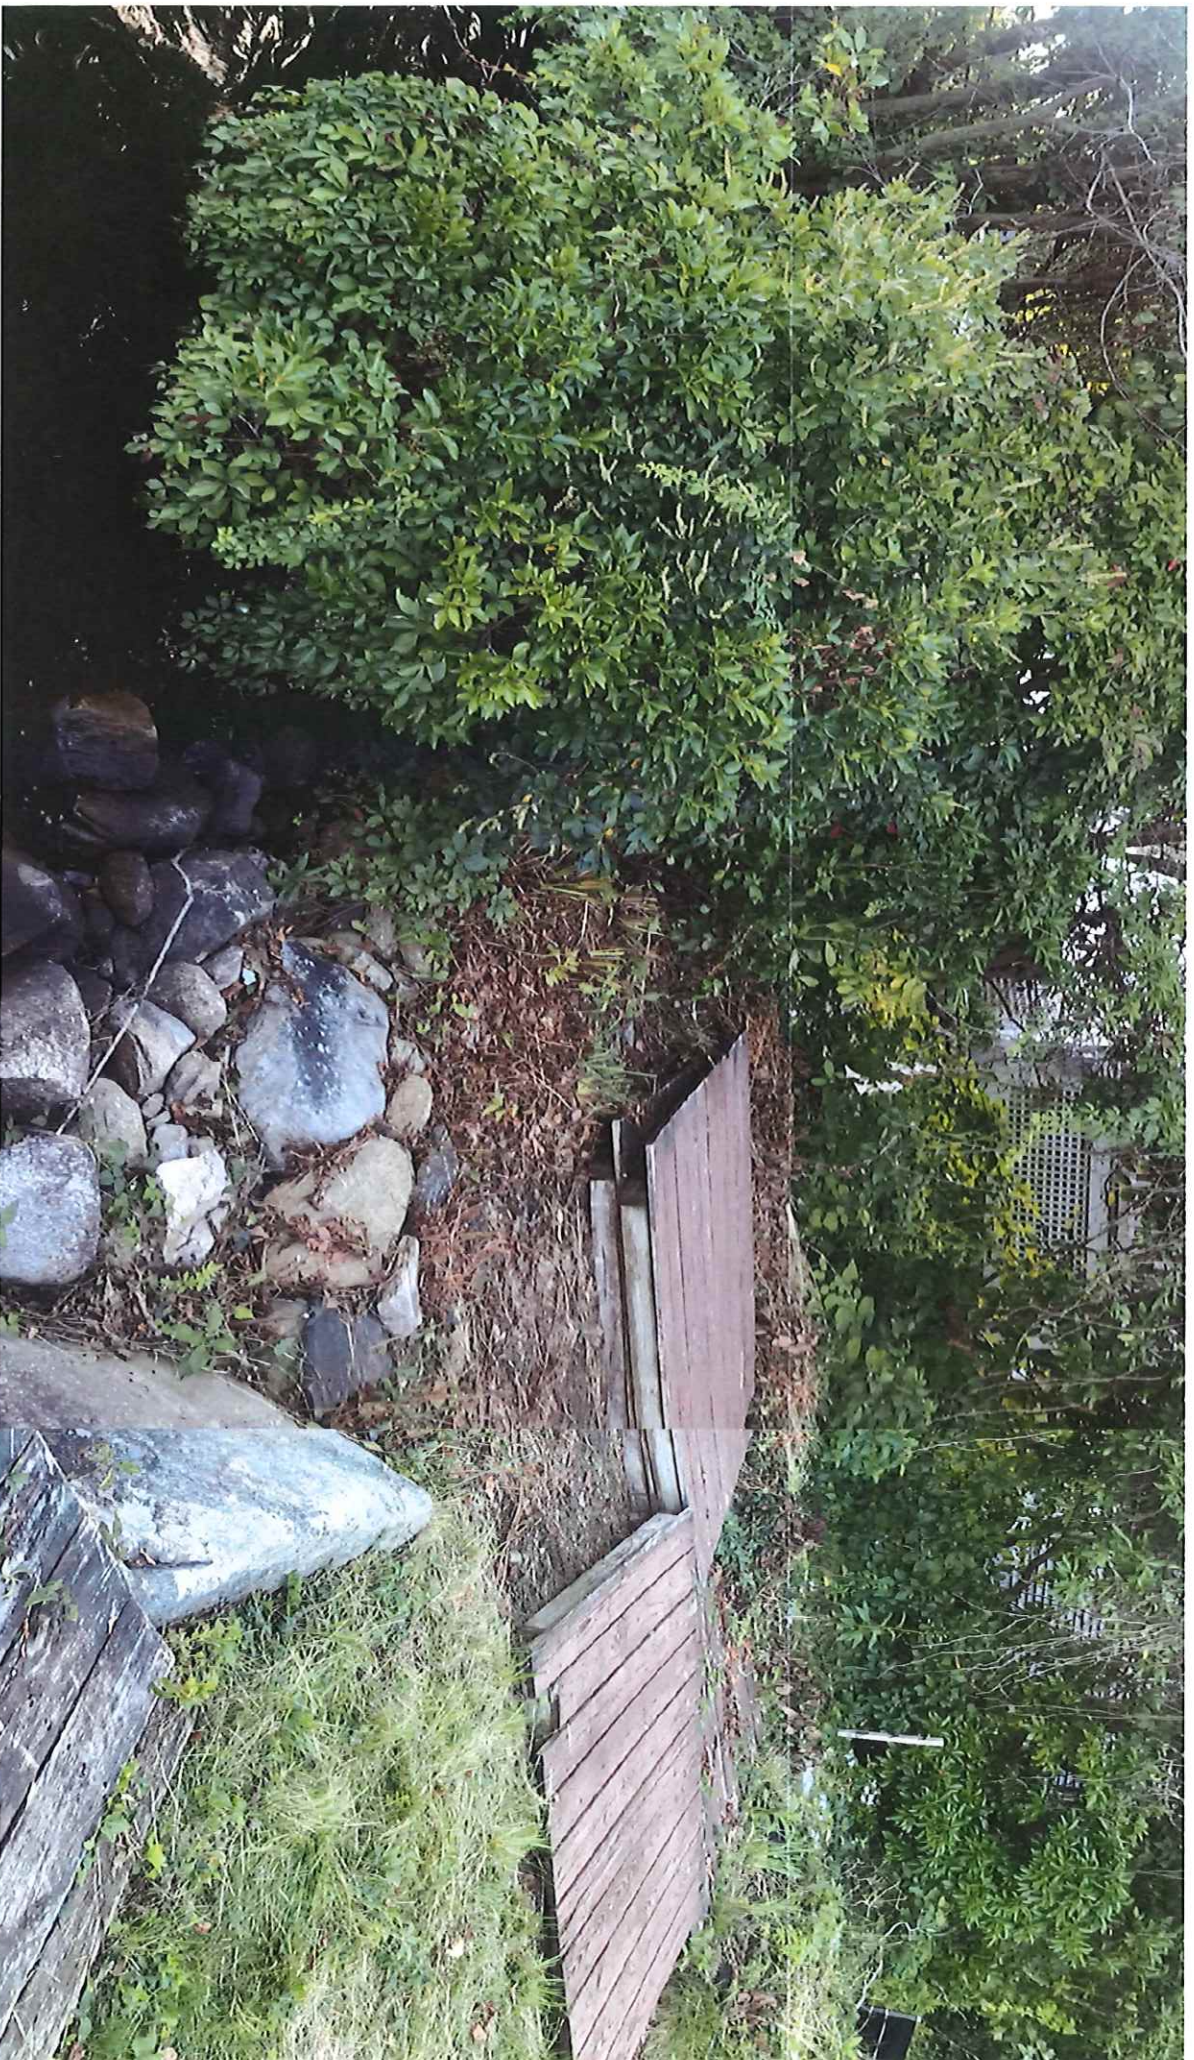
Existing, eroding wall looking westerly

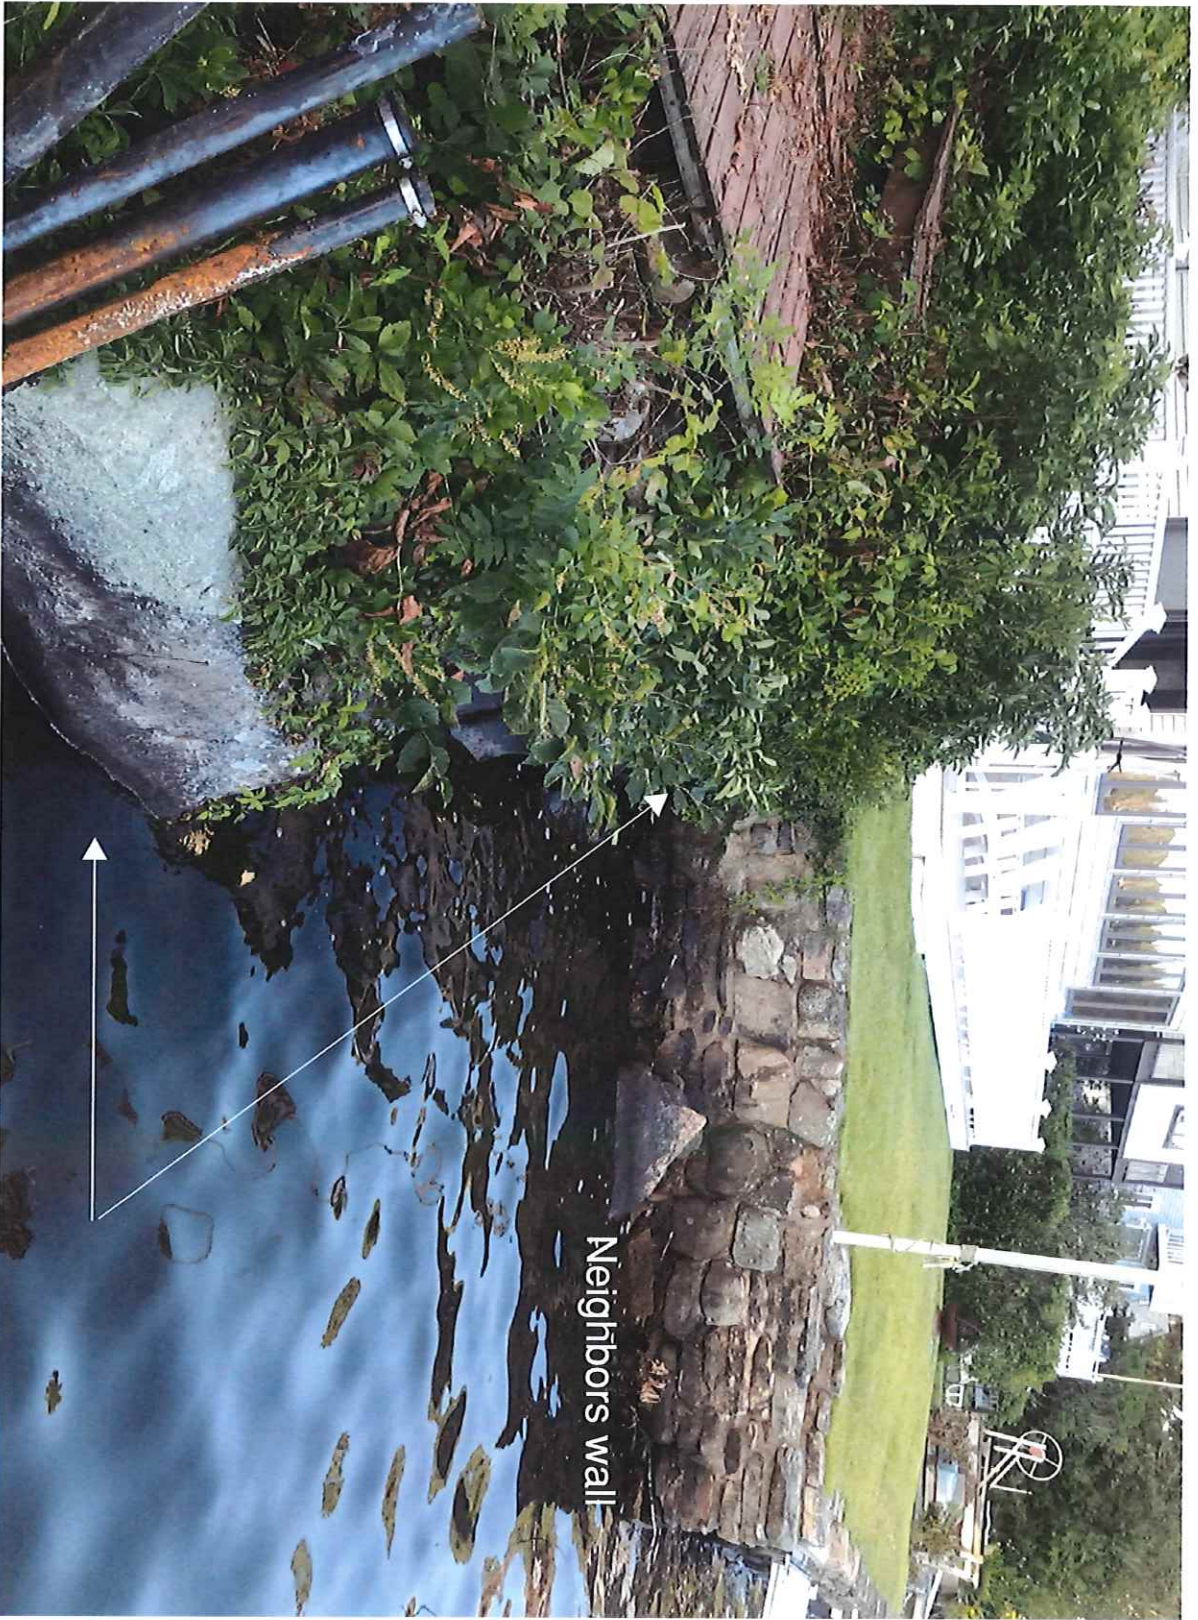
Existing, eroding wall looking easterly

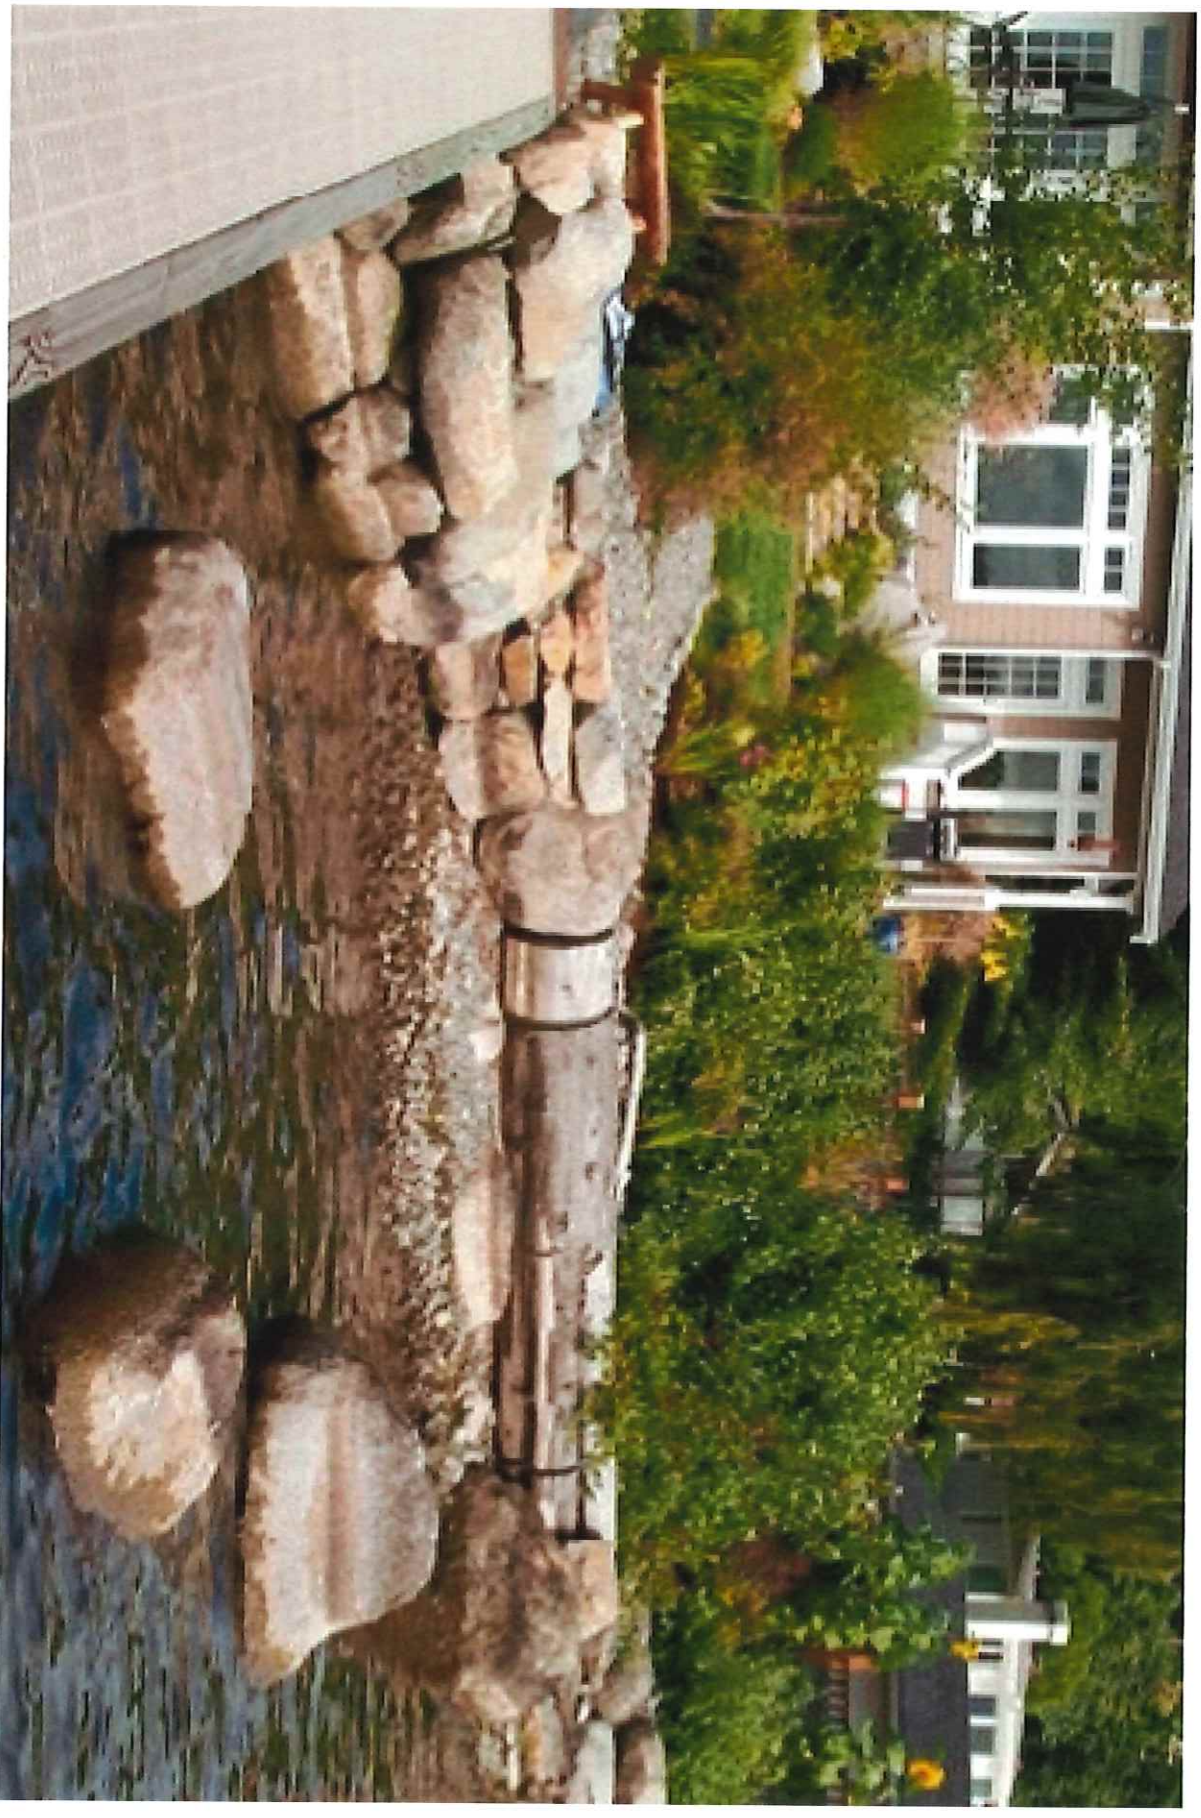
Wall showing dry laid boulders. Boulders in water help diffuse wave action and erosion but limit water use
