Town of East Hampton

Department of Energy & Environmental Protection
Lake Pocotopaug Watershed Water Quality Improvements

Project # - 2020-52

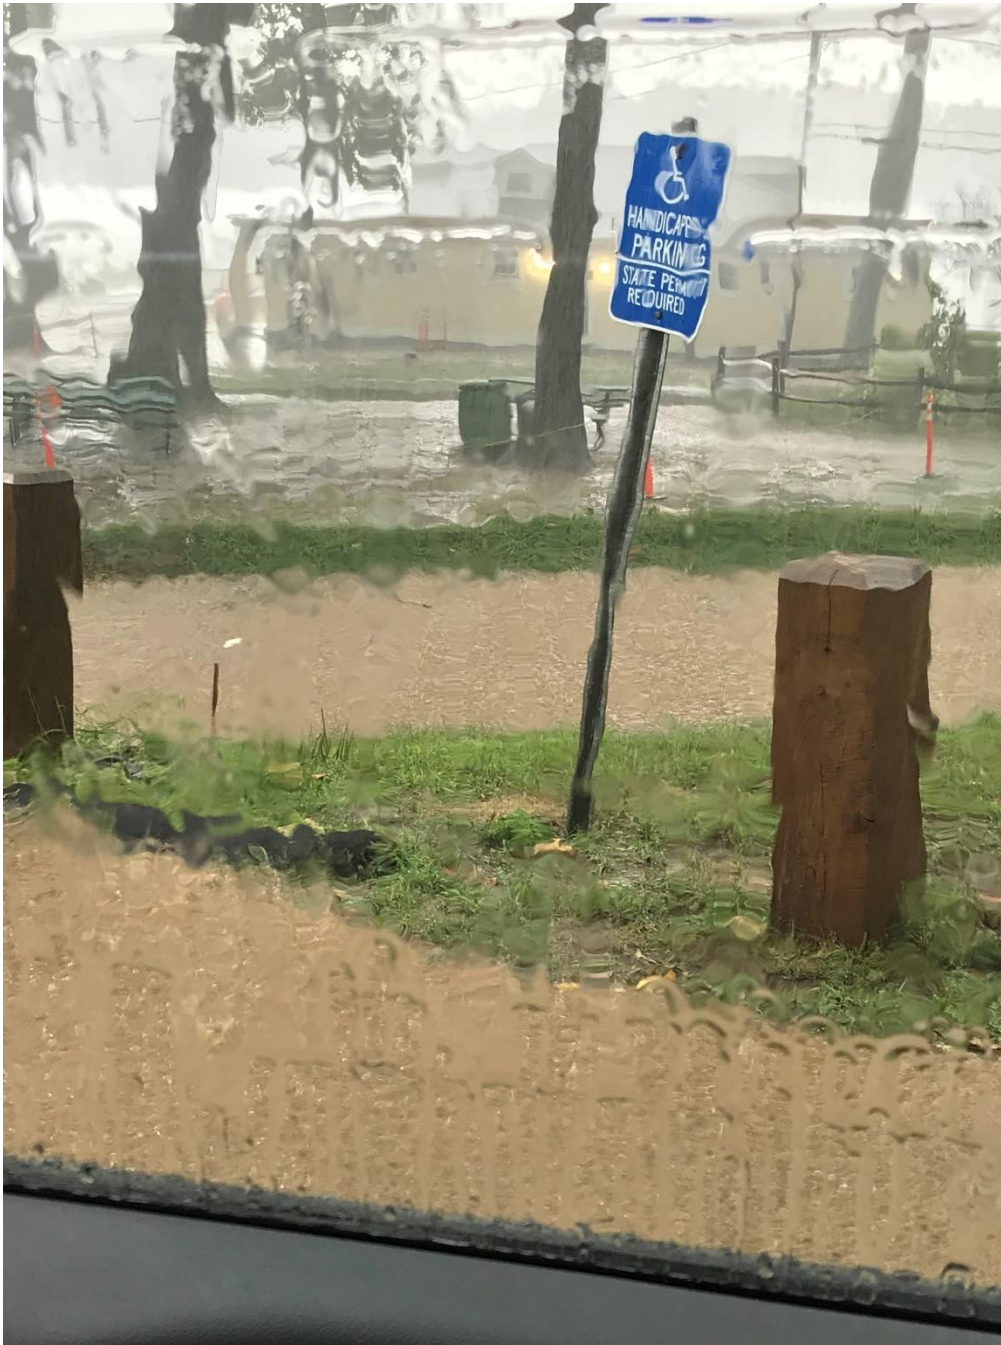
Figure 1 Bio retention system #1 Sears Park after 4.5" rain storm

The results of these projects have proven successful in the short term, you can view the TP and TN levels indicated on the GRTS forms with this final report. Additionally, we have received one large storm on August 24th that accumulated 4.5" of heavy rainfall in a 2.5-hour time frame, this is the equivalent of a 15 year storm. Each of the above LID projects held up to this amount of rainfall and quickly infiltrated into the ground. We will continue to monitor these locations during an active rainfall to gain more insight into the success of these projects.

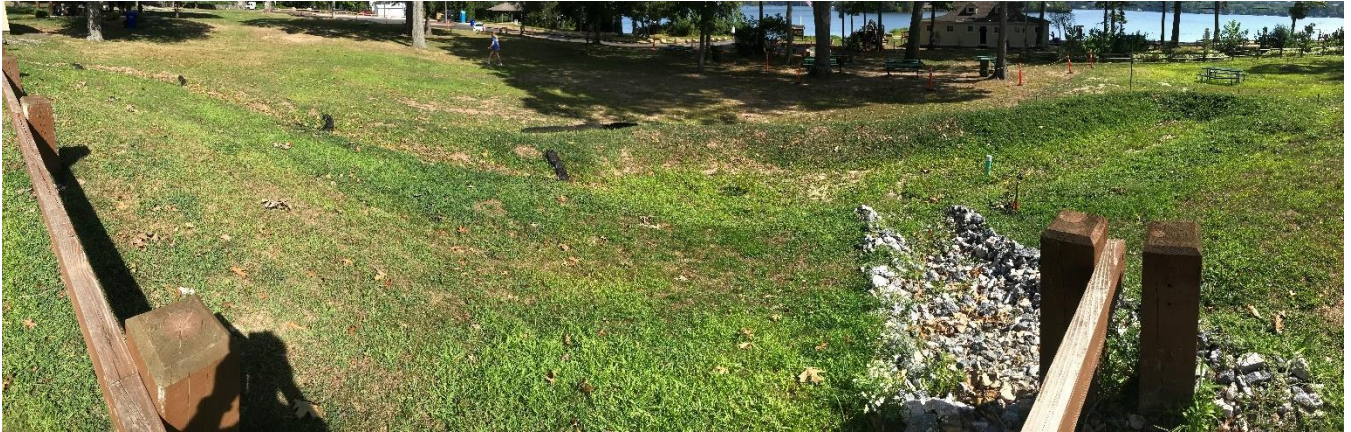
Figure 2 bioretention system #1 Sears Park

Sears Park is the largest body of land owned by the town of East Hampton that sits directly on the lake front. With roughly 5 acres of land where the topography of the land collects water from North Main Street and the upper tennis and basketball courts then sheet flows across the upper parking lot in a north east flow then directly into Lake Pocotopaug. Sears Park is considered a high priority on the 9-point watershed plan, the park received two bio-retention basins on the upper East side to catch the flow off of the tennis courts and upper parking lot and one in the center of the park to catch the flow from the upper lot and North Main Street. Each basin was built to hold 3 feet of storm water with an overflow pipe set at 36" above ground that discharged additional storm water as needed into the rain garden on the south east side of the park. Both basins were designed for a 20-year storm and held up to that test when we received 4.5" of rainfall in 2.5 hours a few weeks ago. Additionally, Sears park was regraded at the boat launch and a Bod Pave porous paver system was installed to trap water and infiltrate it into the soils before reaching the lake. Beneath the paver system sits 12" of process material to allow for additional infiltration.

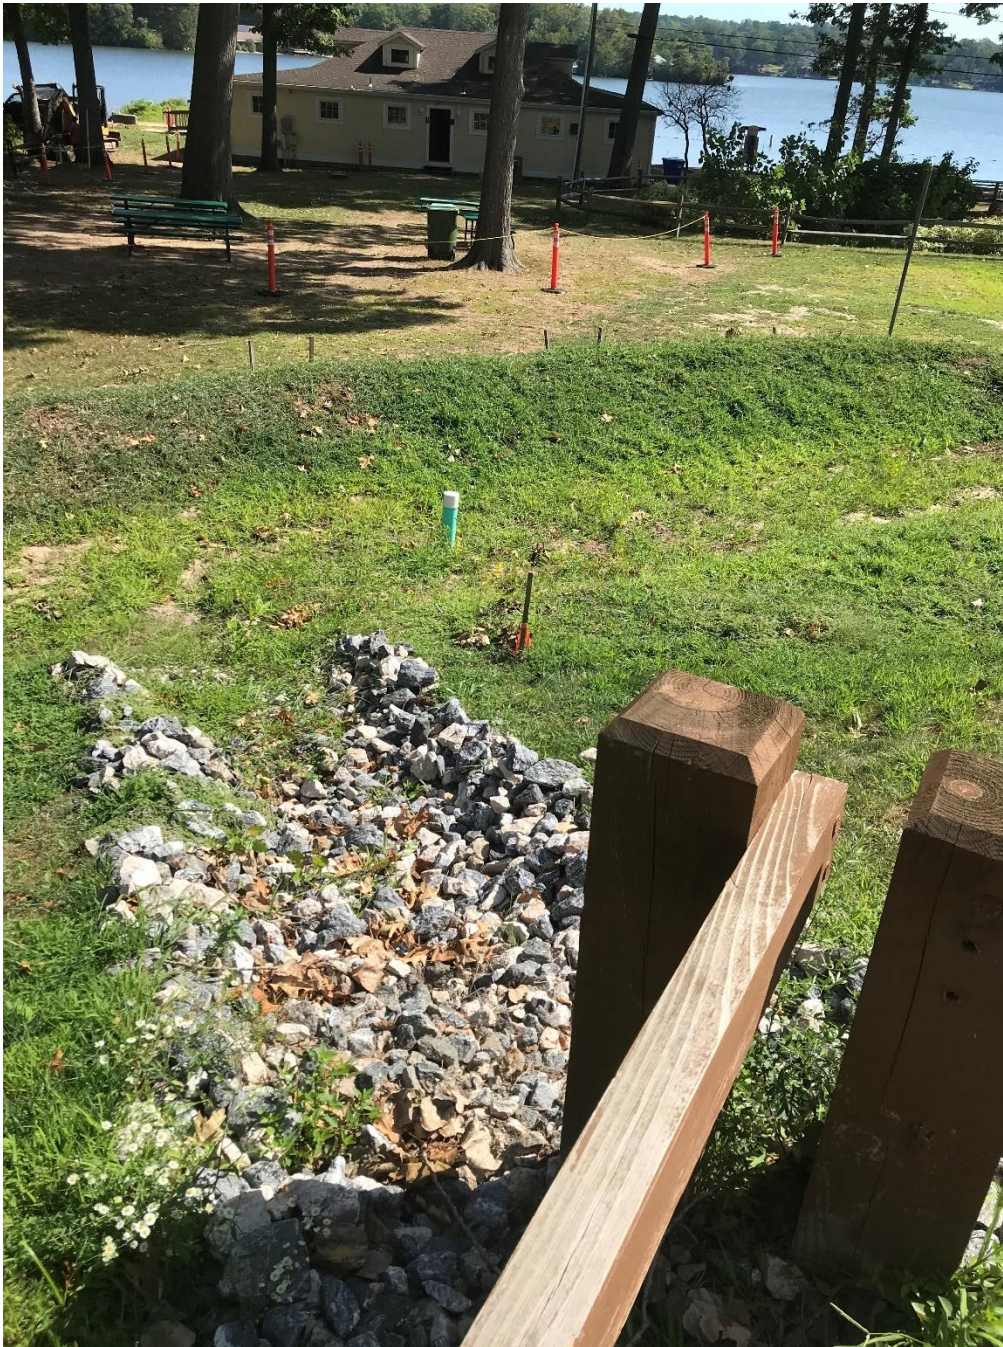
Figure 3 bio retention system #1 Sears Park

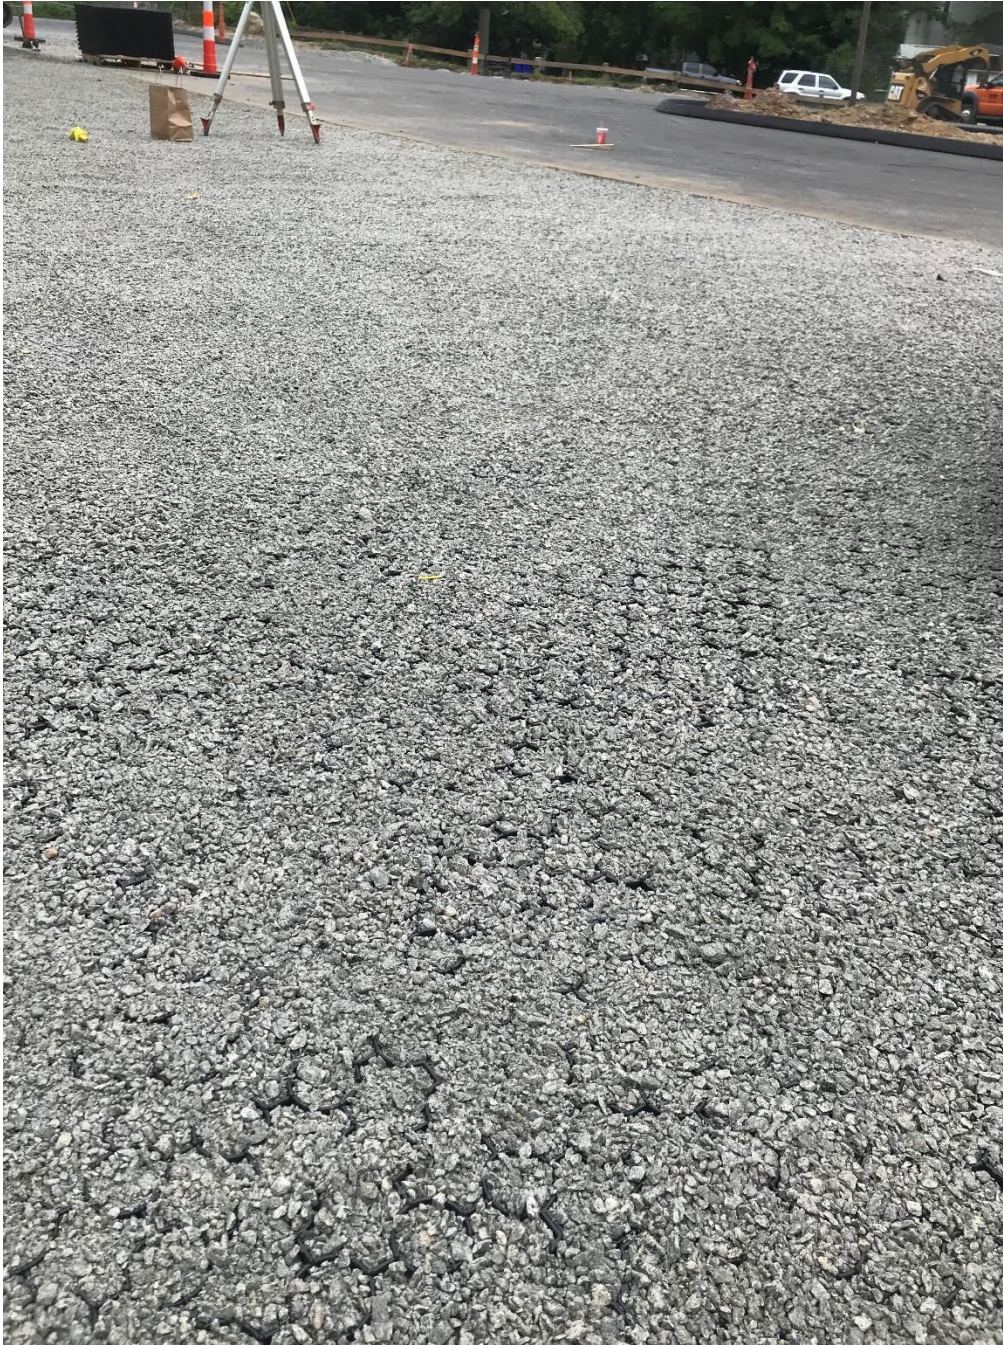
Figure 4 paver system at boat launch

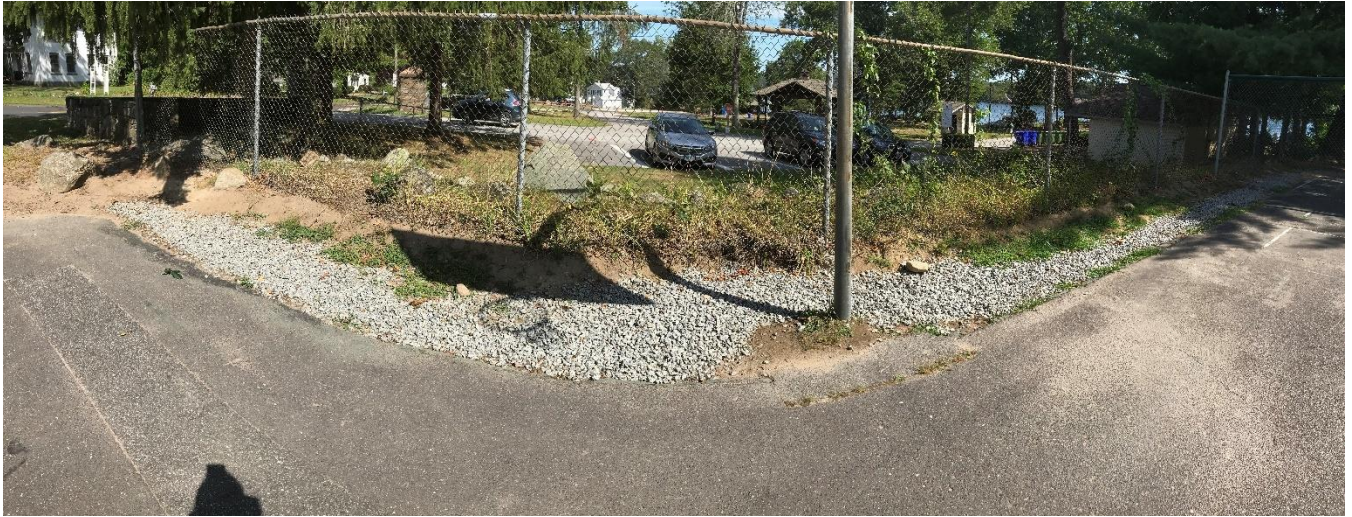
Figure 5 underdrain for bioretention system #2 at Sears Park

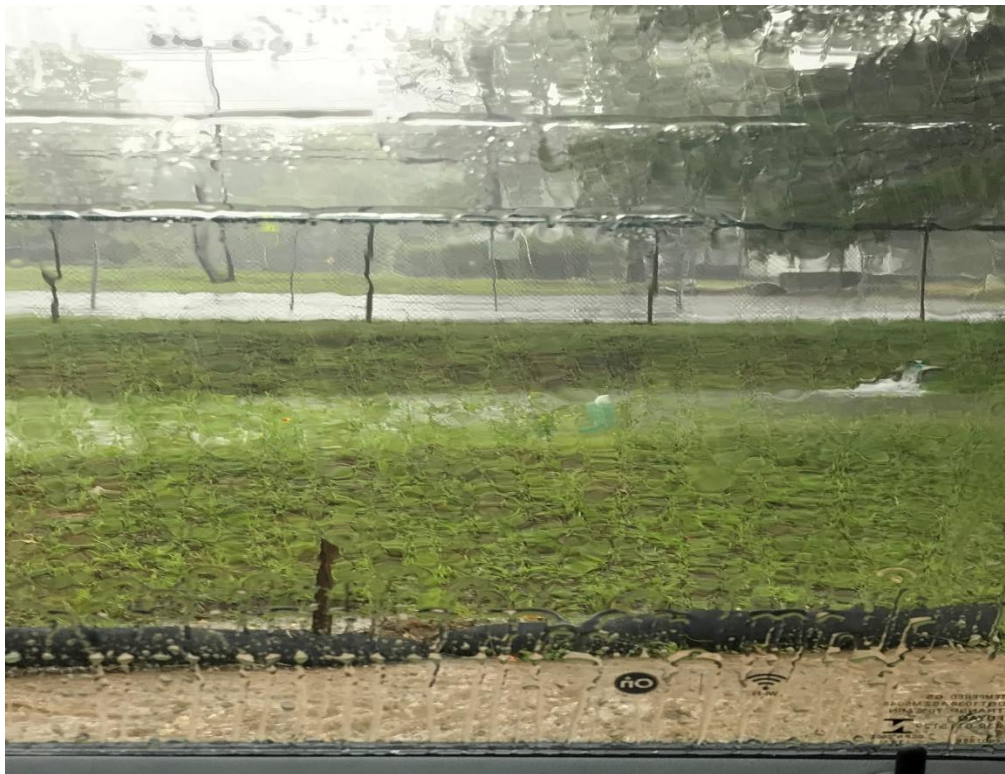
Figure 6 bioretention system #2 at Sears park during 4.5" rain storm

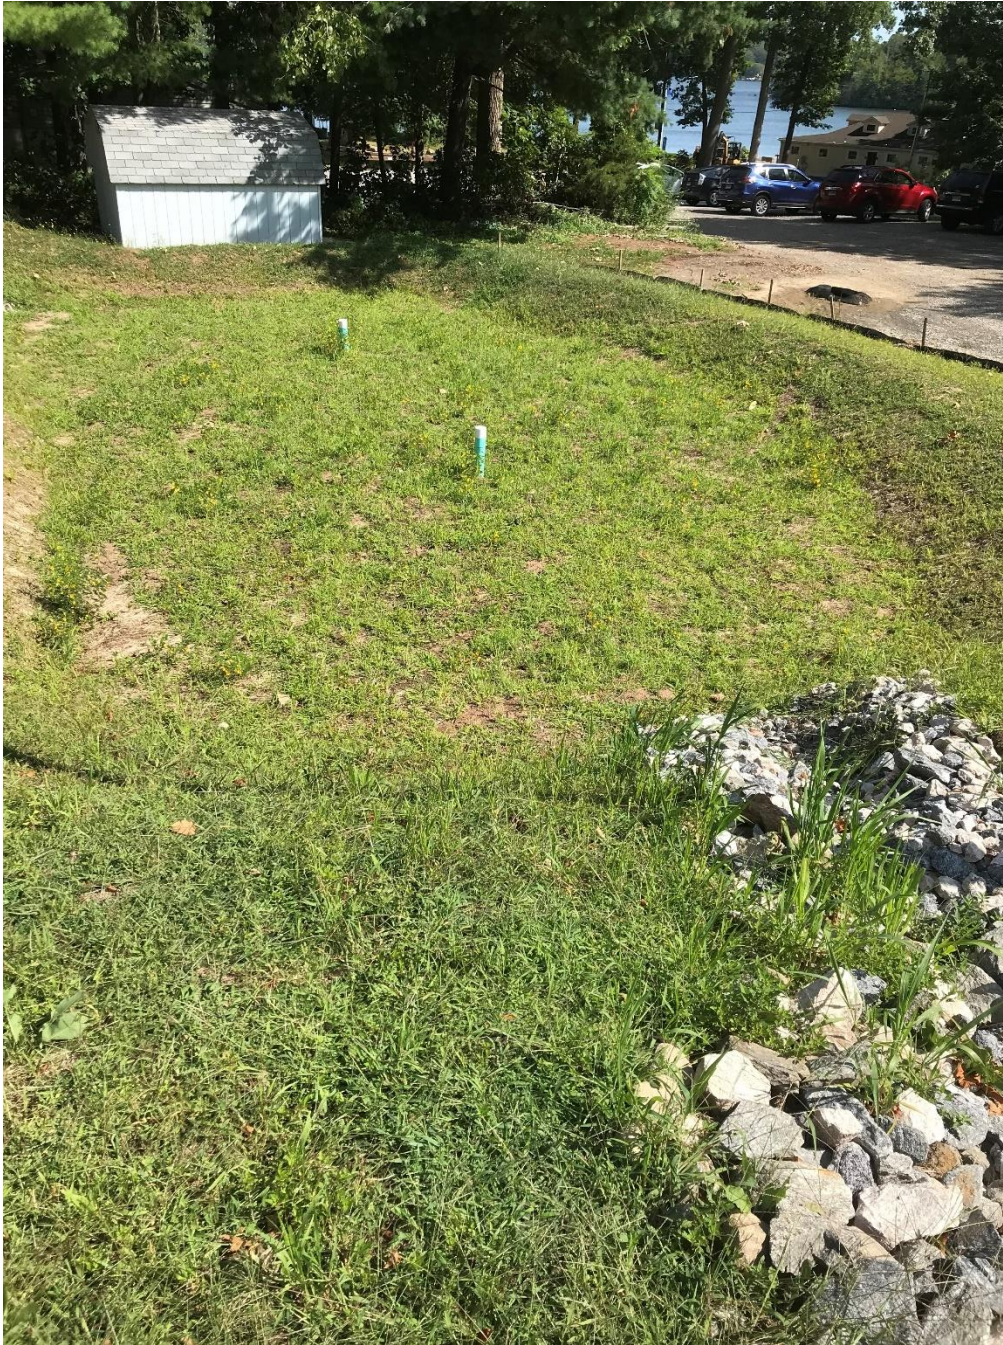
Figure 7 bioretention system #2 at Sears park

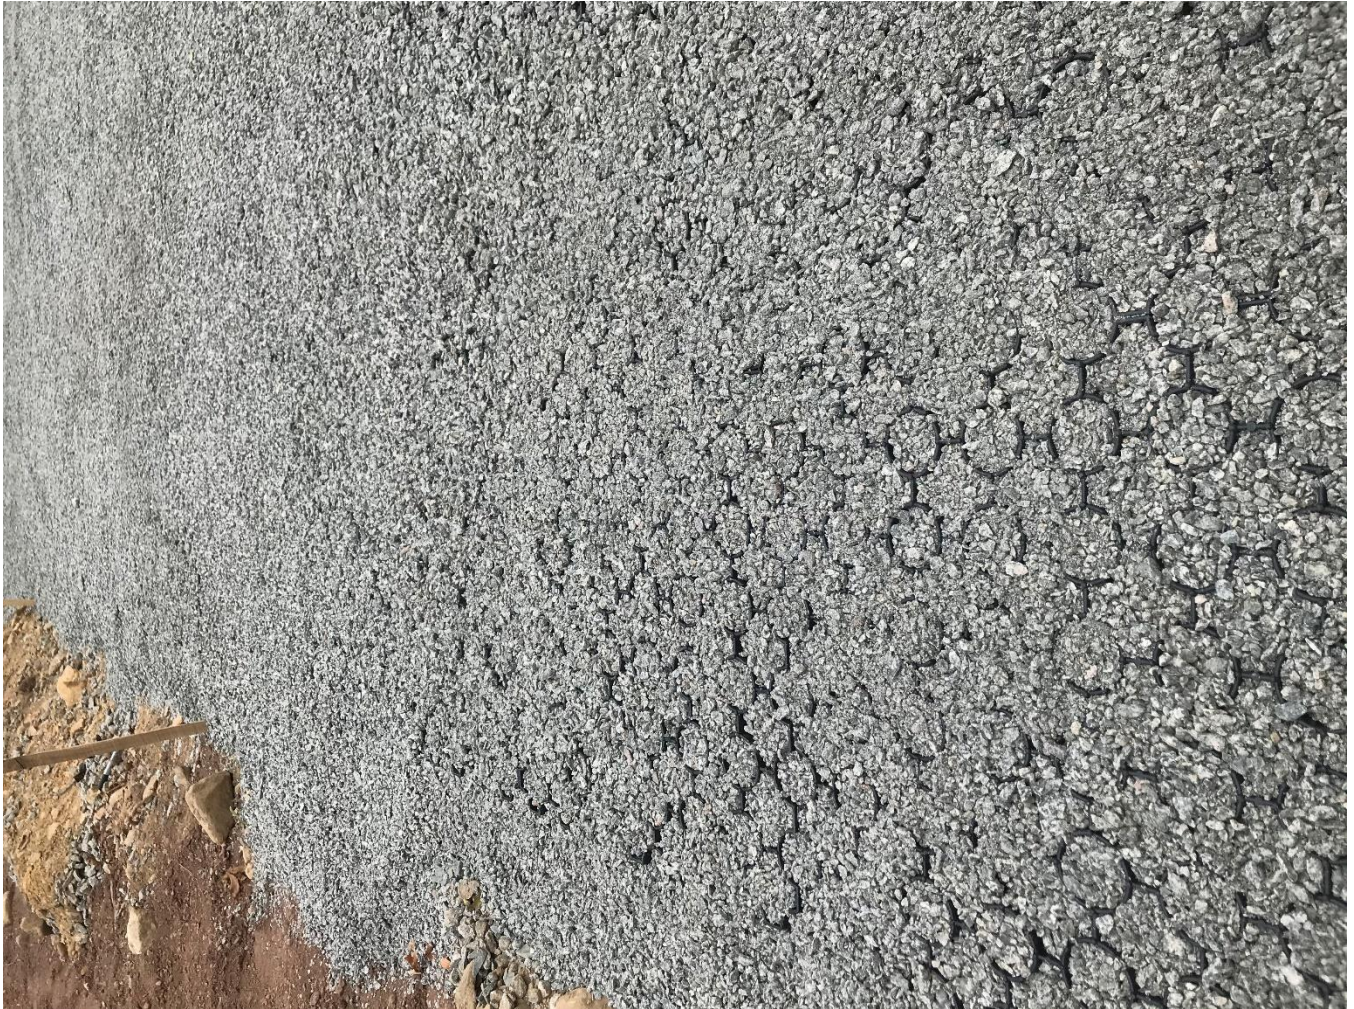
Figure 8 paver system at North end Mohegan (Wangonk)

installed a large rip rap swale on the North side of the beach to allow for nutrient settlement. The storm water discharge is a result of steep grades from Mohican Trail and Seminole Trail. Additionally, a paver system was installed to control nutrient penetration.

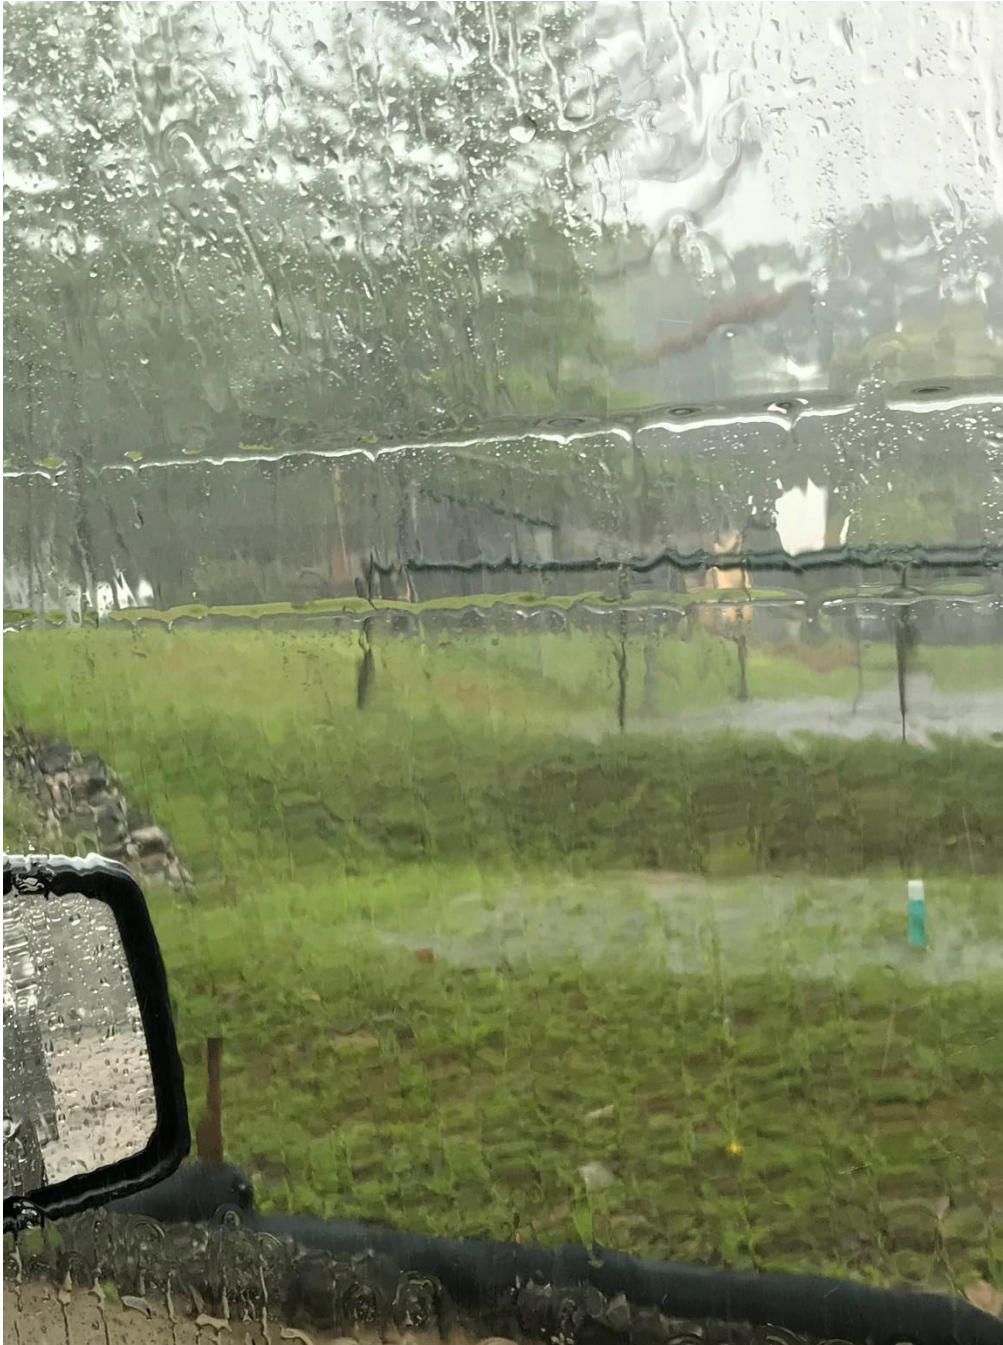
Figure 9 bioretention system #2 at Sears Park following 4.5" rainfall

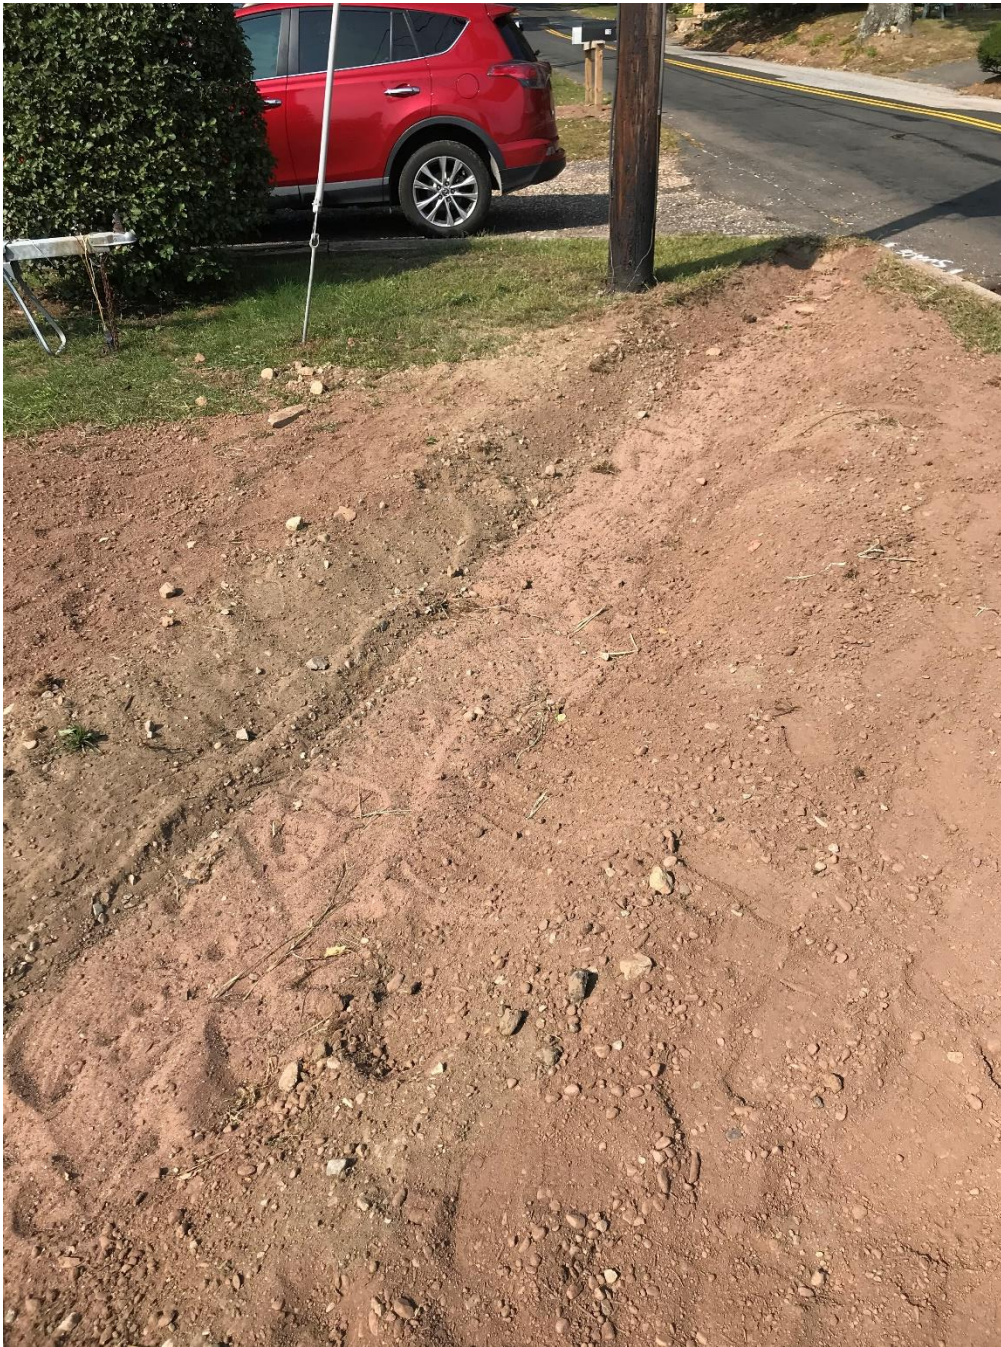
Figure 10 Vegetative swale on Clark hill leading to bioretention system

Clark Hill runs east of the lake and is perpendicular to Lake drive. Its topography grade is significant and as a result dumps large amounts of storm water during each storm directly in the lake and surrounding storm drains. The process of LID for lower Clark Hill was to take the water from the street and funnel it through a vegetative swale directly into a bioretention system located on town property adjacent to the road. The soils were tested and as a result the determination was made that infiltration at this location would be suitable to develop a small detention pond this project would include an overflow pipe if the water accumulates too quickly due to rapid storm water discharge off Clark hill or a 50 year storm. The overflow pipe would discharge from the basin on the far end to allow for some infiltration and would discharge into a lower storm drain further down the property line prior to being discharged into the lake.

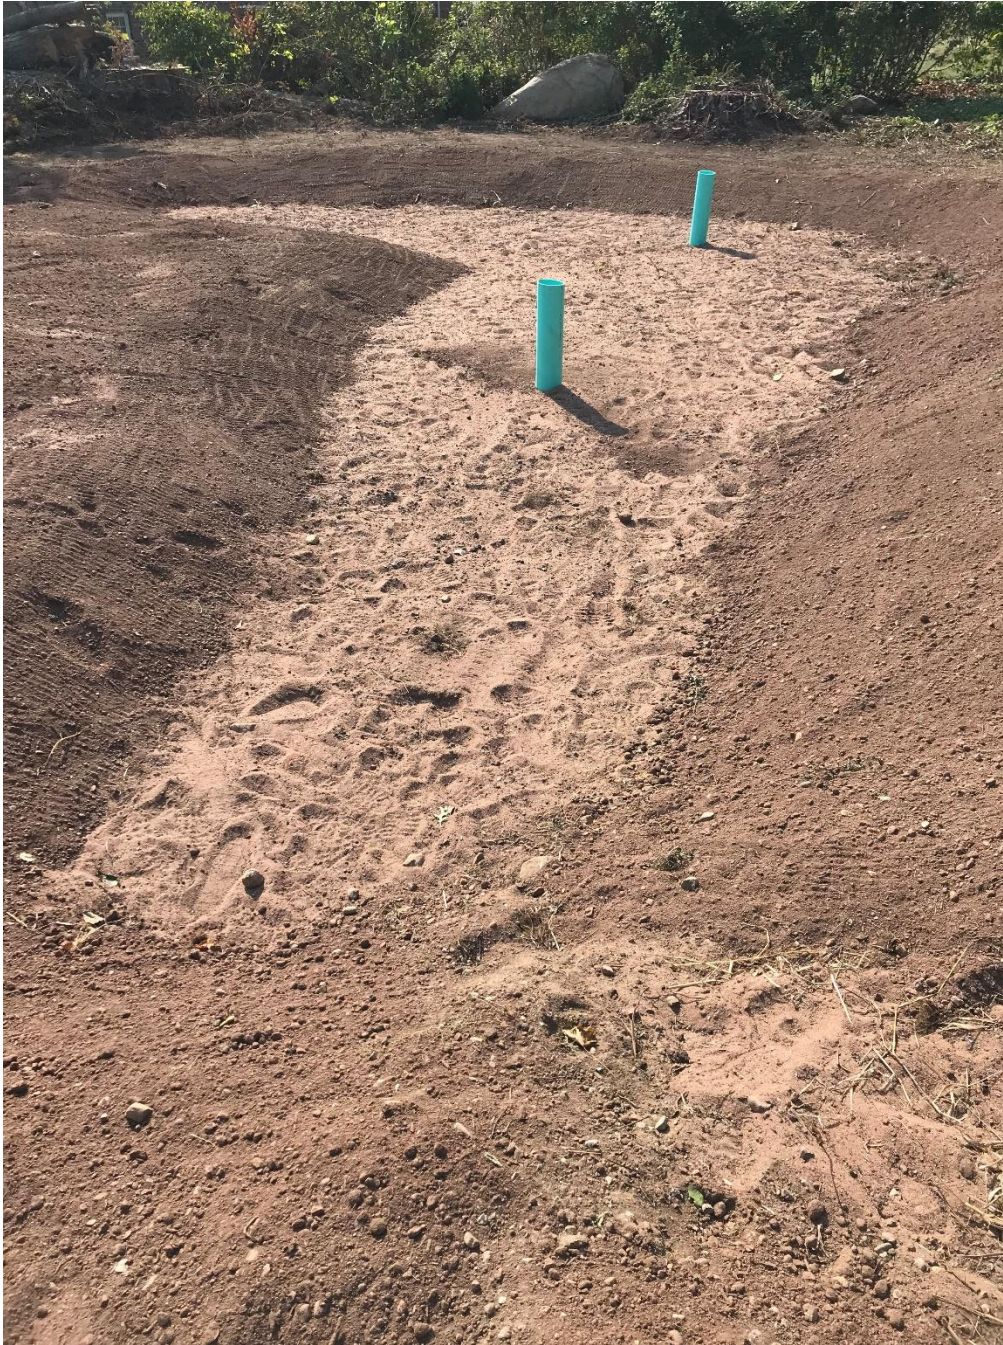
Figure 11 Bioretention system on Clark Hill (pre seed)

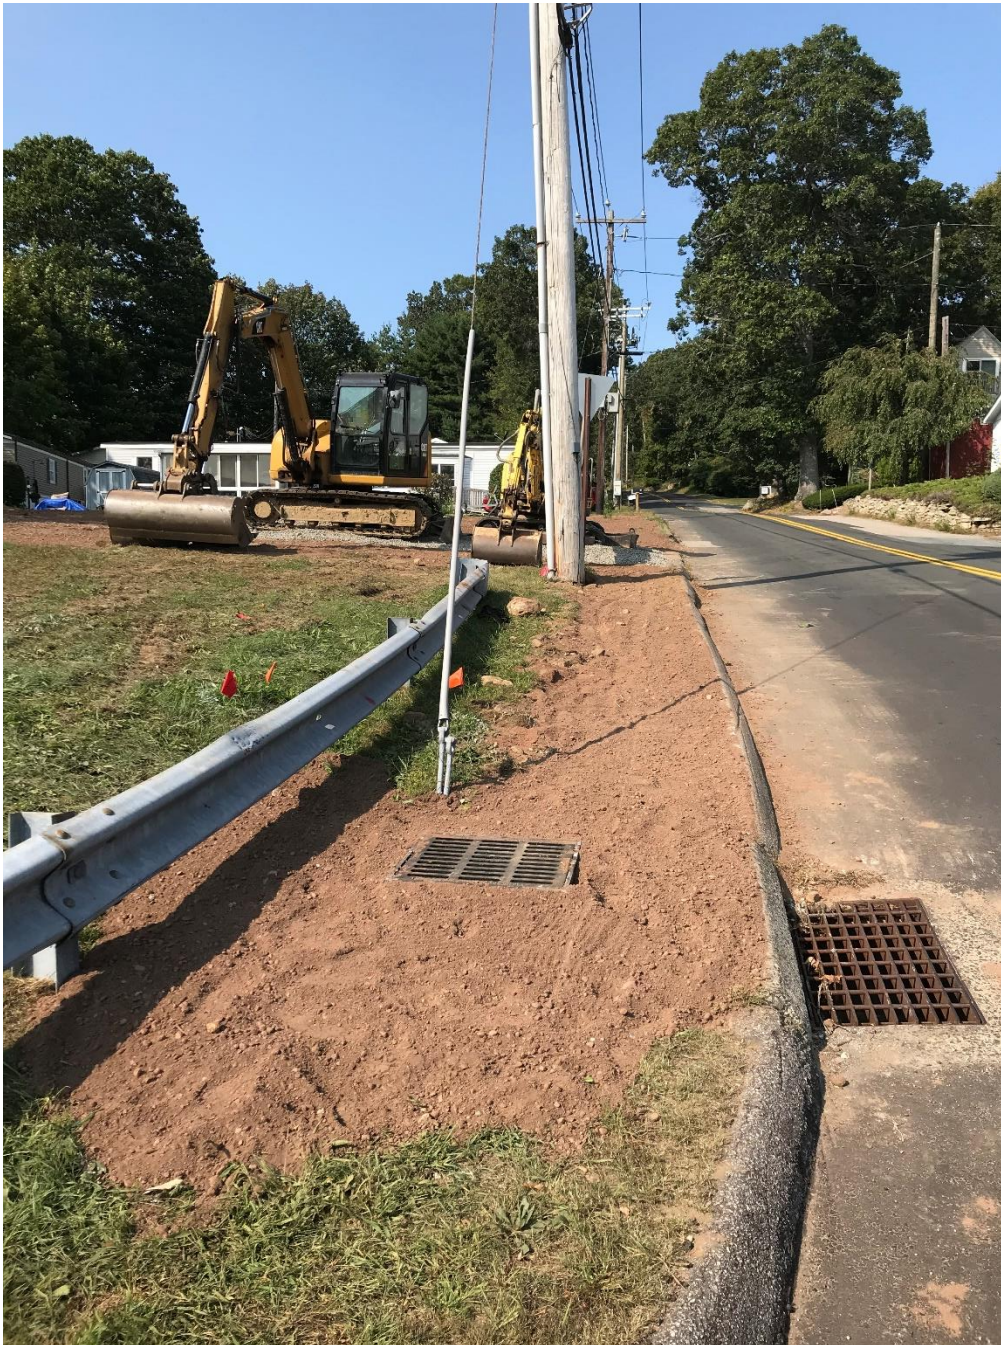
Figure12 Overflow discharge to storm drain on Clark Hill

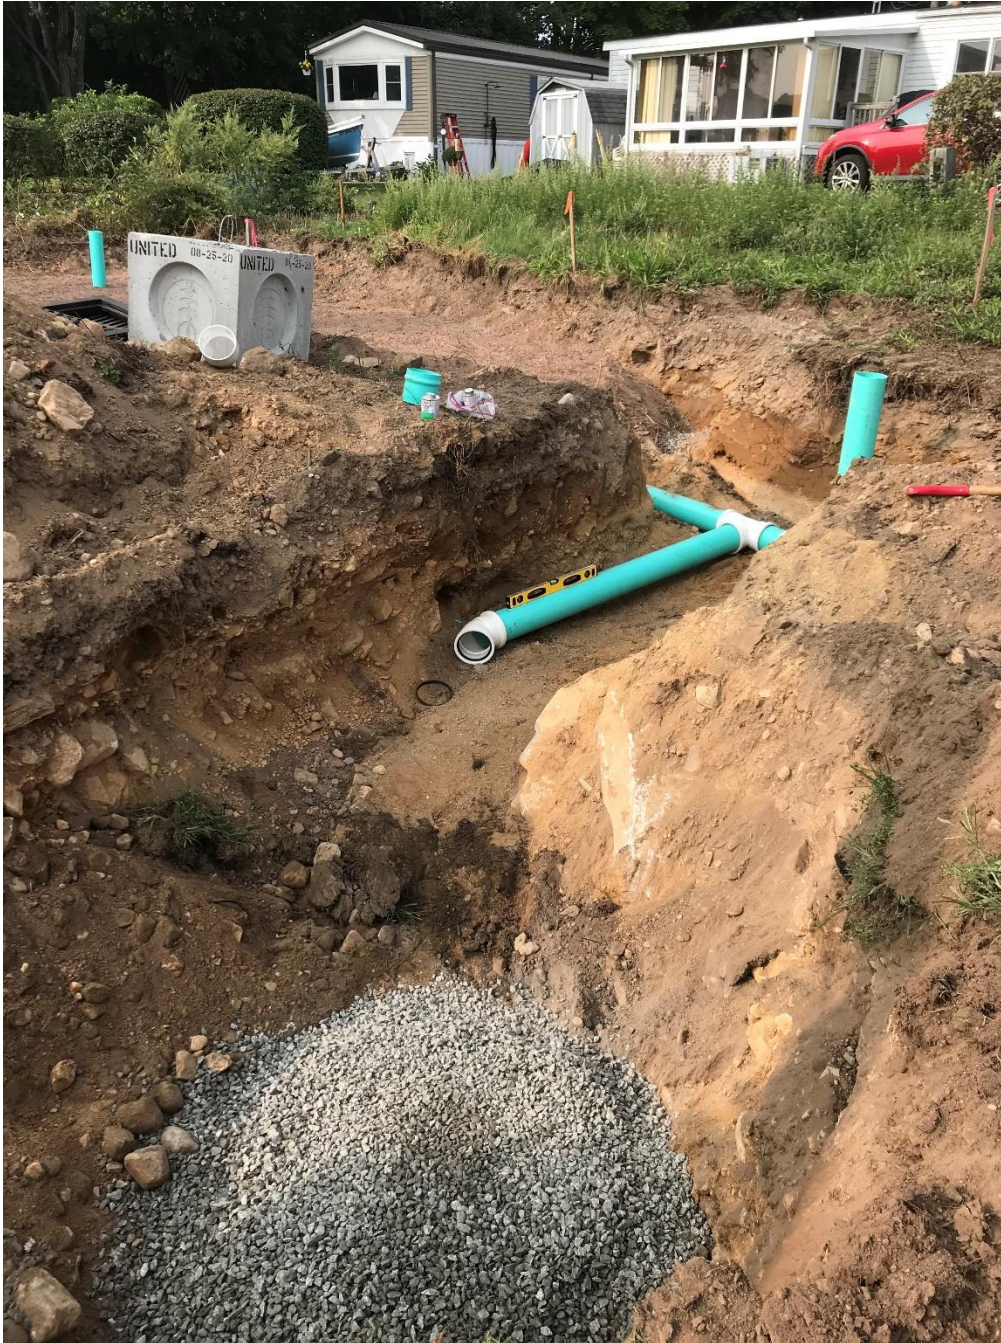
Figure 13 Underground discharge pipes on Clark Hill
