**PHASE I ENVIRONMENTAL  
SITE ASSESSMENT**

**103 Main Street  
East Hampton, Connecticut**

**Project Number: CTA3-0302  
August 1, 2003**

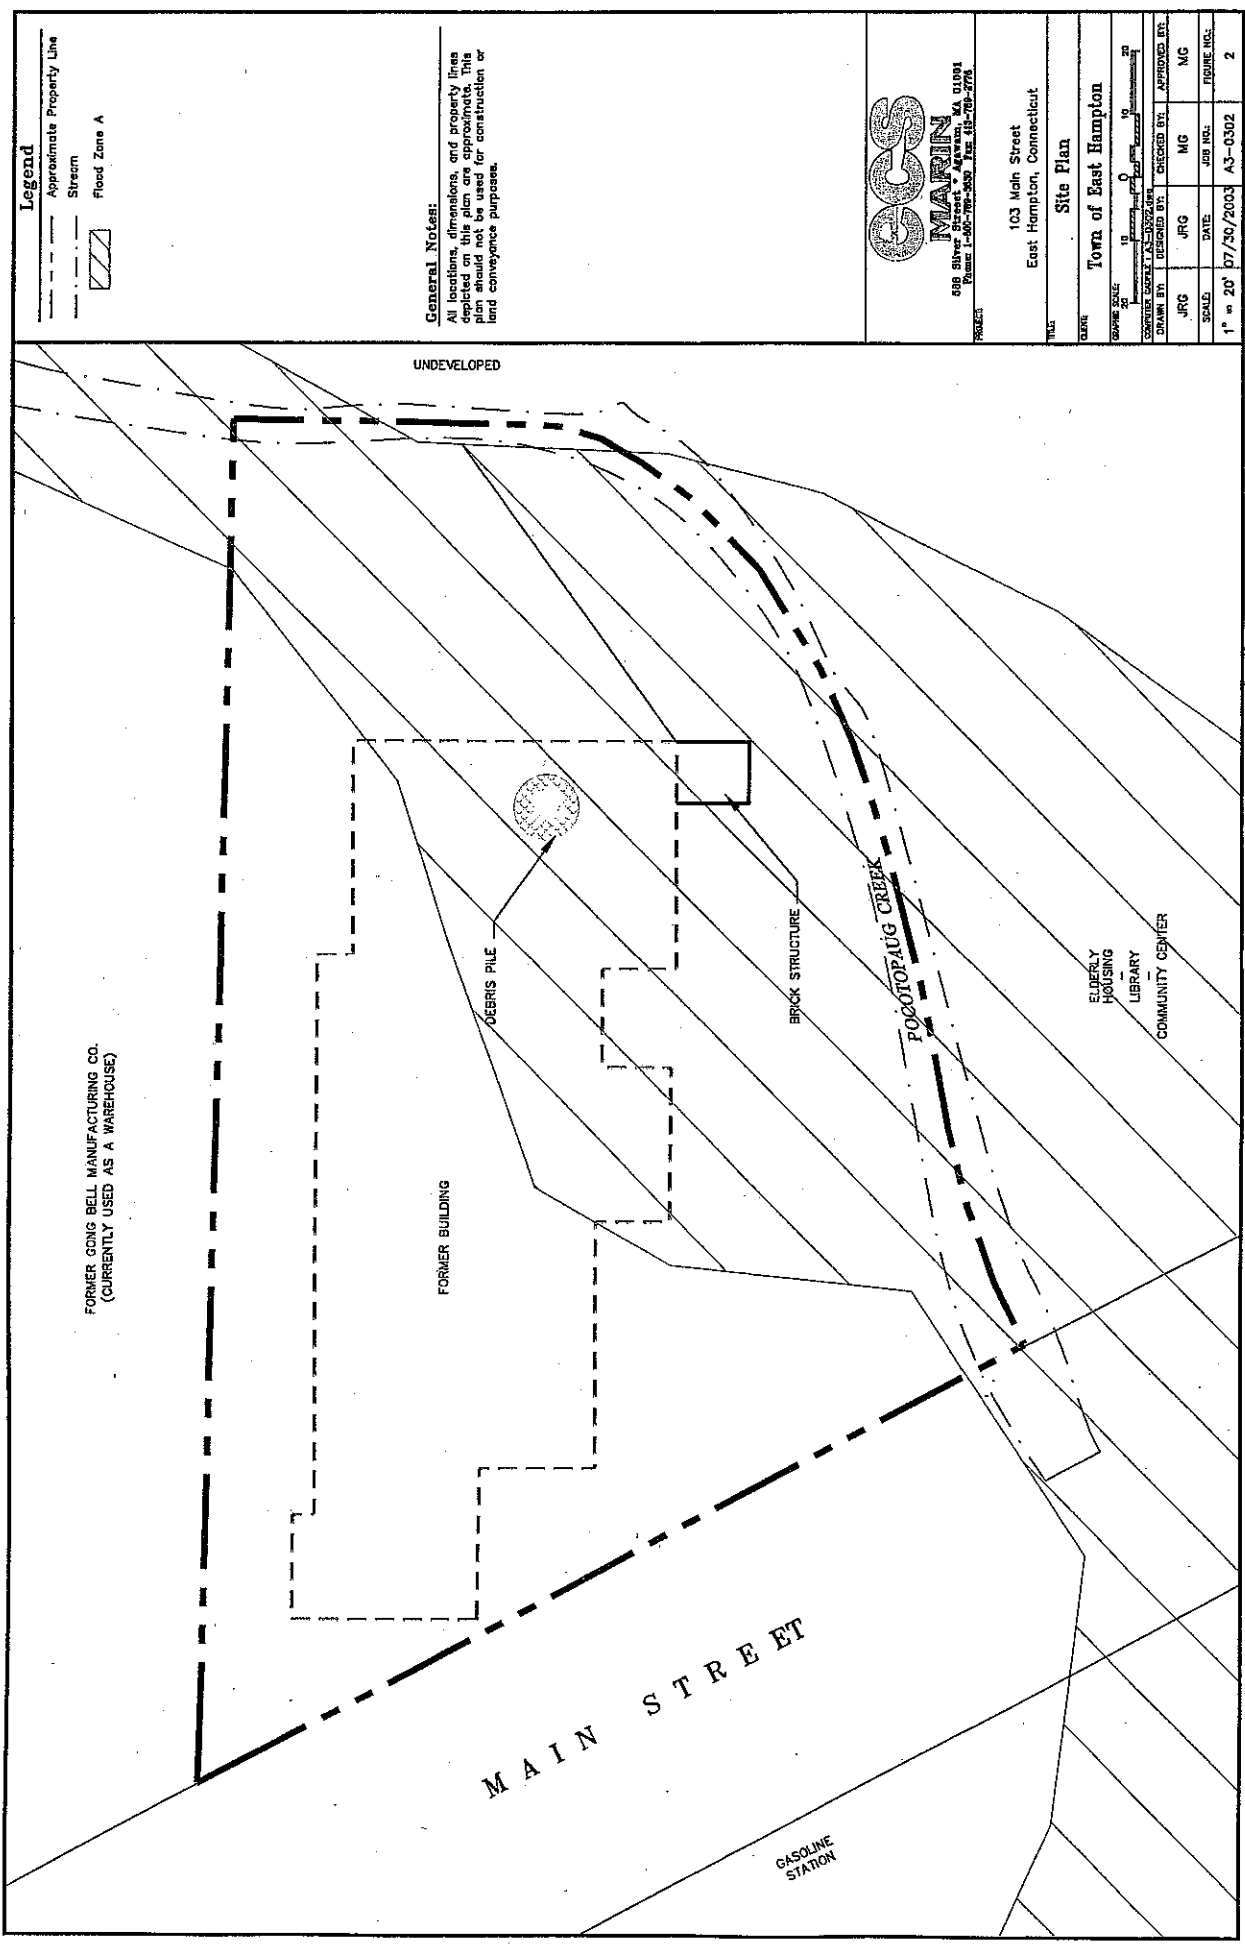
<b>Town of East Hampton</b>			
DATE: 07/30/2003	DESIGNED BY: JRG	CHECKED BY: JRG	APPROVED BY: MG
SCALE: 1" = 20'	DATE: 07/30/2003	JOB NO.: A3-0302	FIGURE NO.: 2

**TITLE:** Site Plan
