# **REMEDIAL ACTION PLAN**

**FORMER GONG BELL SITE  
103 MAIN STREET  
EAST HAMPTON, CONNECTICUT**

**AECOM USA, Inc.  
500 Enterprise Drive  
Rocky Hill, Connecticut 06067**

**July 2010**

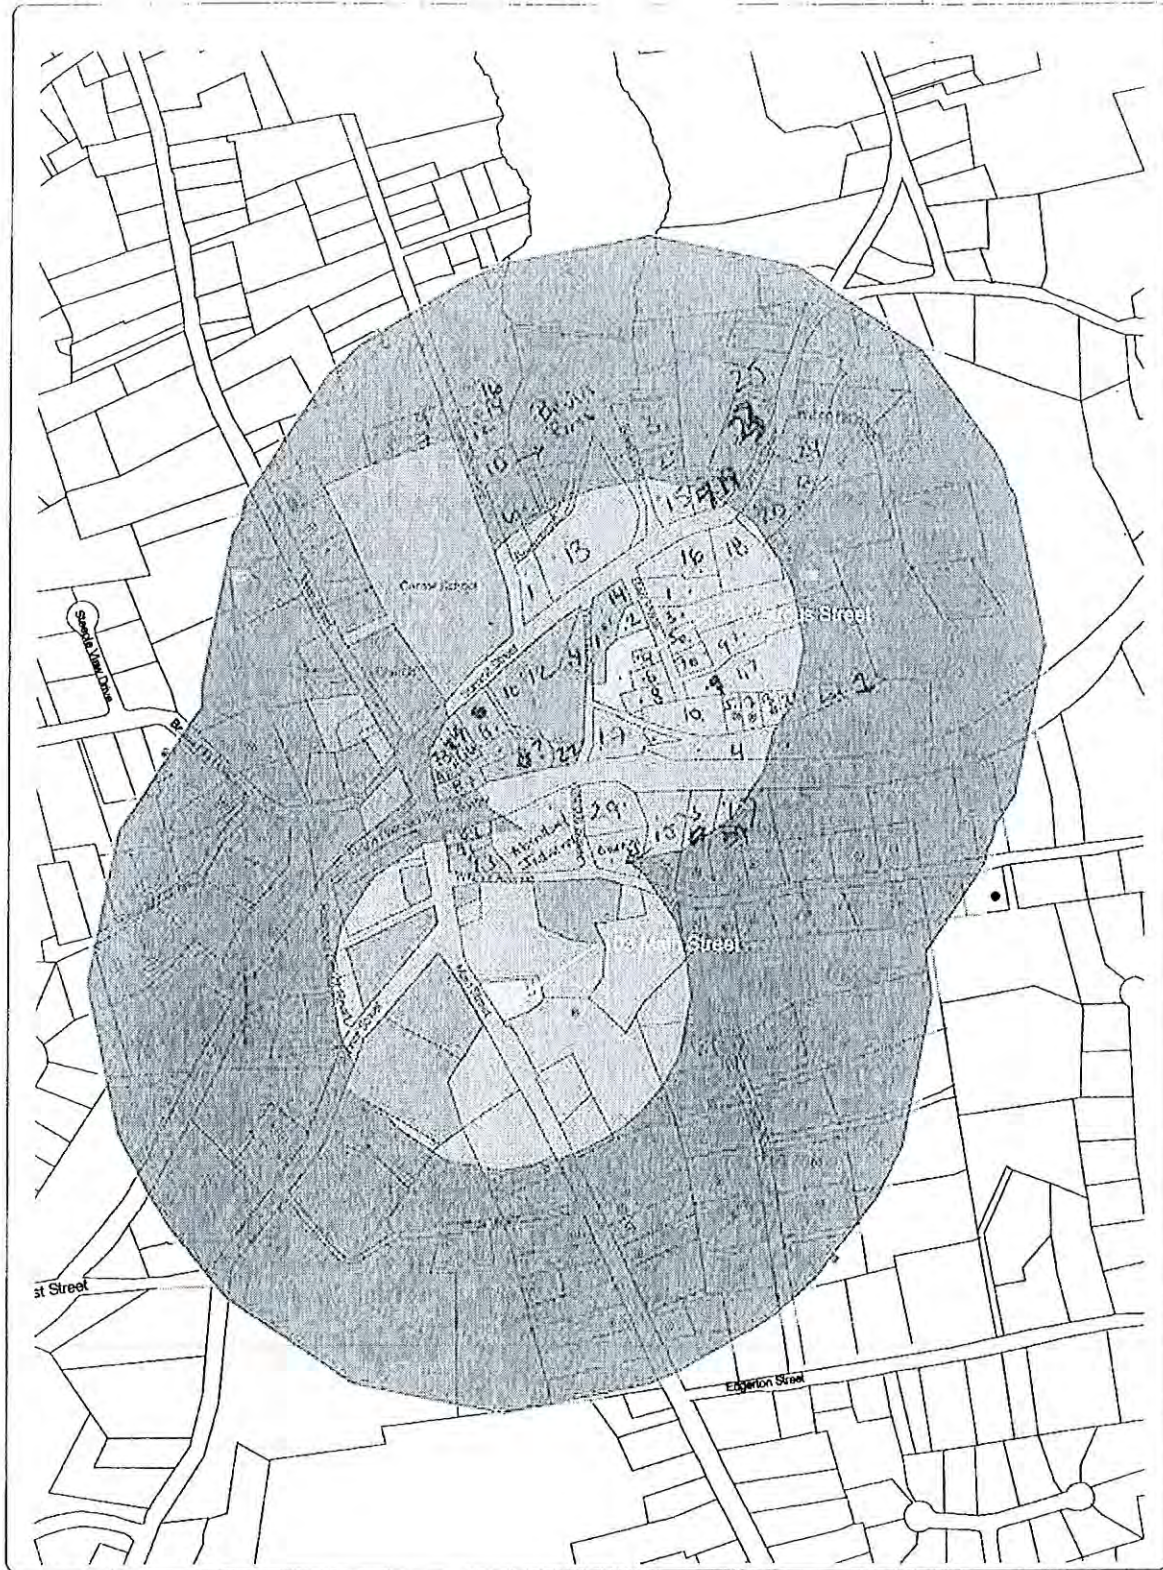
Figure 1

- Approximate location of visible wellhead. Observed during windshield survey.
- Town-owned property
- East Hampton parcels/property boundaries
- Community water customer
- 500-foot buffer of town-owned property
- 1/4-mile buffer of town-owned property

Based on the preparation of this receptor survey, 62 properties are within the 500-foot contiguous potential receptor areas. CTDEP requires any drinking water wells located on these properties to be sampled for the Constituents of Concern (COCs) including TCE, lead, and antimony. Tighe & Bond recommends that the former facility well be re-sampled for pesticides. It is also recommended that CTDEP be consulted for sampling of wells for pesticides in the potential receptor areas.

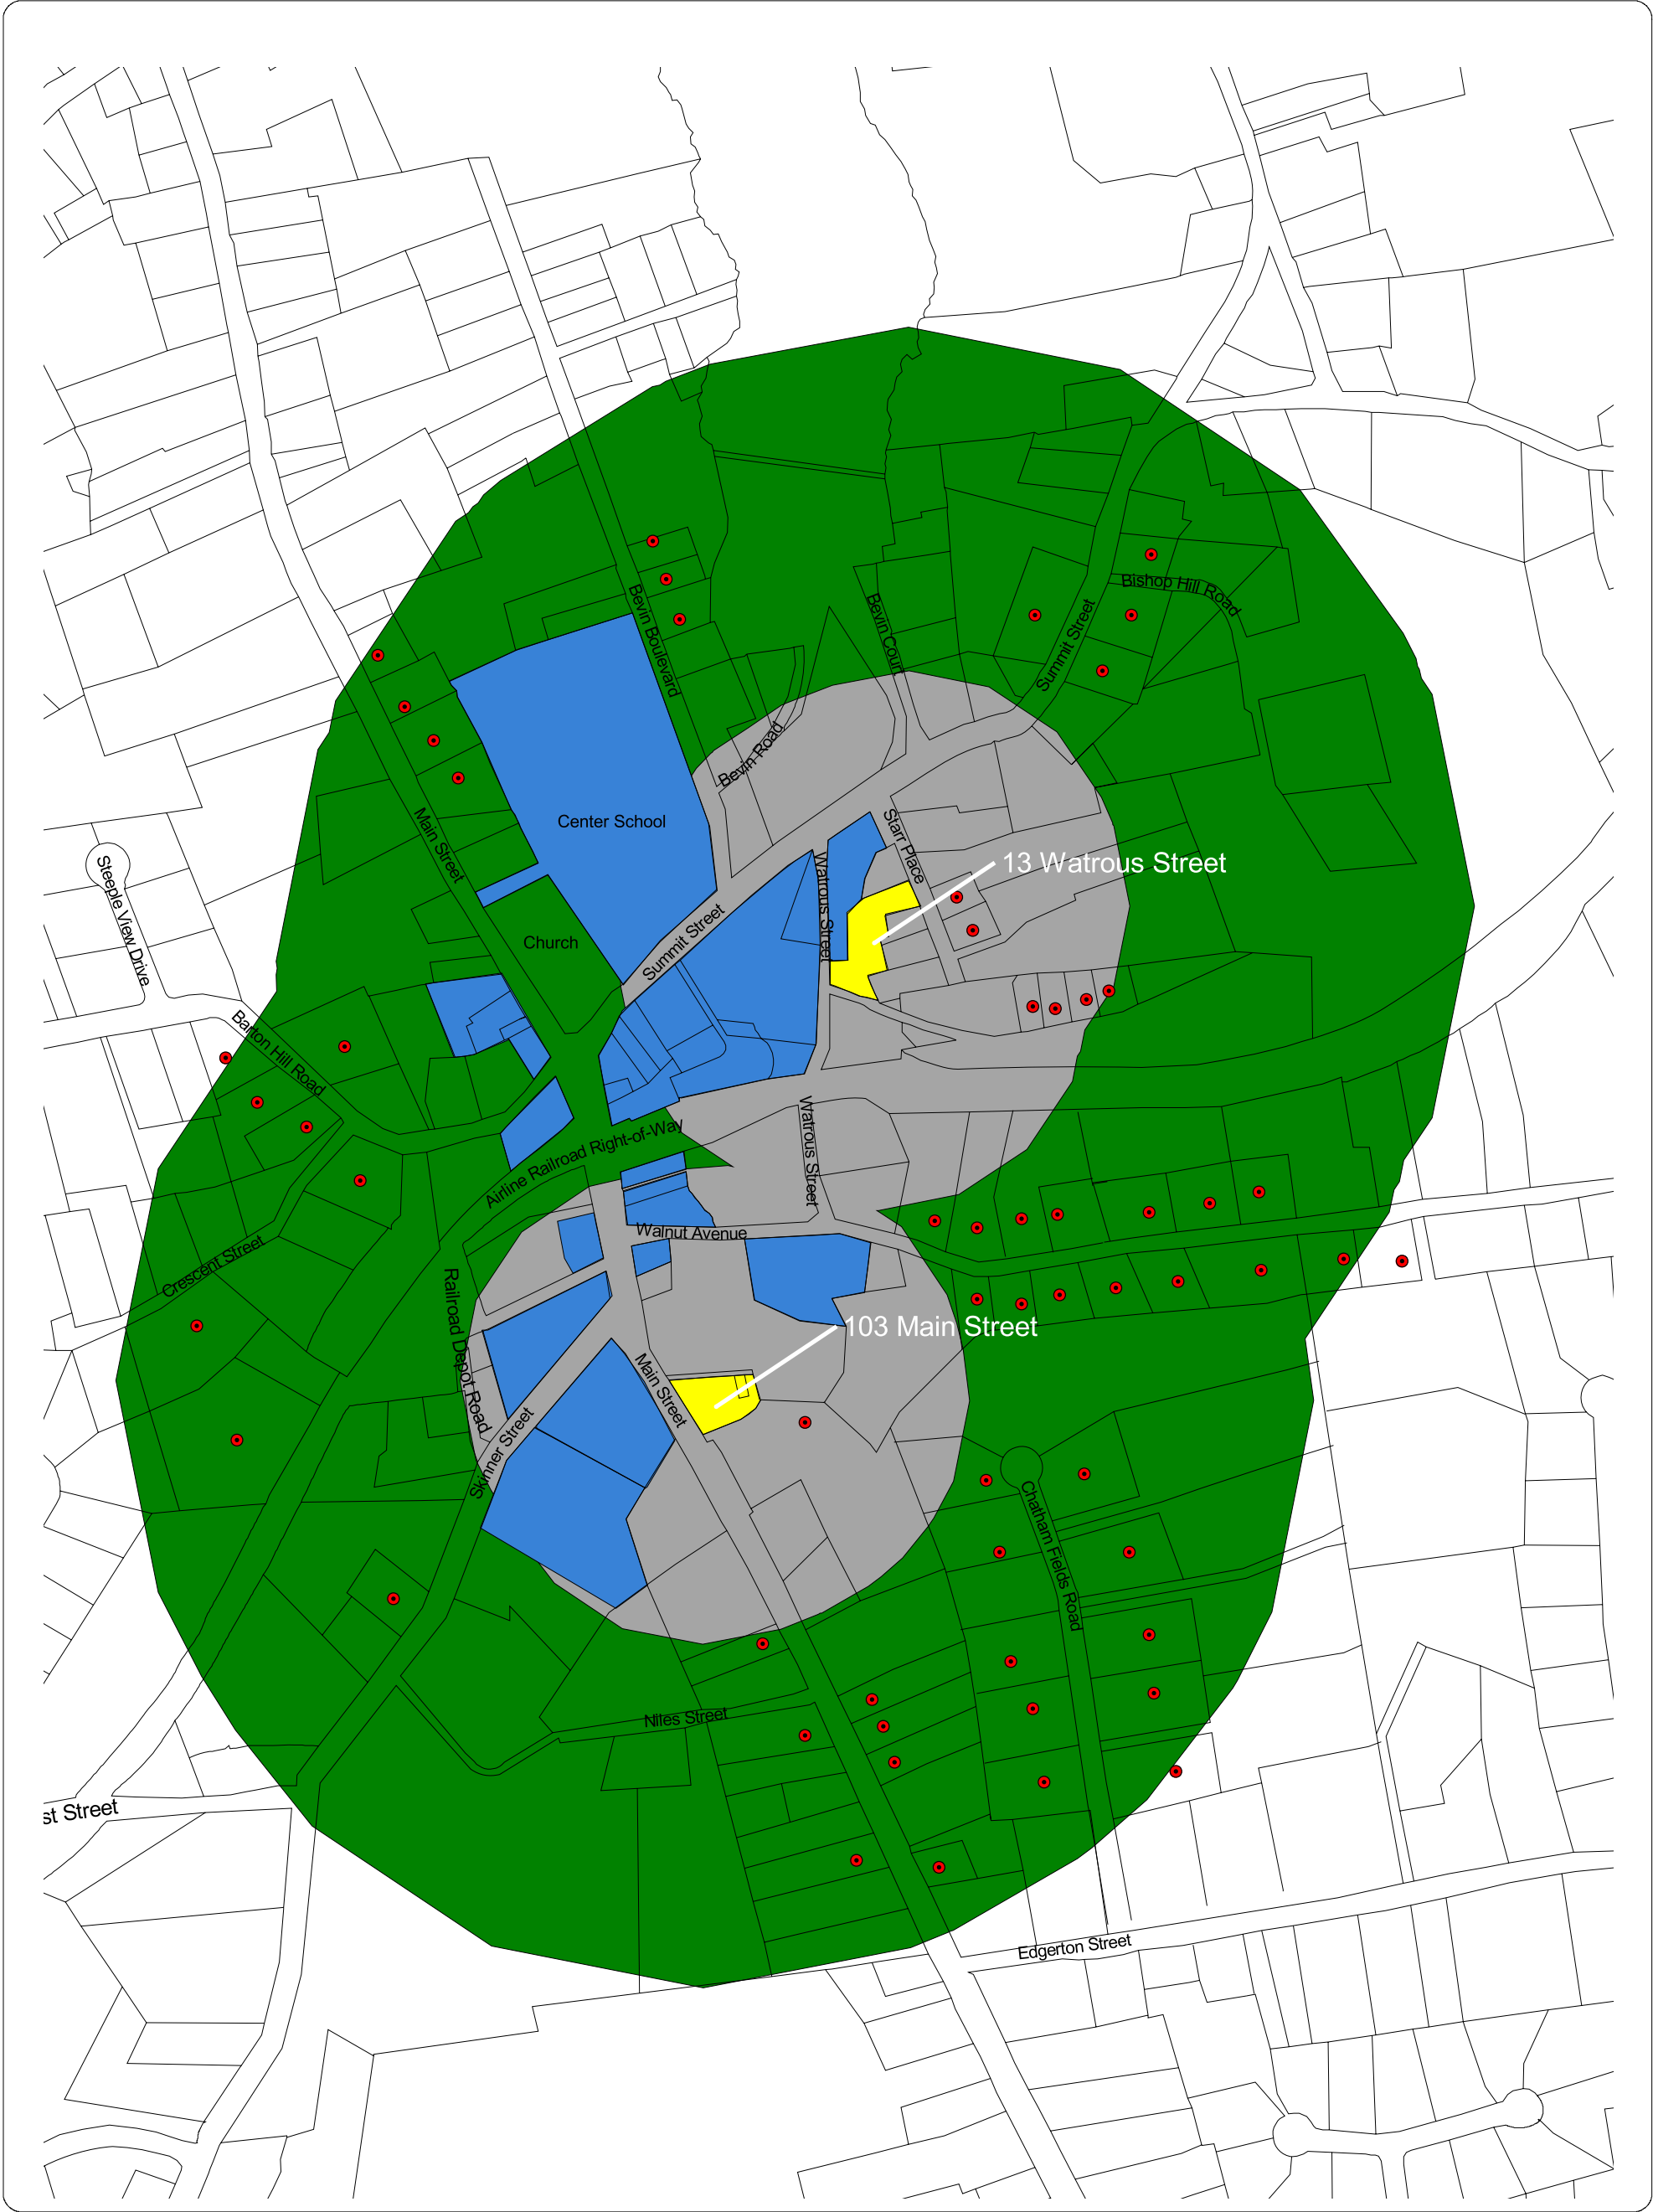
**Figure 1**

- Approximate location of visible wellhead. Observed during windshield survey.
- Town-owned property
- ▬ East Hampton parcels/property boundaries
- Community water customer
- 500-foot buffer of town-owned property
- 1/4-mile buffer of town-owned property

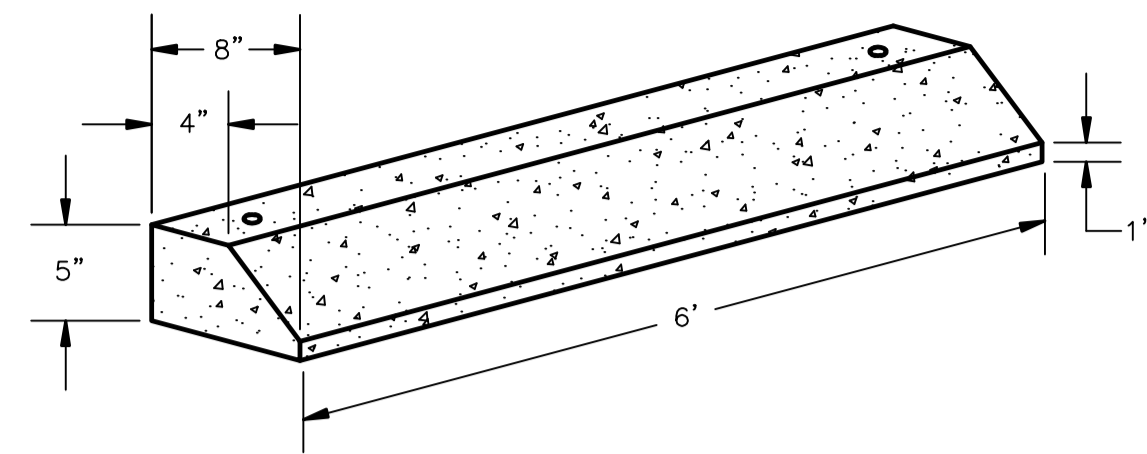
#### CONCRETE WHEEL STOP

1. CONCRETE, 4000 P.S.I., 28 DAYS.
2. WEIGHT: 195 LBS.
3. REINFORCEMENT: 2 #4 BARS.
4. (2) 3/4" HOLES CAST IN FOR ANCHORING.

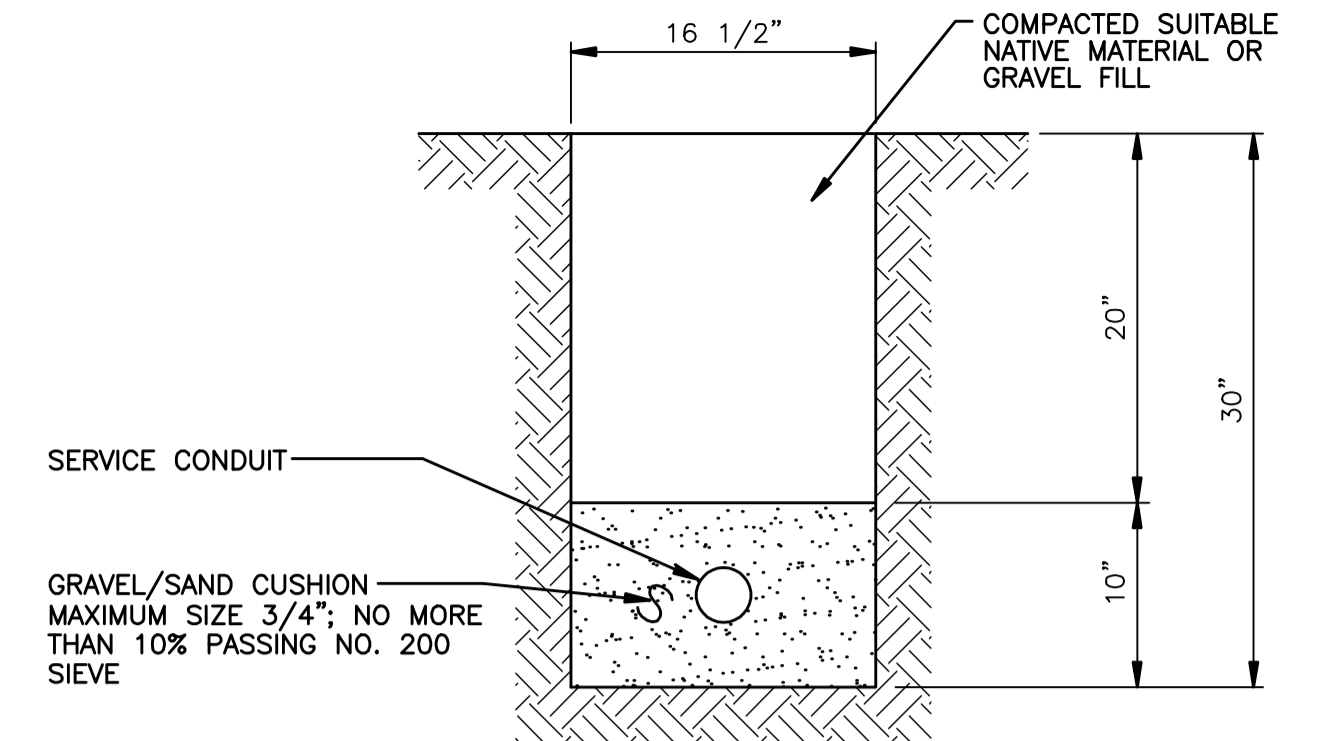
#### ELECTRICAL SERVICE CONDUIT

1. MINIMUM OF 3" ENCASEMENT ALL AROUND
2. IN THE EVENT OF CONFLICTING DEPTHS WITH EXISTING UTILITIES THE NEW CONDUIT AND DUCT BANK SHALL BE INSTALLED BENEATH THE EXISTING UTILITY UNLESS APPROVED OTHERWISE BY THE ENGINEER

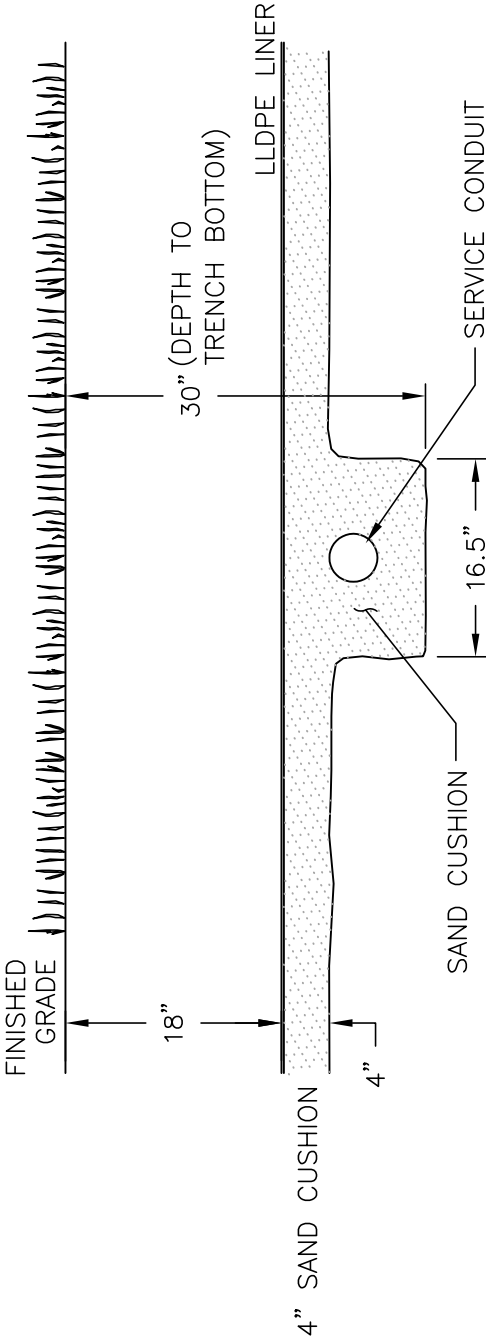
2 ELECTRIC SERVICE BENEATH CAP

NOTE : MINIMUM OF 3" ENCASEMENT ALL AROUND CONDUIT

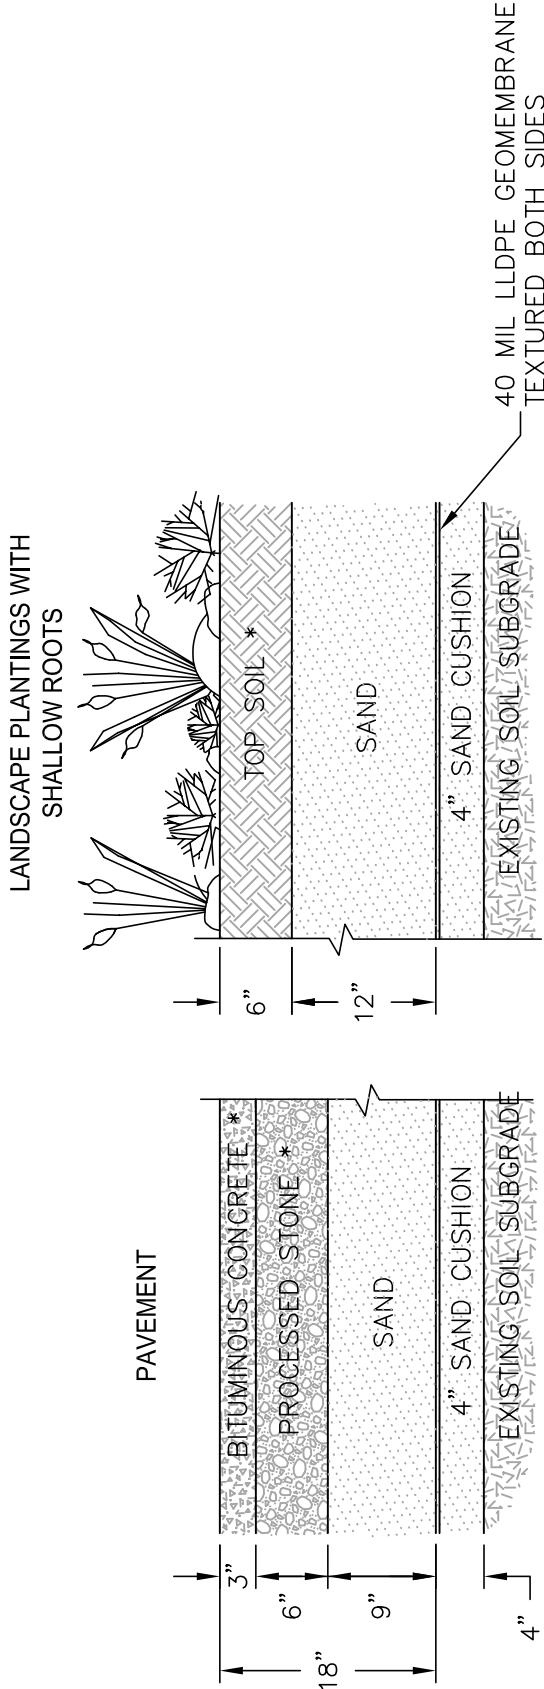
#### 4 IMPERMEABLE CAP CROSS SECTION

EXISTING SOIL SUBGRADE – GRADE TO PROPER ELEVATION.  
REMOVE ANY ROCKS, DEBRIS, OR PROTRUSIONS FROM SUBGRADE.  
ROLL SMOOTH WITH SMOOTH DRUM ROLLER

\* PAVEMENT AND LANDSCAPED SURFACE TREATMENTS AS SPECIFIED BY OTHERS

A sand buffer/drainage layer will be installed directly upon the geomembrane. The sand drainage layer will be tied directly into a perimeter cap drain piping along the downgradient limit of the liner. This cap perimeter drain will consist of a 6-inch perforated pipe which will outlet to the adjacent creek bank. This cap drainage system will collect stormwater infiltration which reaches the liner surface and convey this to the adjacent creek.

A layer of sand backfill will be placed immediately on top of the geomembrane. This material will not contain large particles that could damage the liner. The layer of sand will range from 9 to 12 inches in depth. Heavy equipment will not be allowed on the liner. Low ground pressure equipment will be used for placing and spreading the clean fill materials (sand) over the liner. In addition, the liner manufacturer's quality control results will be required for submission and review prior to spreading backfill on the liner.

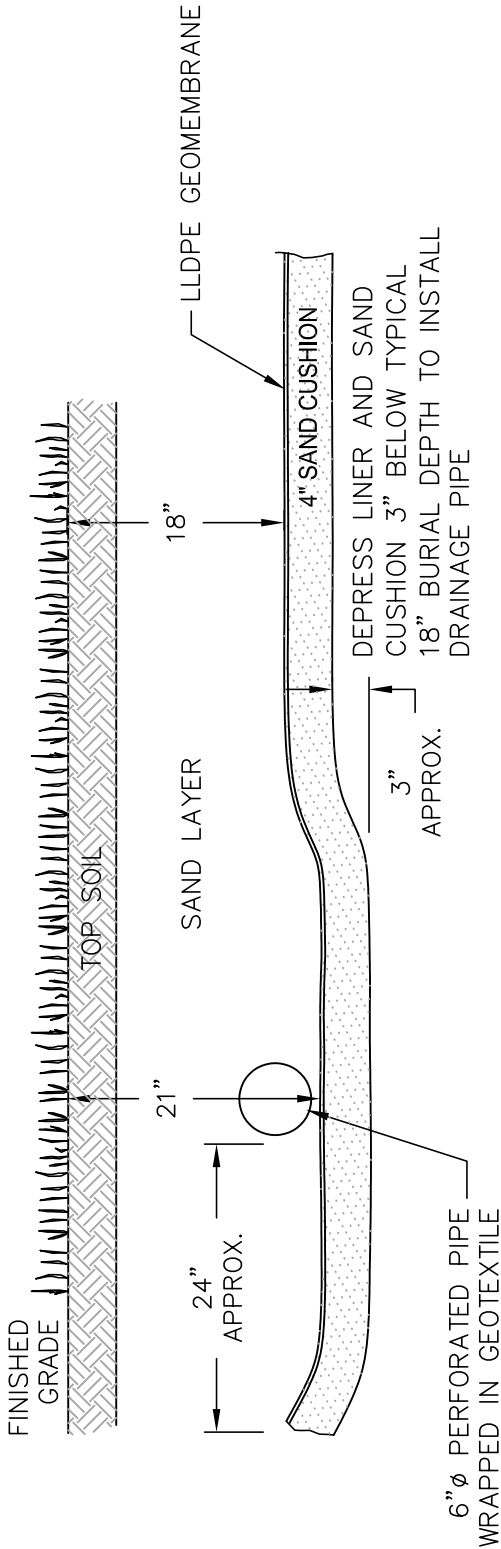
#### 5 CAP DOWN-GRADIENT PERIMETER DRAINAGE PIPING

NOTE : INSTALL CAP DRAINAGE PIPING ALONG ENTIRE DOWN GRADIENT EDGE  
OF LINER (AS SHOWN ON PLANS)
