Memorandum

Re: Waste inventory of Northern Section of 13 Watrous Street

A meeting was held on 5/31/06 to discuss the cease and desist order filed on behalf of the Town of East Hampton to the current tenant of the northern section of 13 Watrous Street, East Hampton (site). The Town Manager and Town council directed Tighe & Bond to perform a waste inventory of potentially hazardous on-site materials and storage containers. The building is currently occupied by James Meyer Jr. who accompanied the walk through. Philip Visintainer, East Hampton Fire Marshal was also present for the majority of the visit.

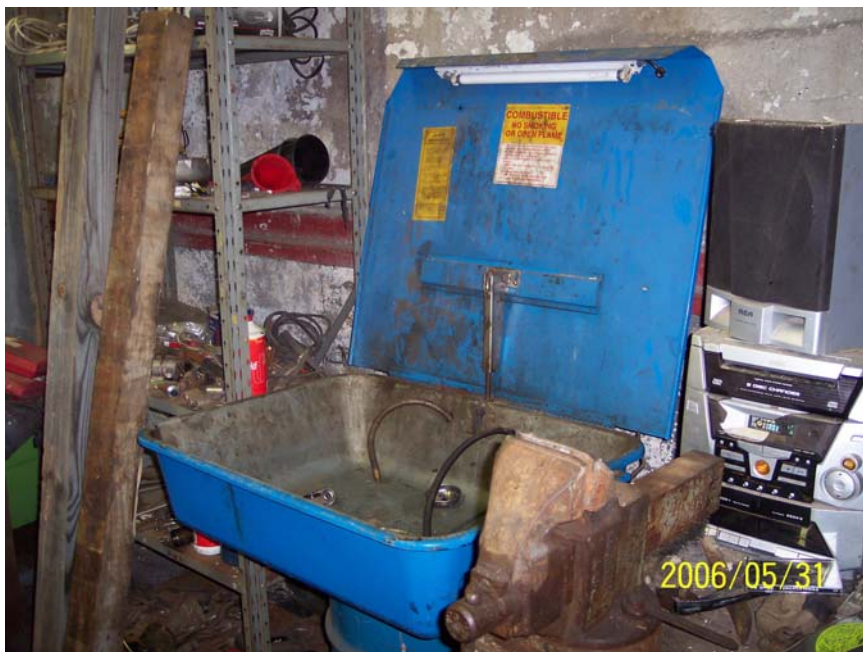
- A parts washer. A parts washer is present on the southern wall of the site. There are two 20-gallon drums associated with the washer. The washer is the property of James Meyer, Jr. and the chemical composition of the washer solvent is not known. The drums are unlabeled and lacking material safety data sheets.

PHOTO: 01
 LOCATION: 13 Watrous Street
 DESCRIPTION: Parts degreaser with 20-gallon tank underneath

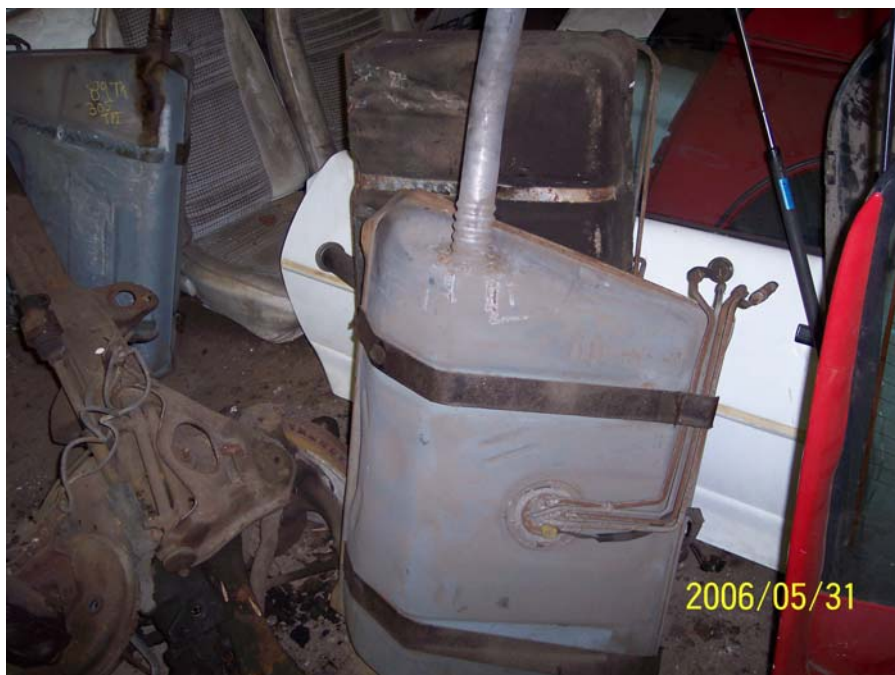
- Six gasoline cans with approximately 15 gallons of fluid. The odor and pour spouts suggest that they contain gasoline.
- Multiple automotive gasoline tanks. At least six automobile-gasoline tanks were on site removed from the automobile bodies. The tanks appeared to be empty but were not opened.

PHOTO: 02
 LOCATION: 13 Watrous Street
 DESCRIPTION: Two automotive tanks removed from the automobile.

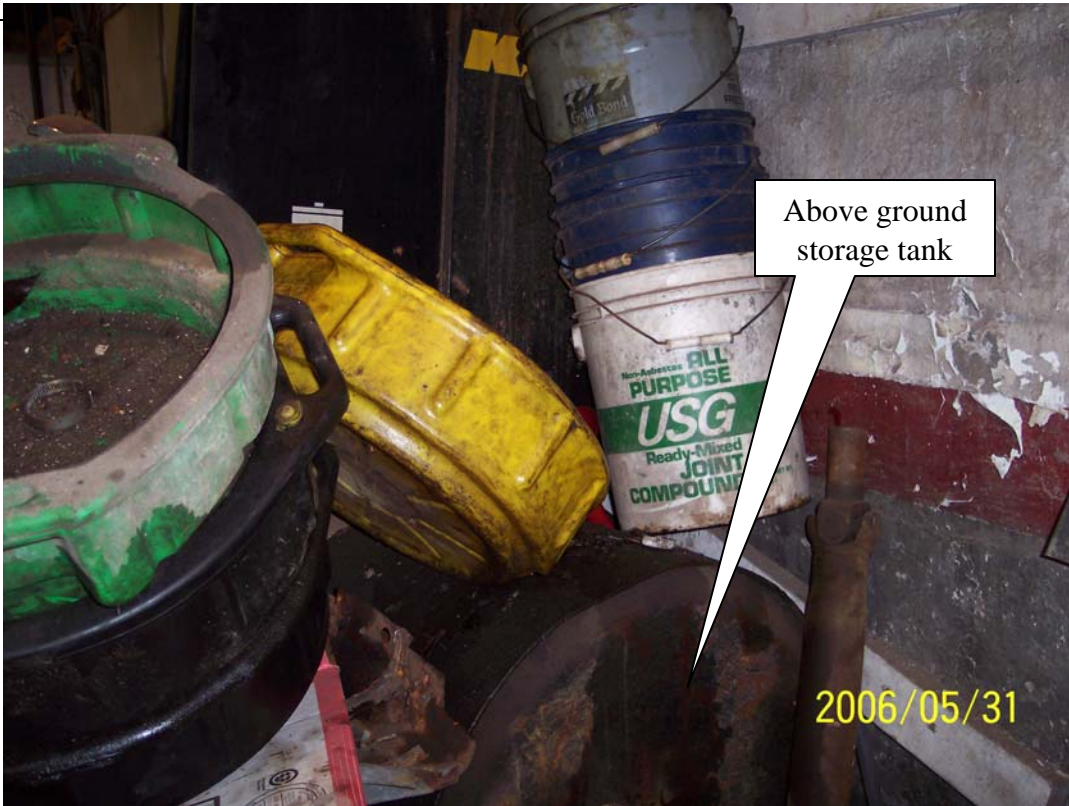
- A 250-gallon above ground storage tank (AST). An oil pan was observed draining into the tank. A drum thief was placed into the tank and it contained approximately 10-inches of product at the bottom of the tank. The product appeared to be motor oil. According to statements from Mr. Robert Fuller, site lessee, the tank was on-site prior to his occupancy. The contents of the tank are from multiple sources and the chemical composition is unknown.

Above ground
storage tank

PHOTO: 03
LOCATION: 13 Watrous Street
DESCRIPTION: Oil pan draining into above ground storage tank

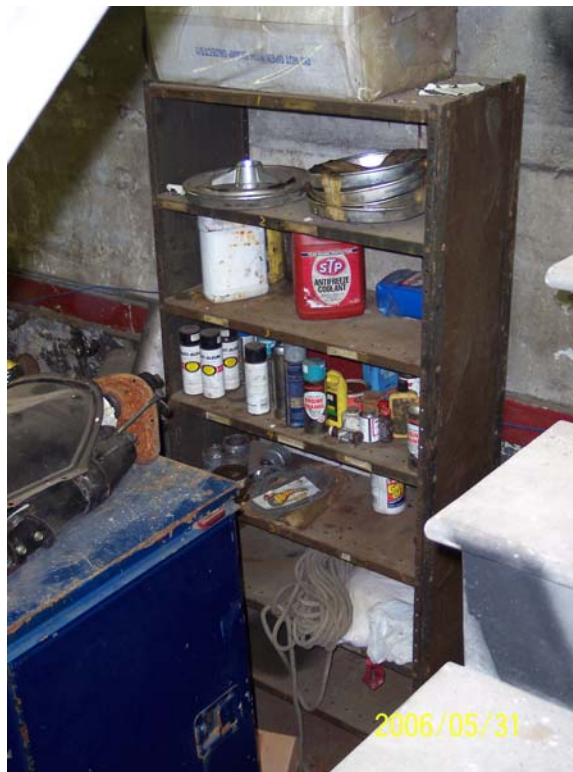
- Automobile batteries. Over 30 automobile batteries were viewed on site. The tenant stated that he plans to recycle the batteries for a fee.
- Assorted labeled containers including automotive cleaning products, biodegradable degreasers and automotive fluids.

PHOTO: 04
LOCATION: 13 Watrous Street
DESCRIPTION: Assorted automotive containers

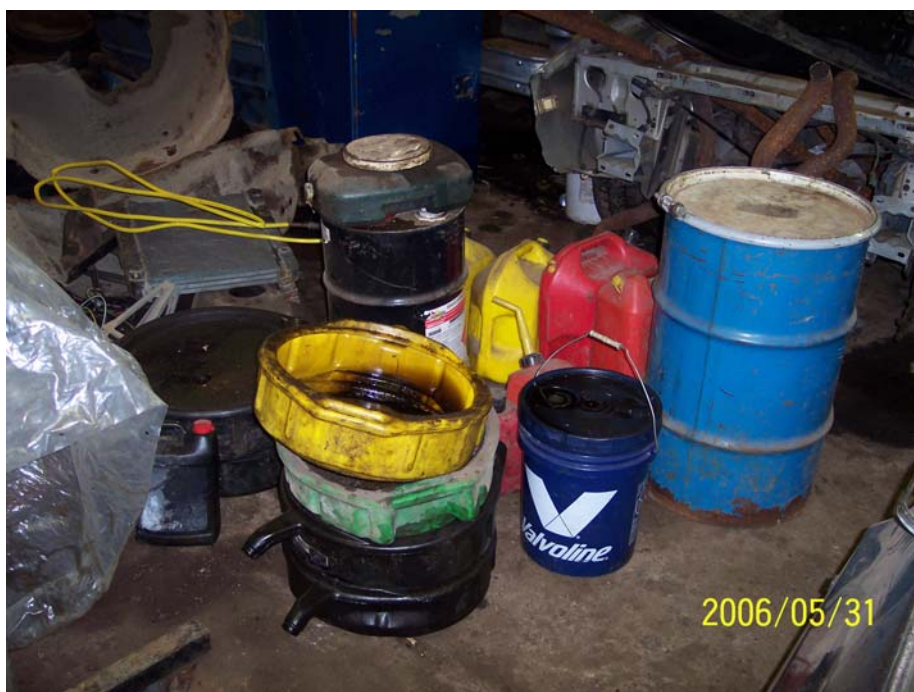
The tenant assisted with identifying the containers and stockpiling the containers into a center of the property.

PHOTO: 06
 LOCATION: 13 Watrous Street
 DESCRIPTION: Waste containers stockpiled.

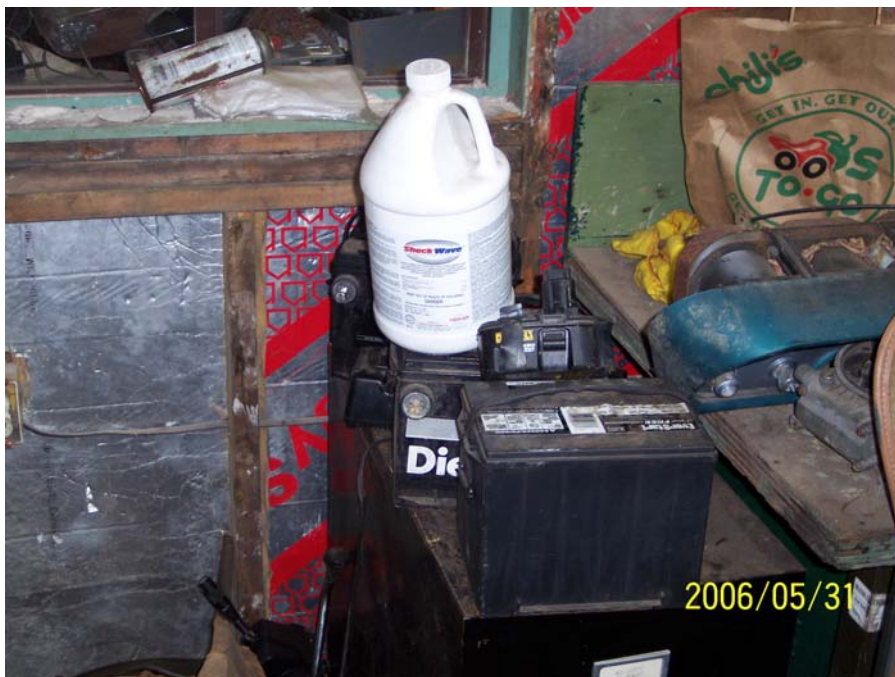
PHOTO: 07
 LOCATION: 13 Watrous Street
 DESCRIPTION: Car batteries and cleaners.

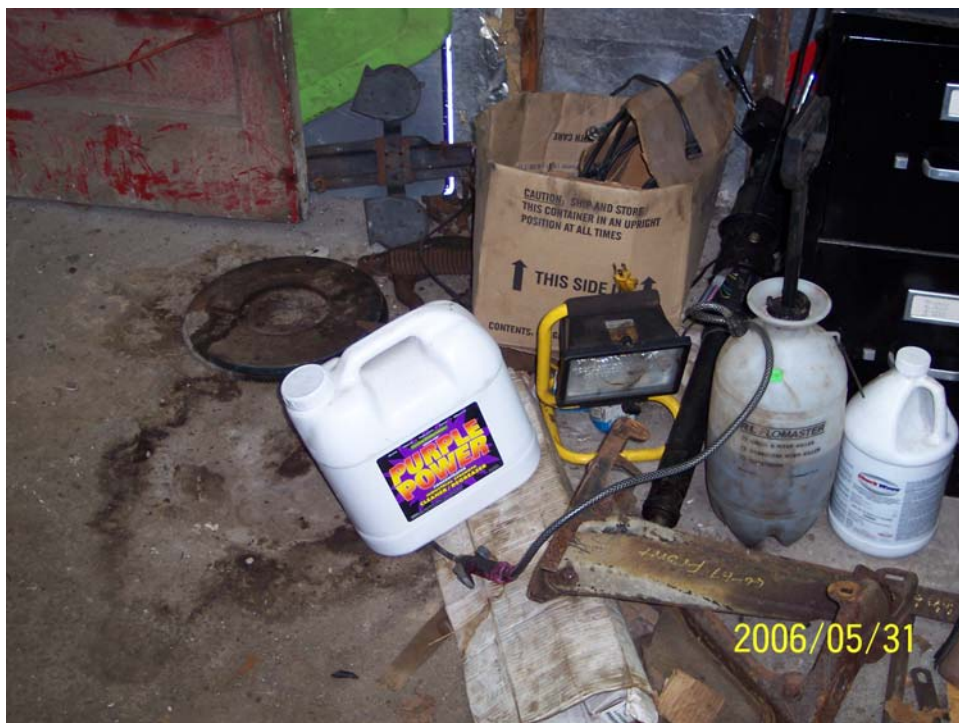
PHOTO: 08
 LOCATION: 13 Watrous Street
 DESCRIPTION: Biodegradable parts cleaner.
