LAKE WARAMAUG TASK FORCE 30 YEARS OF SUCCESSFUL LAKE RESTORATION

DR. KORTMANN DESIGNS
UNIQUE IN-LAKE “LAYER AIR”
RESTORATION SYSTEM
SYSTEMS INSTALLED IN 1989
AND UPGRADED IN 2003
MIXES MILLIONS OF GALLONS
OF WATER EACH DAY
FROM JUNE TO
SEPTEMBER

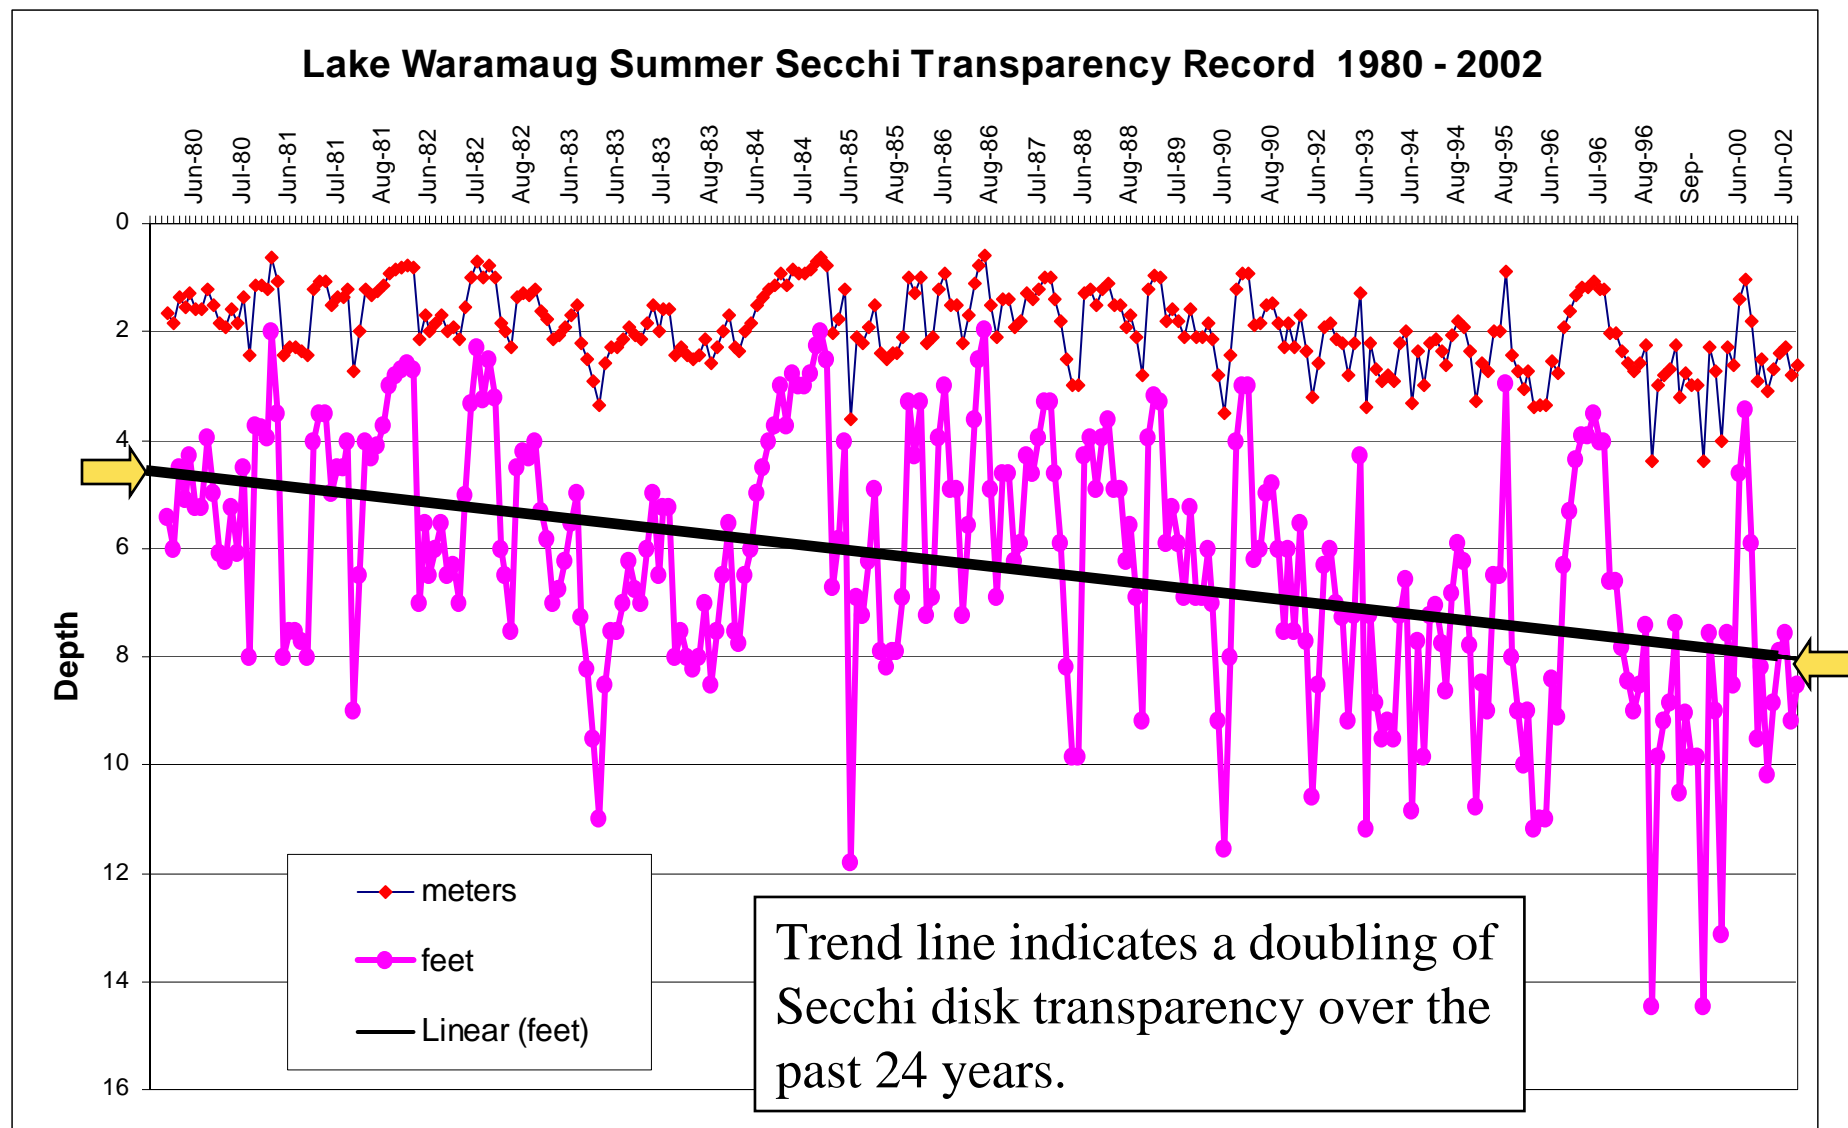
Water Clarity Record at Lake Waramaug 1980 to 2004

(Meters in Red; Feet in Purple; Black Line is the Linear Statistical Trend)

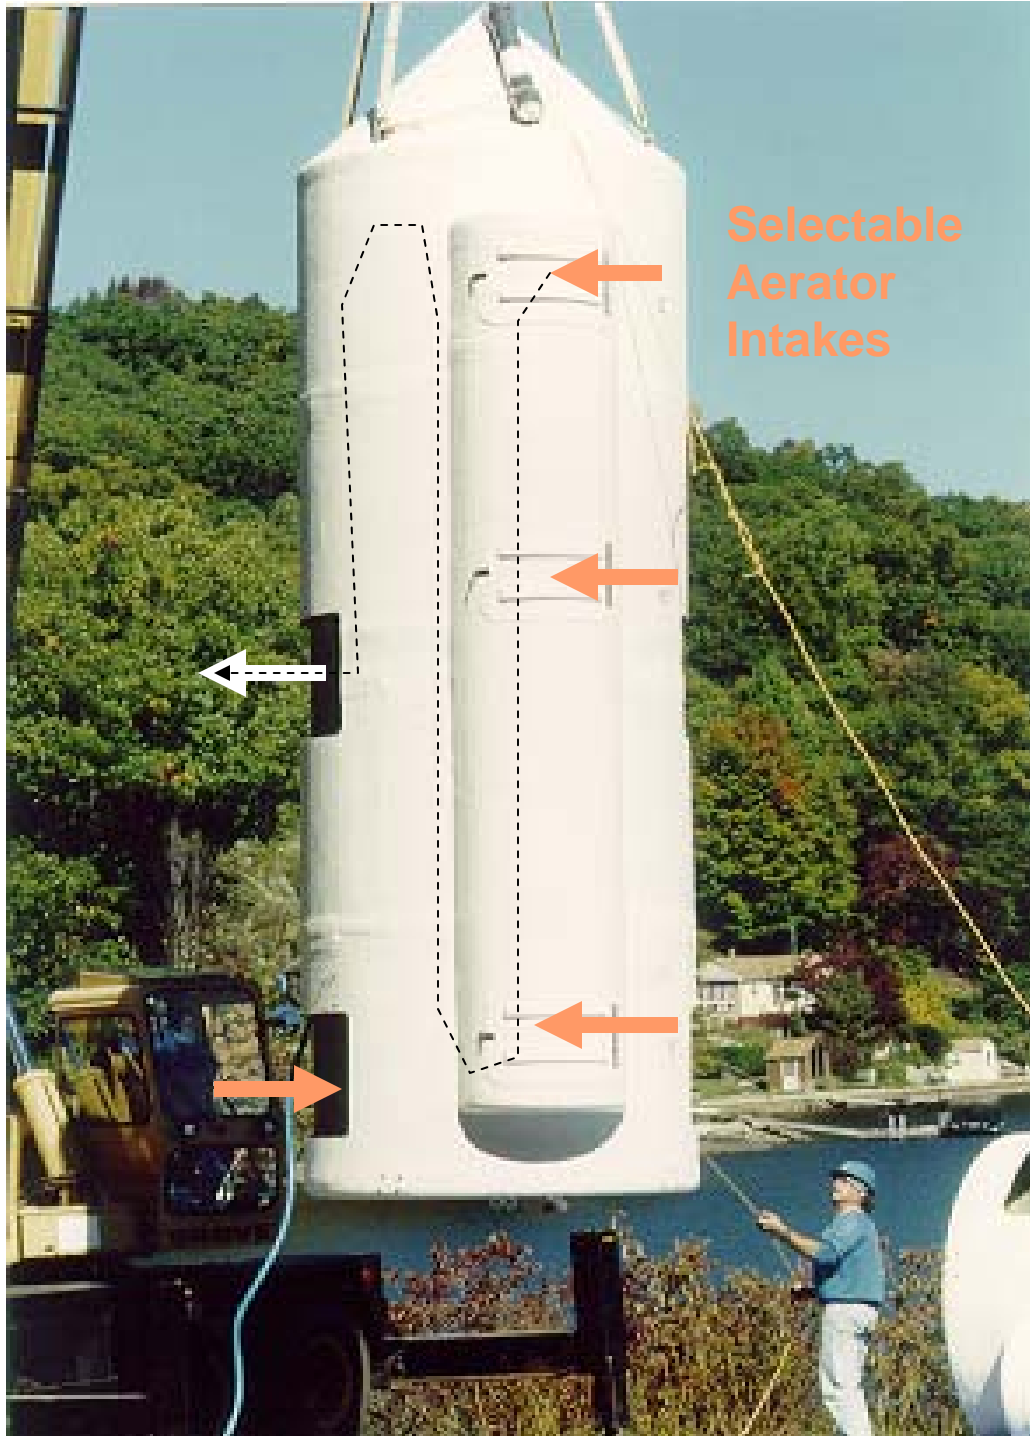
Lake Waramaug Layer Aeration

Selectable
Aerator
Intakes

Layer Aeration is similar structurally to hypolimnetic aeration. However, water is selectively drawn into the aerator from several depths, aerated, blended, and returned at an intermediate depth. Hence, returned aerated flow is at an intermediate temperature (between temps of aerator intakes) and is neutrally buoyant. This is useful for creating a distinct aerobic water layer for cold water fish, zooplankton refuge habitat, etc.

Air diffusers inside the aeration tower pumps, aerates, and blends water from selected depths.

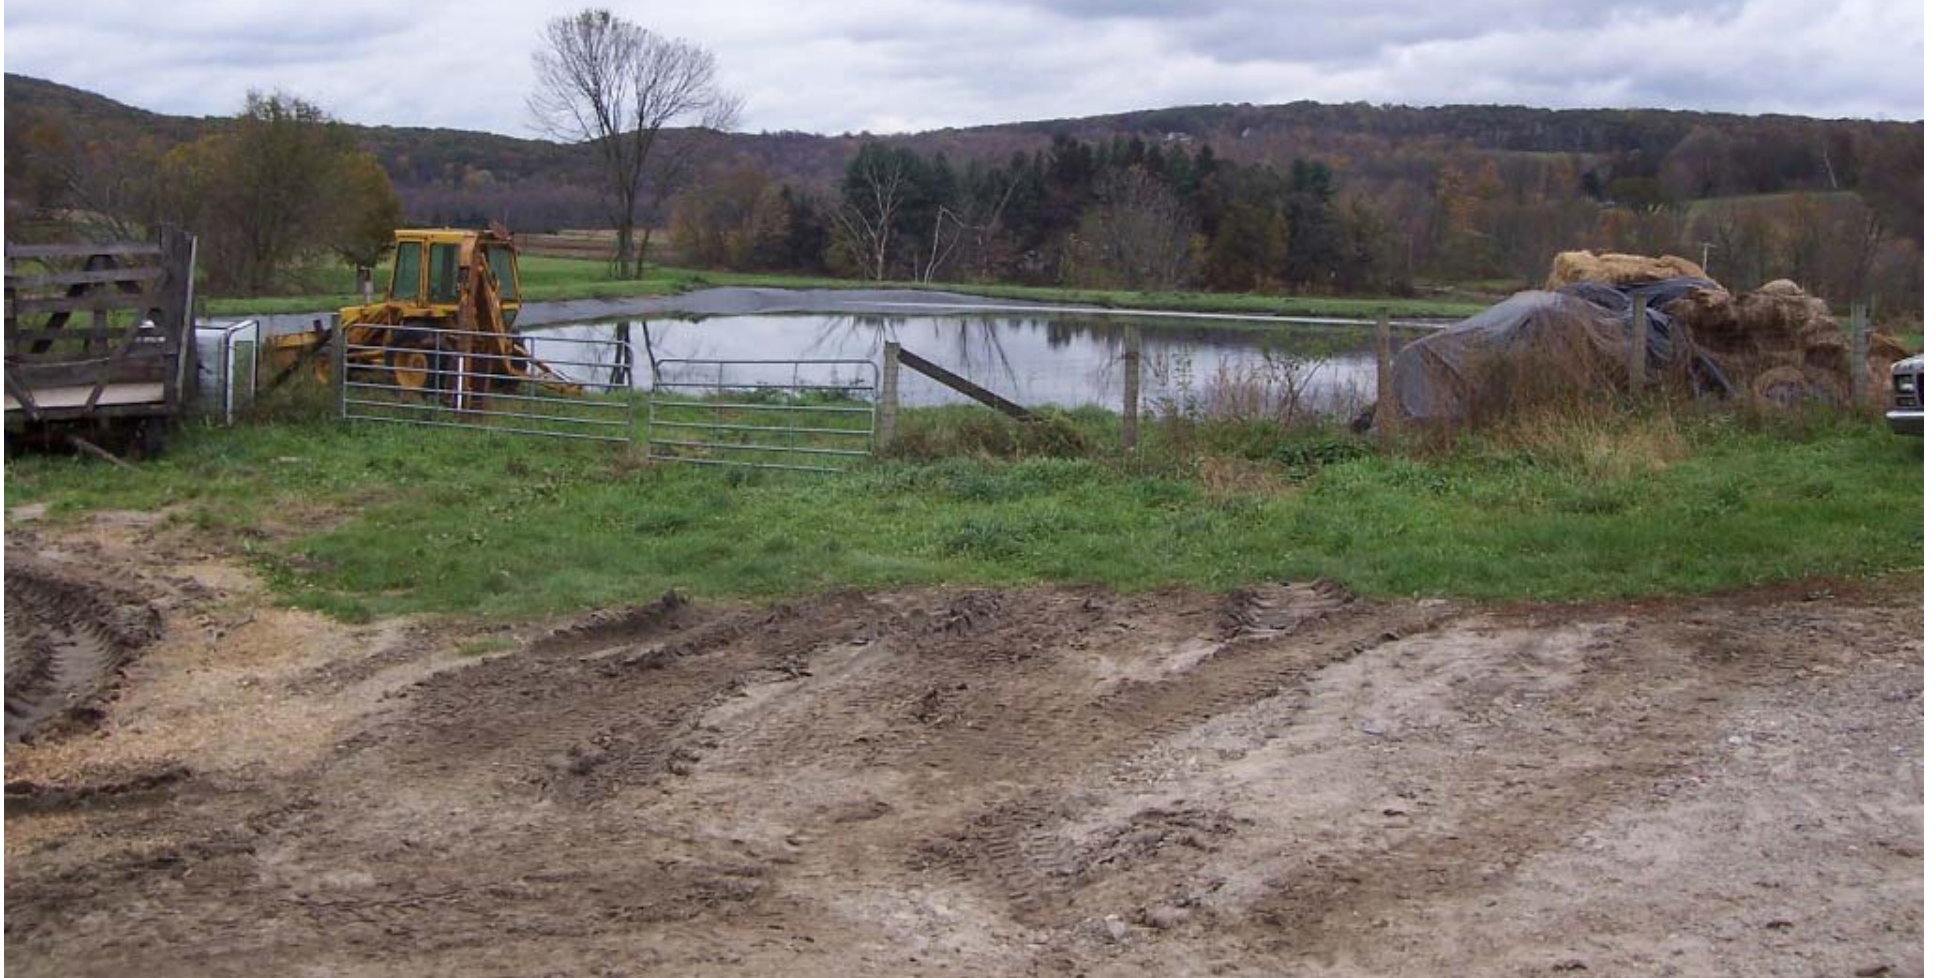
Task Force and USDA fund “whole farm” waste management system

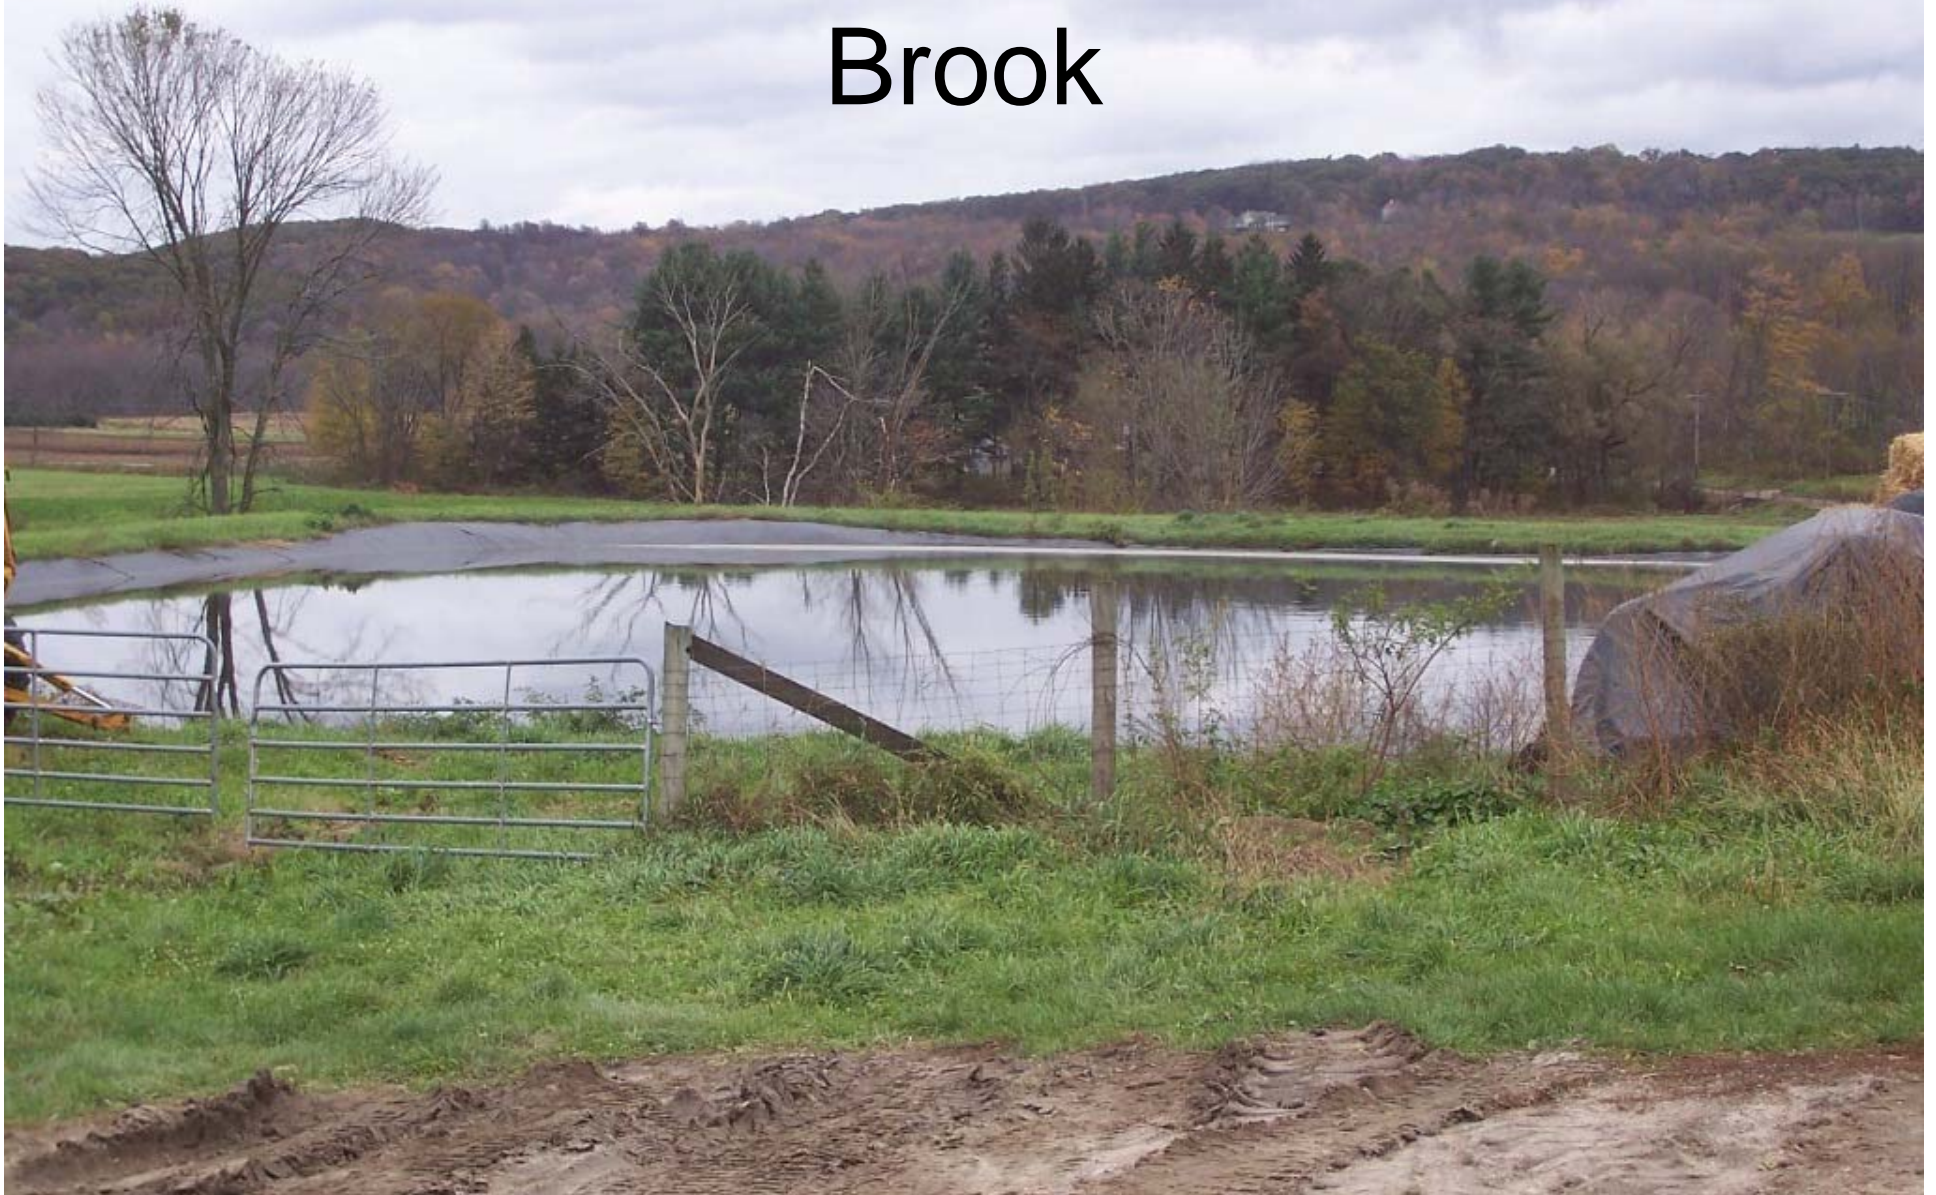
Lined lagoon holds all farm run-off
for pumping to fields away from
Brook

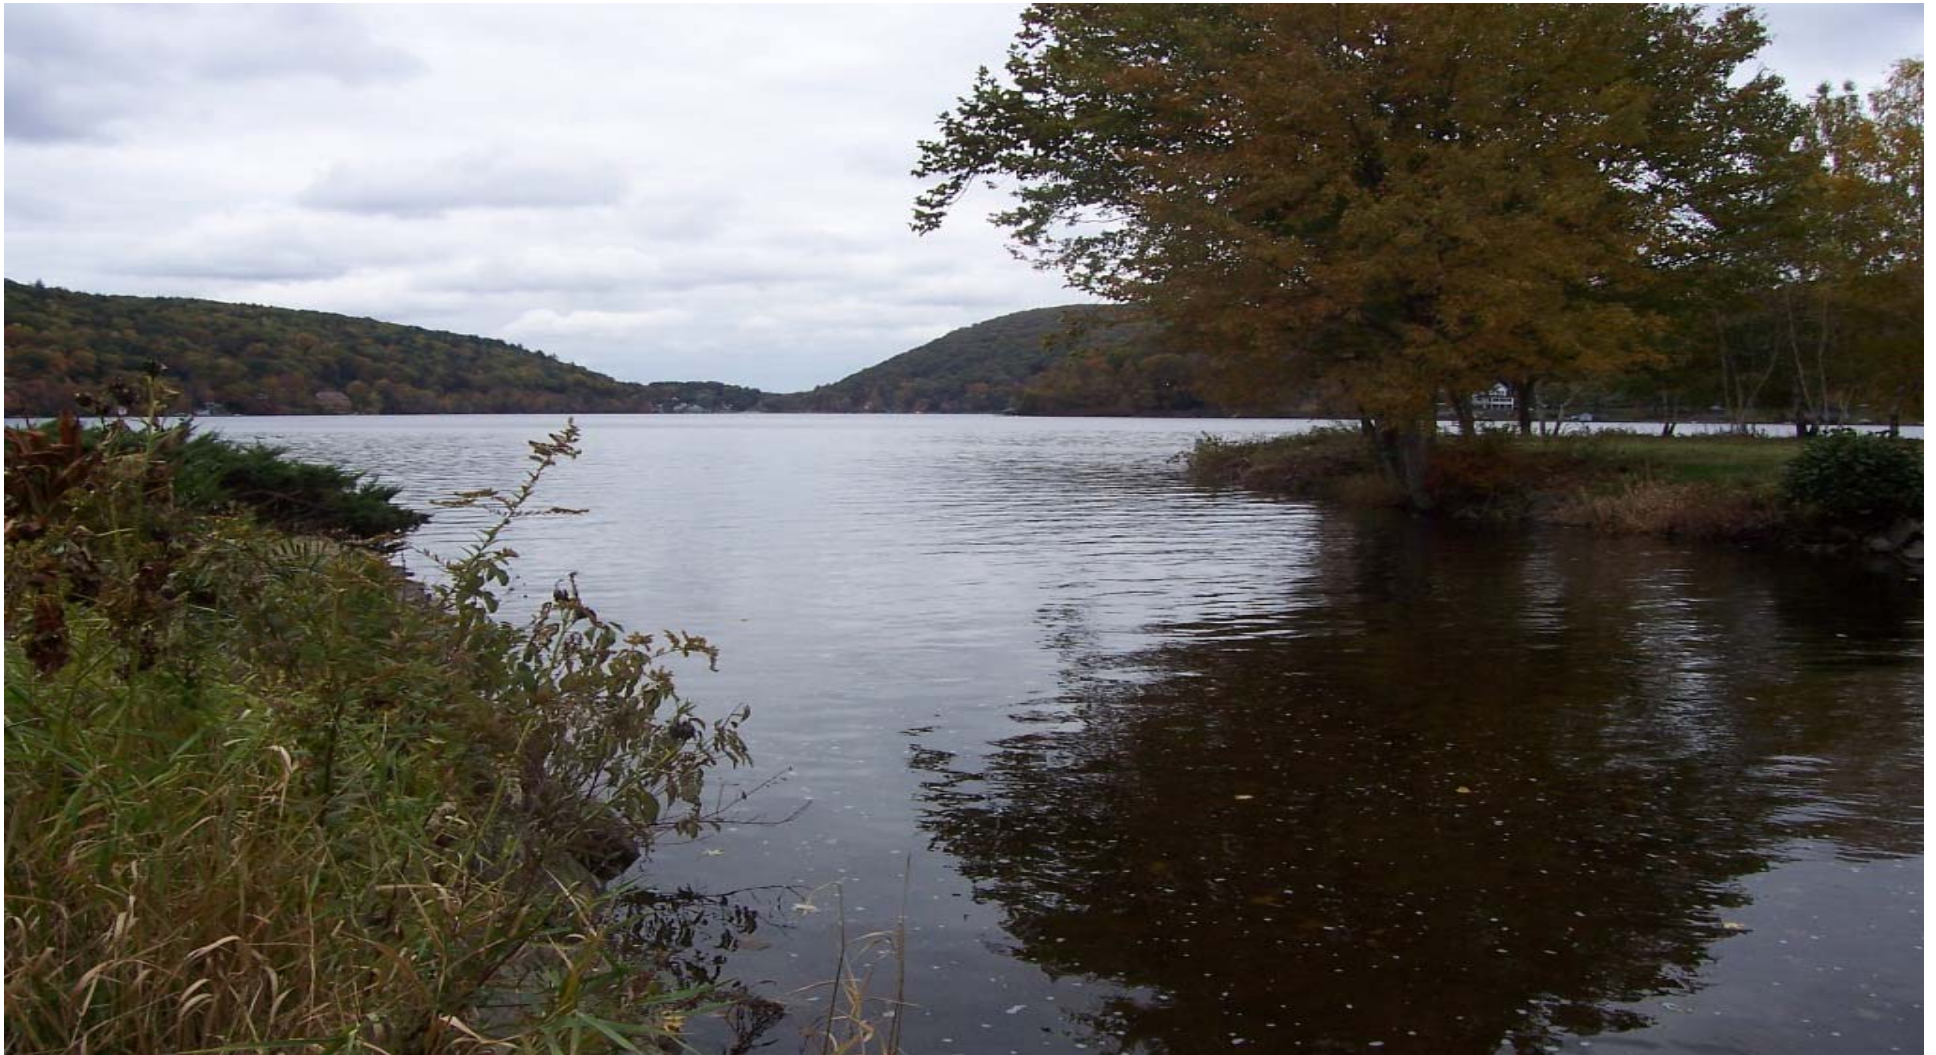
Sediment build up in Waramaug
from Sucker Brook remains serious
concern to lake water quality

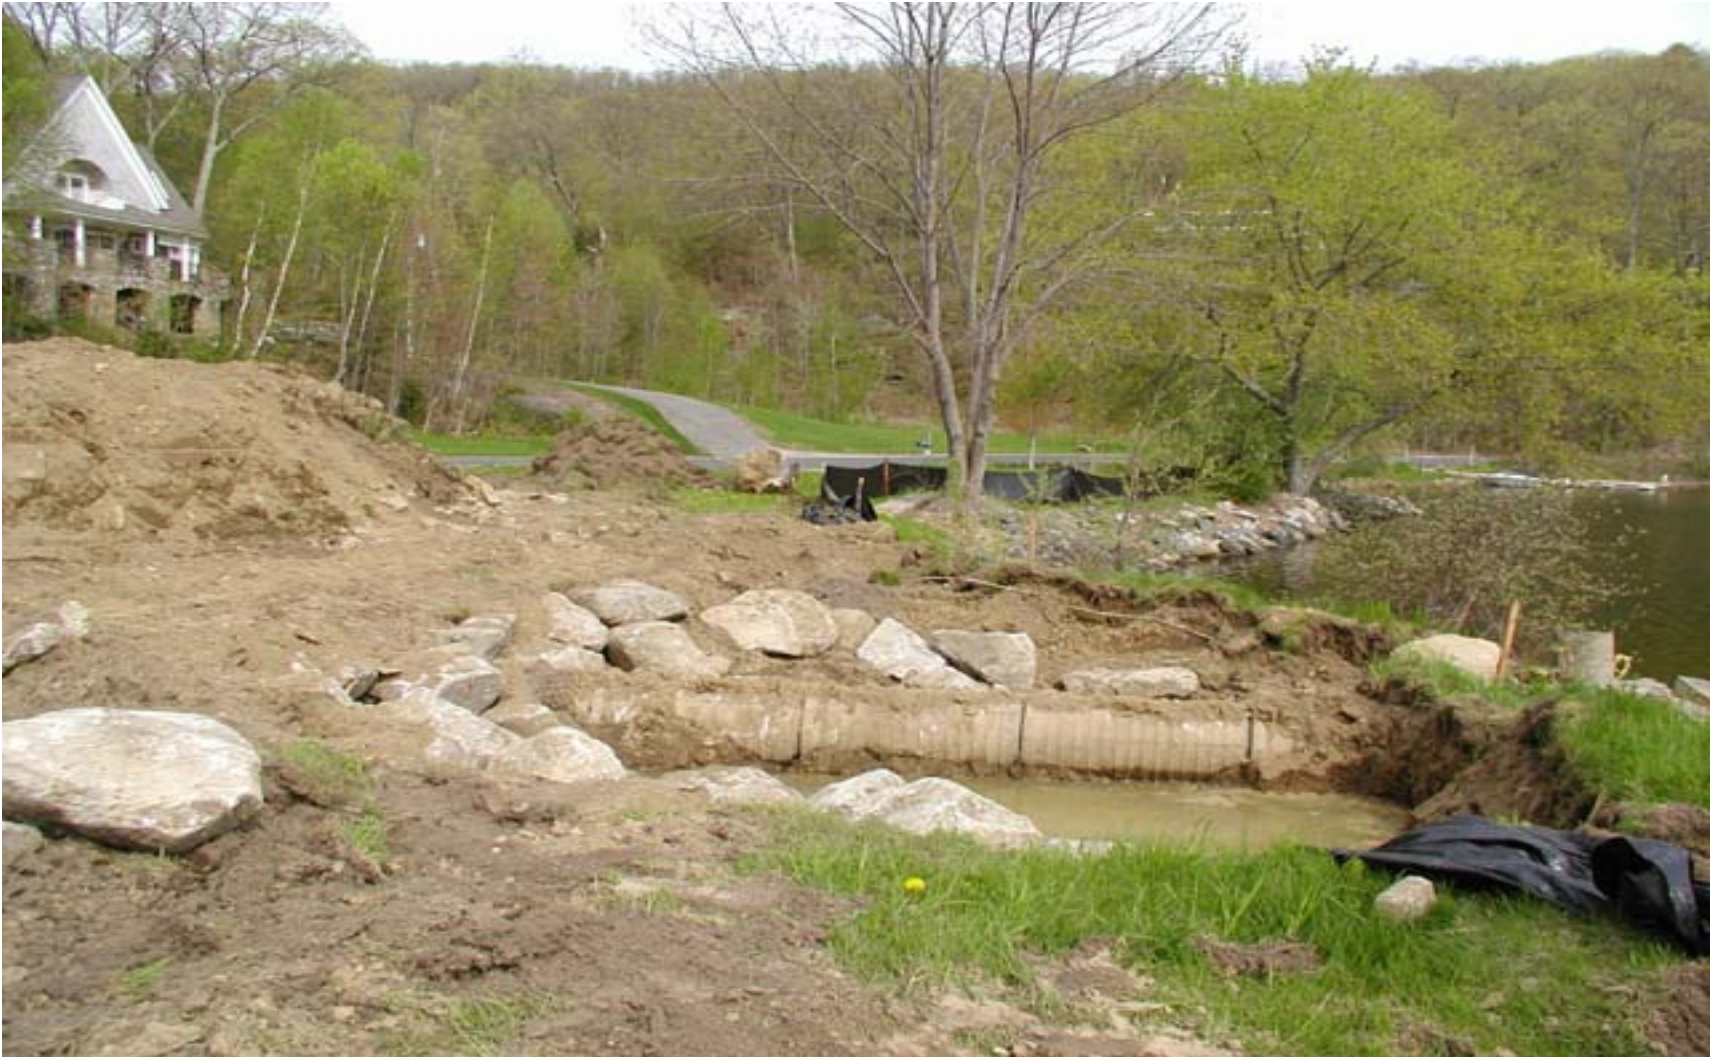
Create bio-filter to treat culvert storm water runoff

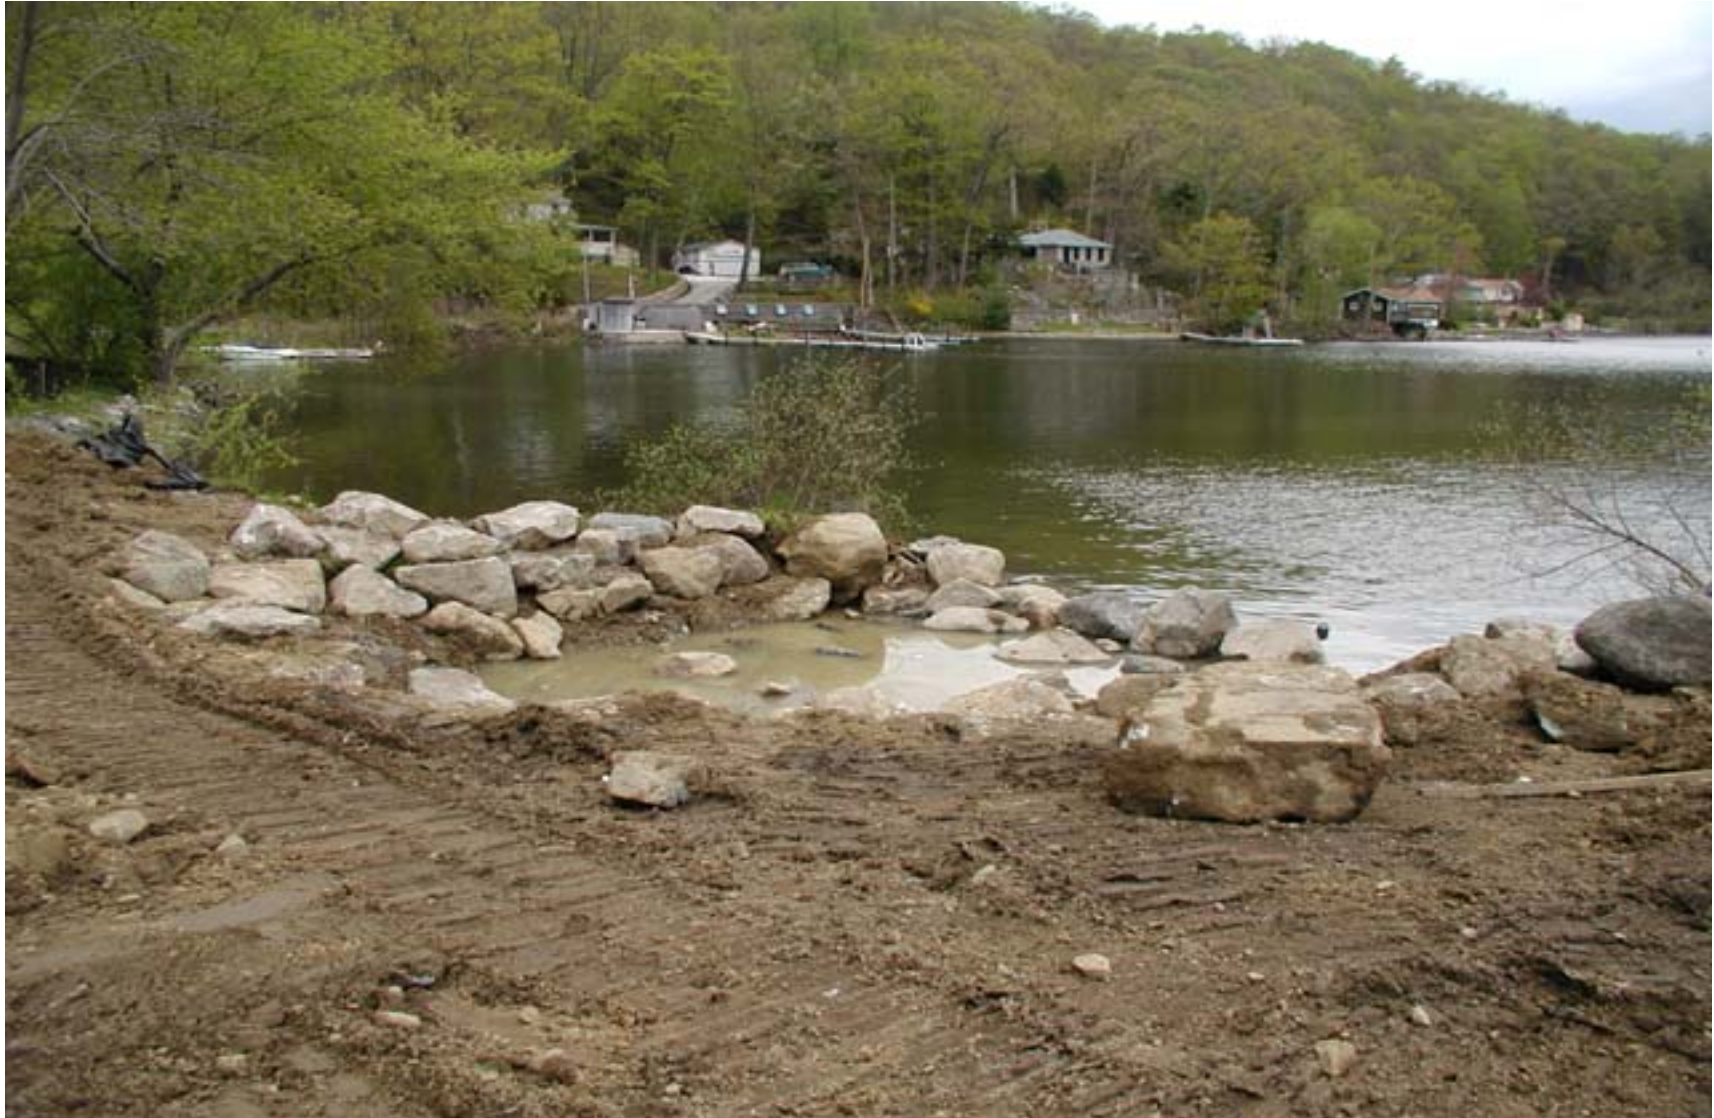
Instead of discharging direct to lake
culvert water is filtered in basin

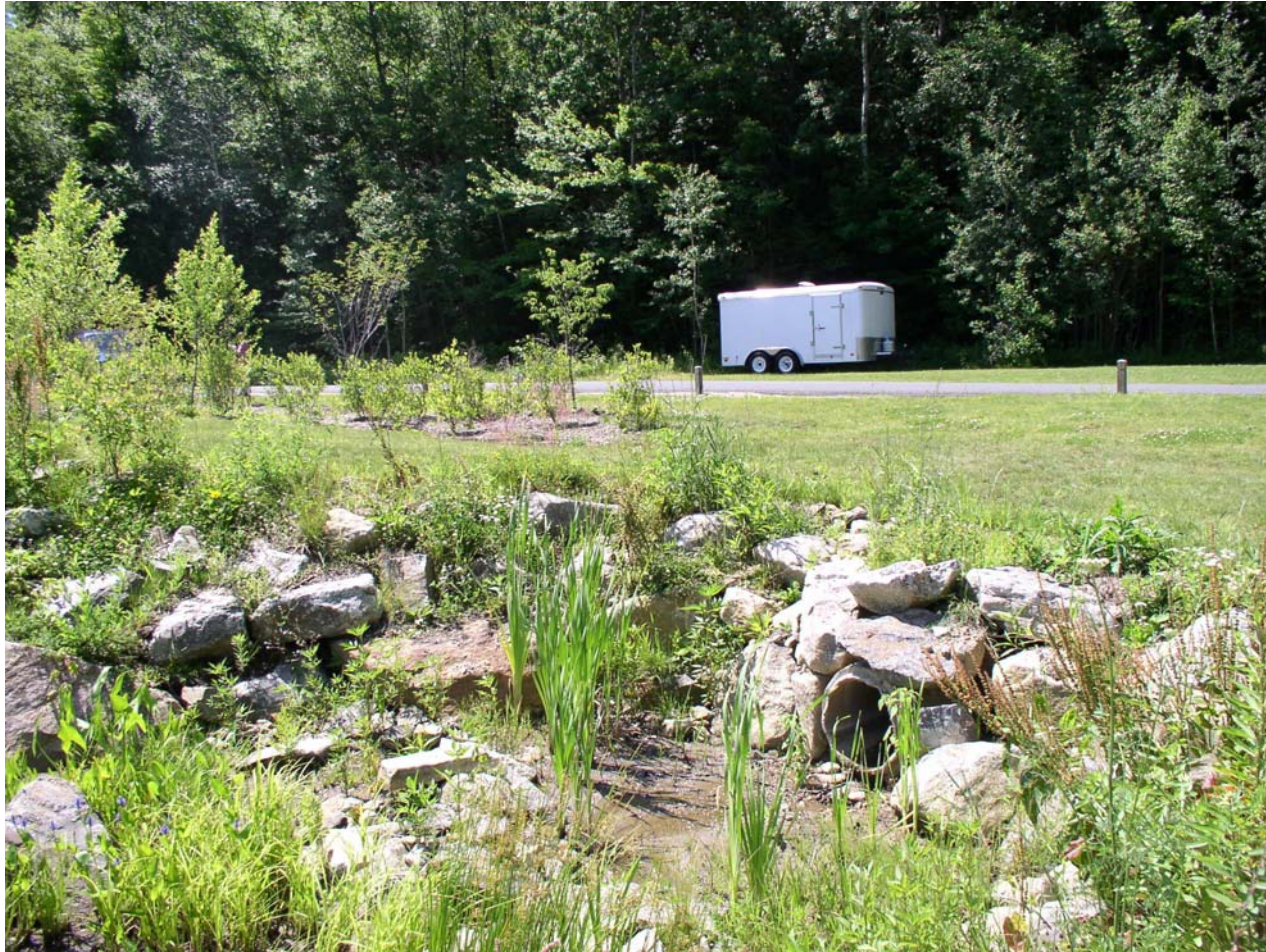
Native wetland plants filter runoff in bio-filter basin

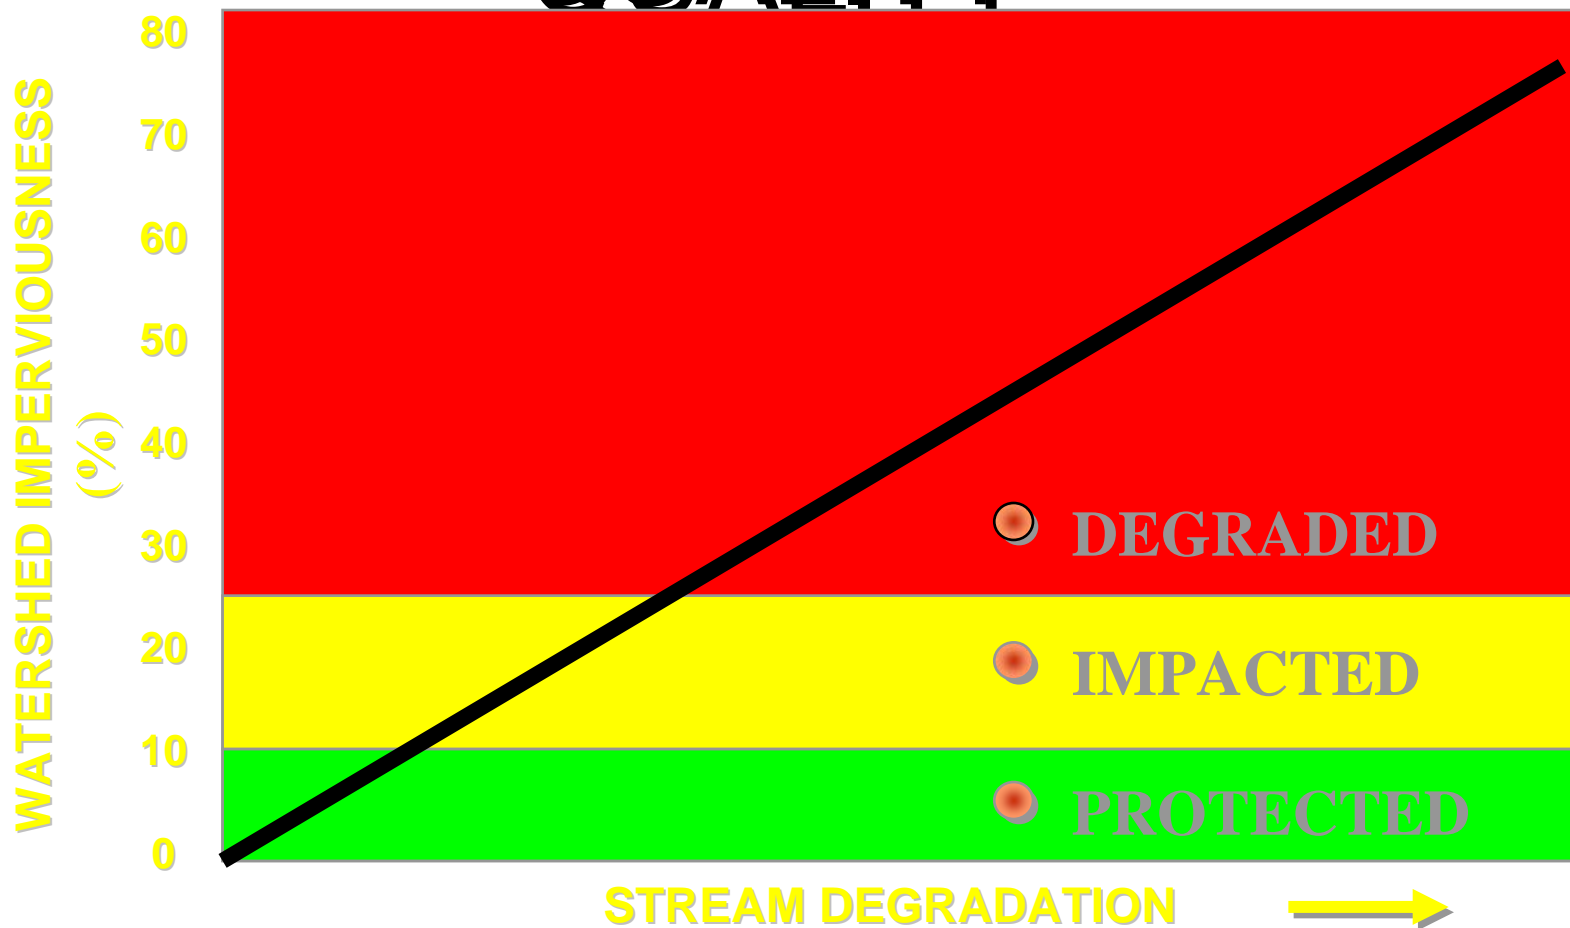
IMPERVIOUS SURFACE COVERAGE - WATER QUALITY

ADAPTED FROM SCHUELER, ET. AL., 1992
