# Feasibility Study

EAST HAMPTON, CT

# TOWN OF EAST HAMPTON FEASIBILITY STUDY

## EXISTING FACILITY / SITE / MEP CONDITIONS – INTRODUCTION

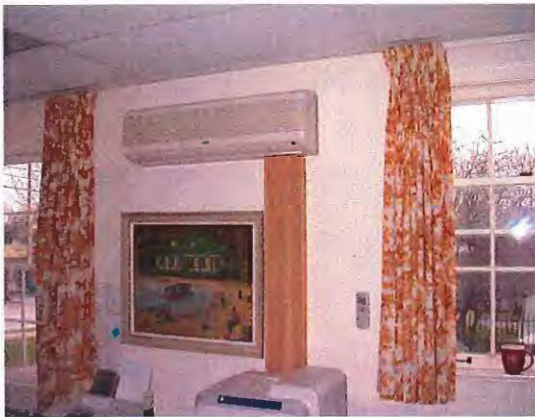
Cooling is provided by three indoor air handlers with DX coils. The condensing units serving the air handlers are located on grade at the front of the building. The office area is served by a 1.5 ton split DX air conditioner, while the vault is served by a dedicated rooftop air handling unit that heats and cools the vault.

Split DX air conditioner serving the office area.

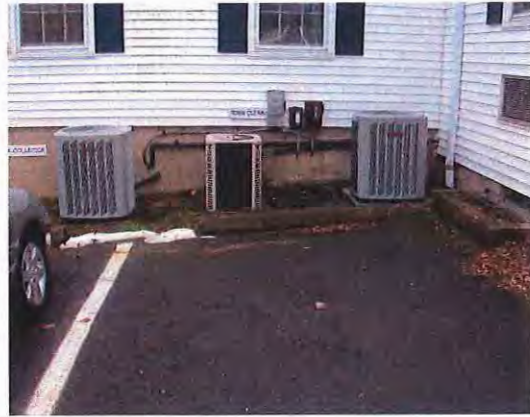
Condensing units serving the air handlers at front of building.

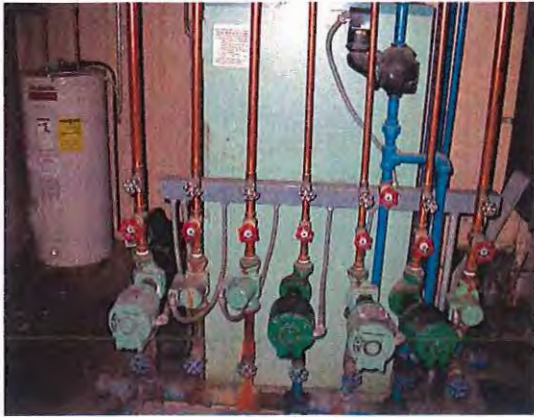
The building is heated by a Peerless boiler with an output of 415 MBH. Hot water is distributed throughout the building by in-line hydronic circulators.

Boiler and in-line hydronic circulators.

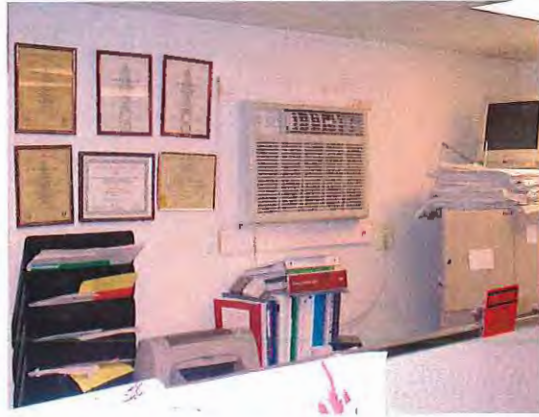
Adjacent to the Town Hall a portable building houses the Building Department. This building is heated by electric baseboard and is cooled by window air conditioners.

Window air conditioners used to cool the Building Department.

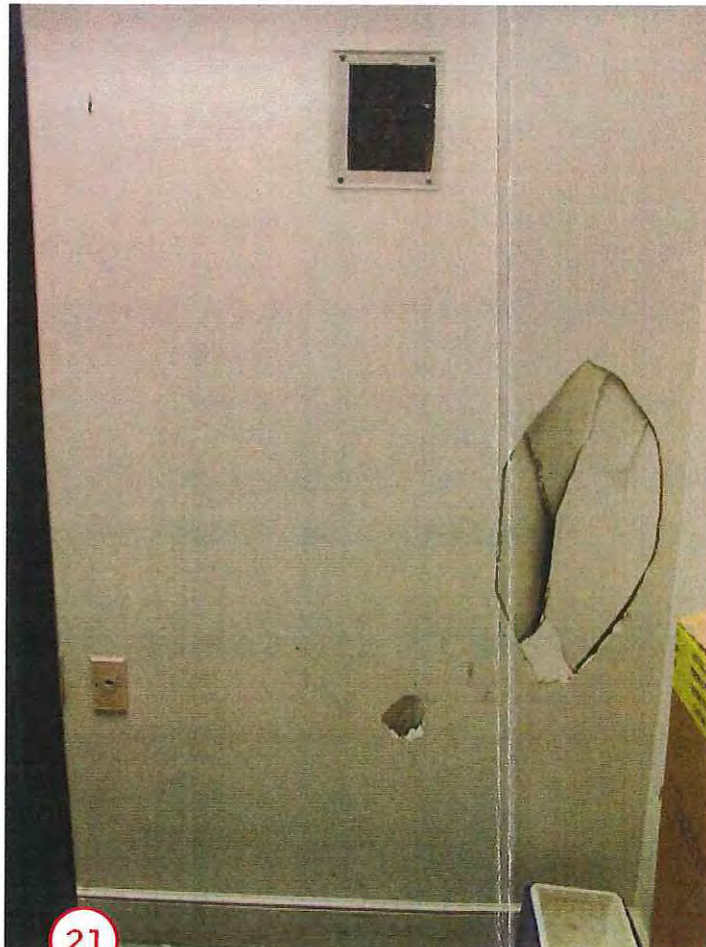
21

The existing detention area is another area creating serious safety and liability concerns. Presently, there are two holding cells with bars at the front. These, along with the many cracks and reveals within the ceilings, the open ventilation grill in the wall, and fixture surrounds afford multiple opportunities for a prisoner to harm himself or herself. The acoustical tile ceiling lends itself to maltreatment as much as the single-layer gypsum wall, which has a large hole in it from a previous prisoner. Also, the corridor is being used for storage. While this may seem to be a necessary stopgap measure, it provides the means by which a violent prisoner could cause damage to officers transporting him or her, similar to the condition in the booking area.

CONDITION OF WALL AT CELLS

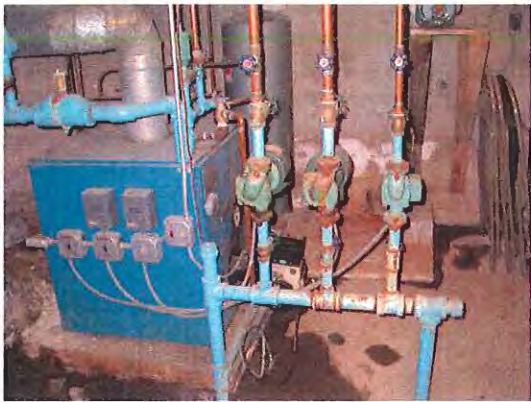
The building is heated by an oil-fired boiler located in the basement. Two 275-gallon No. 2 fuel oil storage tanks are installed to provide fuel to the boiler. Heat is distributed throughout the building by circulation pumps to finned tube radiation. Space temperature is controlled by wall-mounted thermostats. The system appears to be in fair condition.

Oil fired boiler located in basement.

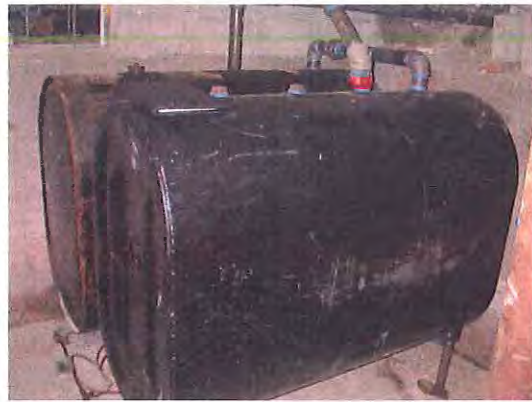
Two 275 gallon fuel oil storage tanks.

- A new double-wall fuel oil tank with leak detection should be considered for any tank greater than 20 years old.
- Complete building sprinkler systems in accordance with NFPA-13 should be considered for all buildings.

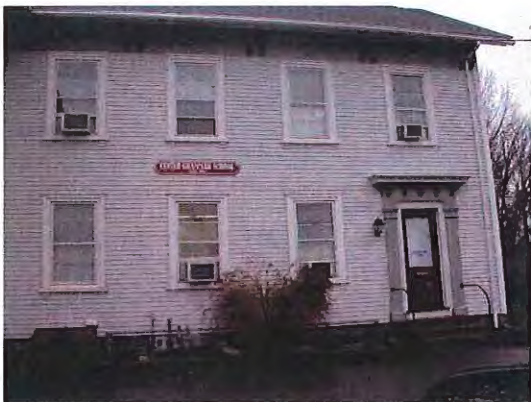
A central air conditioning system is not provided. Offices are cooled by window-mounted air conditioners.

Window mounted air conditioners.

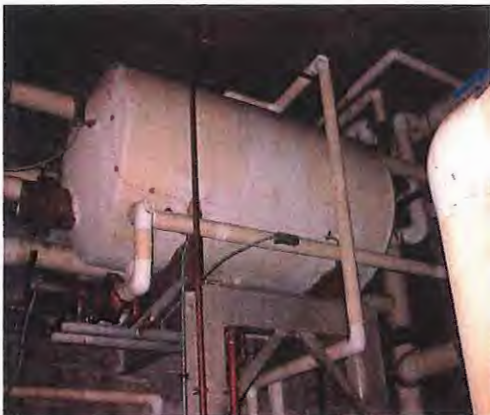
Domestic hot water is provided by a heat exchanger and storage tank system. The water is heated by the heating system boilers and stored in the associated storage tank. Electric hot water heaters are also installed and are utilized when the boilers are not in operation.

Domestic hot water storage tank.
