# Core PQS Field Test for Natural Turf

Organization: East Hampton High School

Field Name: Soccer Field (Inside of Running Track)

# CORE PQS SUMMARY:

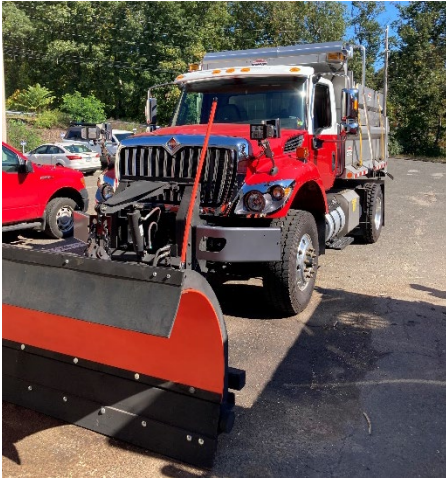
- On Thursday, October 5, the Department took delivery of its new Public Works Dump Truck. This truck was purchased utilizing ARPA funds and is replacing a 2002 vintage truck.

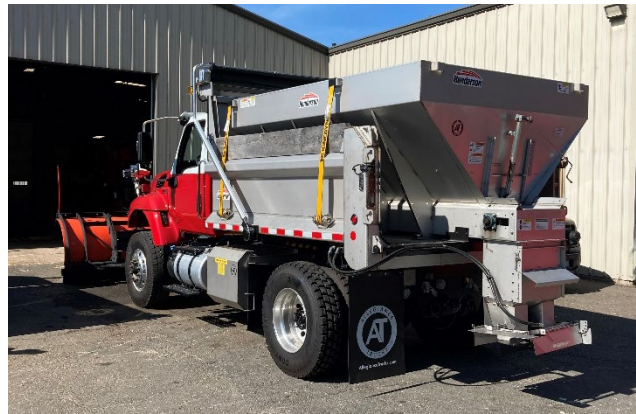
As the Council will recall, the Town was able purchase this truck quickly because it was originally ordered by another municipality that ended up not taking the delivery. Otherwise, the replacement truck would not have arrived until sometime in 2025. One other note of interest is that this truck has come equipped with a stainless steel

slide-in sander, as opposed to an "all season body." This change allows de-icing material to be discharged at the rear of the truck instead of at the side, which will help keep salt from accumulating on the truck's frame and will extend longevity of the truck. An added benefit of the slide-in sander is that when removed, the truck is able to carry more weight than a truck with an all season body.

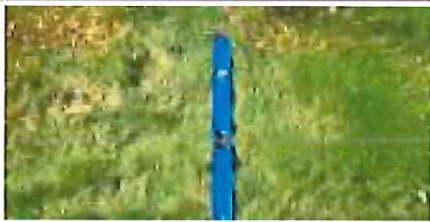
<p><b>A 3 Meter Straight Edge</b> is the tool which is placed upon the field surface in order to observe and measure surface undulations with a graduated wedge gauge.</p>
Rotational Traction

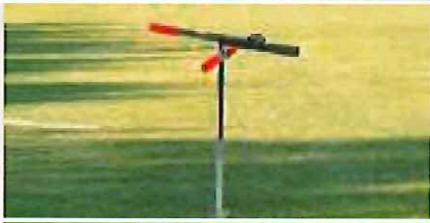
<p><b>Traction Meter</b> is a tool which measures the rotational resistance and the shear strength of the turf grass surface.</p>
Compaction Rating 1" & 3" Depth

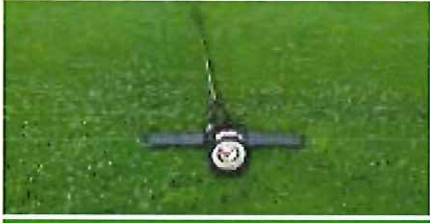
<p><b>The Penetrometer</b> is the tool of choice for measuring soil compaction. Soil compaction differs from field hardness. Compaction is measured in the pounds per square inch (PSI) required to drive the probe to differing depths.</p>
Surface Hardness (GMax)

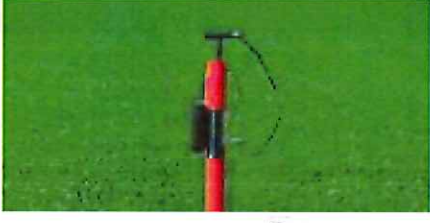
<p><b>The Clegg Hammer</b> is a tool which measures field surface hardness. Surface hardness may contribute to athlete injury and poor playing conditions.</p>
Moisture 2.2" Depth

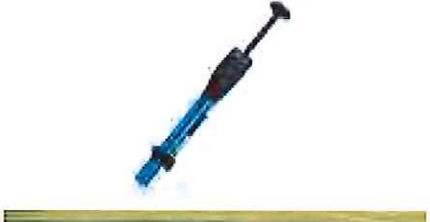
<p><b>Pogo Pro+</b> is a tool which measures the Volumetric Moisture Content of a wide range of soils. Soil moisture affects turf grass health and playability. It also measures salinity canopy temperature, soil temperature, and can be used for precision gps mapping</p>

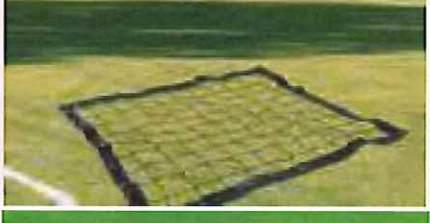
<p><b>The Grass Quadrant</b> is a grid of 100 equal squares used to accurately measure the percent of certain field imperfections.</p>
Surface Debris

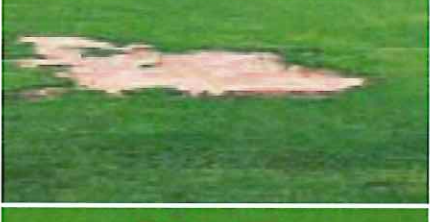
<p><b>Observation and Measurement</b> The Field Technician conducting the test surveys the field looking for and noting obvious deficiencies. These include hazardous debris, bare areas, overall condition, signage, fencing, field markings, goal posts, and other structures.</p>
Turf Infiltration Rate

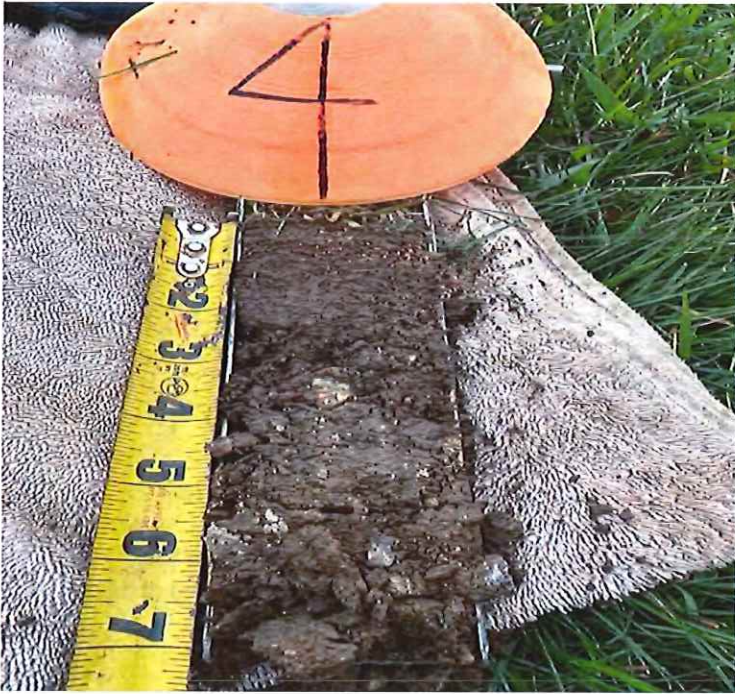
When evaluating the soil profile, there was a transition to a much stonier material at the 2.5-3" depth in all sample locations. The turf grass roots appeared to struggle breaking through this threshold. This issue has likely led to the low Rotational Traction scores. Having a compacted transition layer higher in the soil profile typically leads to moisture retention closer to the surface of the field. This leads to high Volumetric Water Content readings and very low Surface Hardness readings.

Northwest wing area soil profile.  
Note the 3" transition to stonier  
material.

- 1) A more thorough Soil Investigation should be carried out to determine the extent of the drainage challenges being created
  - 2) The planarity, and grading survey also identified that the difficult soil conditions are being exacerbated by inconsistent surface levels. (For more information see gradient survey on pages 13-14)
  - 3) The rain sensor on the irrigation system should be checked, the programs were running on other fields as the survey was being carried out.
  - 4) The drain covers inside the track around the border of the field should be cleared of all vegetation, and any impeding ridges that may hinder water flow to the drains should be addressed.
  - 5) A thorough cultural maintenance regime should be implemented to increase the percentage of desirable coverage in the stand; including topdressing, overseeding and deep tine aeration.
-

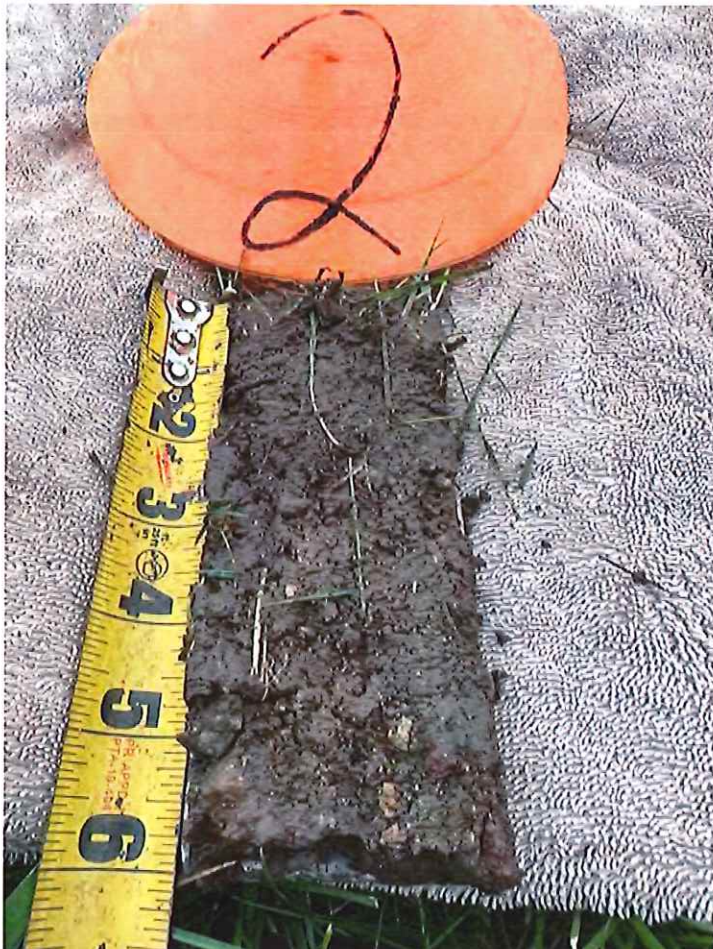
Southeast wing soil profile. Note  
how much more moisture is in  
this profile compared to the one  
above and the brick colored  
aggregates at the base.

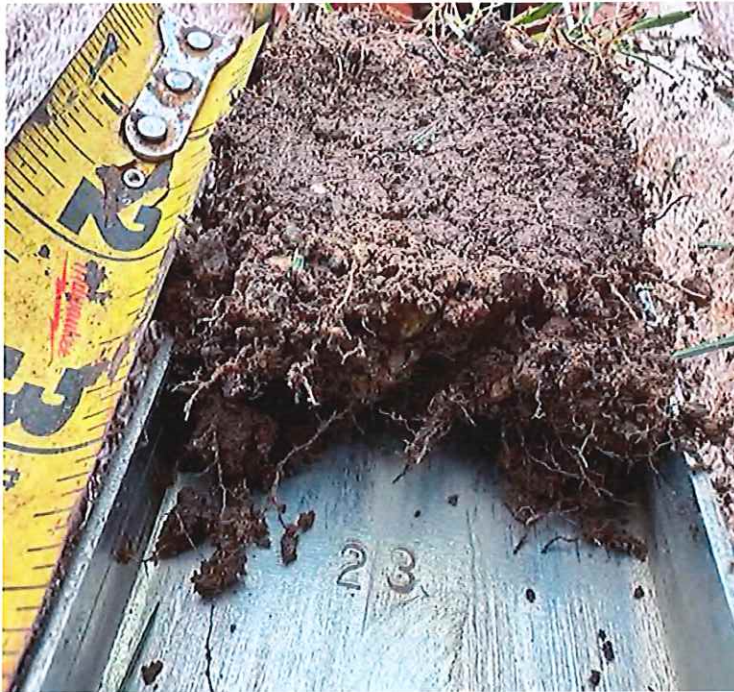
Minimal root depth into stonier material at 2.5-3" depth. Note the roots that are present are thin and tan.

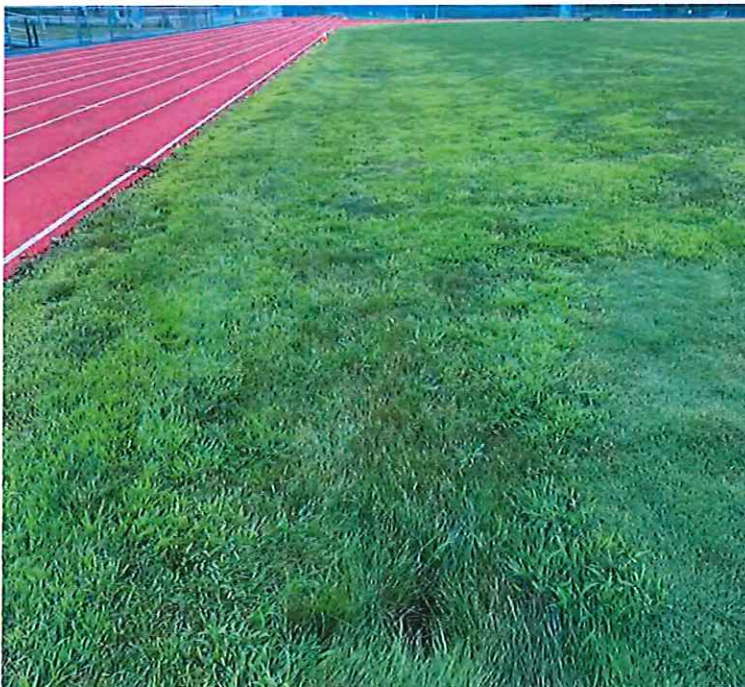
There are surface drains along the border to the inside of the track, however, they are overgrown with vegetation and appear to have lips built up in the 20 foot radius around them. While the field does appear crowned towards the drains there are many shelves and ridges that may affect sheet flow of surface water to the drains.

Overgrown drain area. Drain should be cleared to expedite excess water off the playing surface.

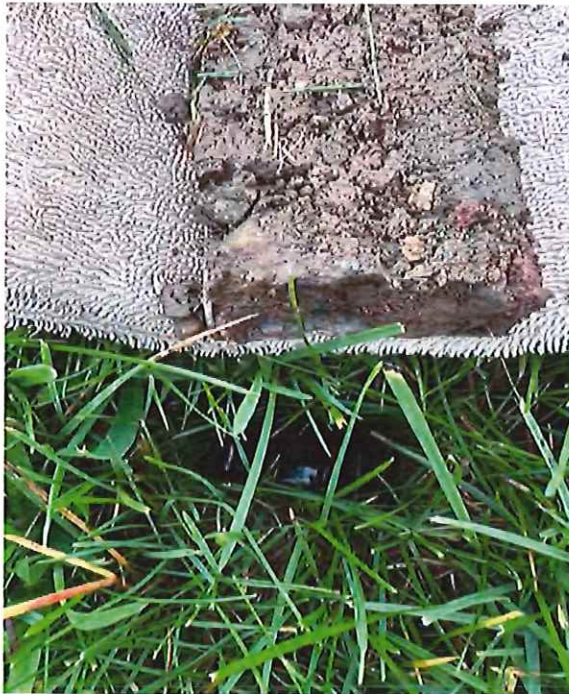
Additionally, after driving the profile extraction tool into the surface with a mallet and removing a core, a compaction reading was taken at the sub-base transition. This layer was nearly impenetrable, in fact at Test Location 2 there was water visible in the extraction hole, likely due to excess moisture being unable to drain through the sub-base.

Southeast wing area profile extraction hole with water at the base, not draining through sub-base.

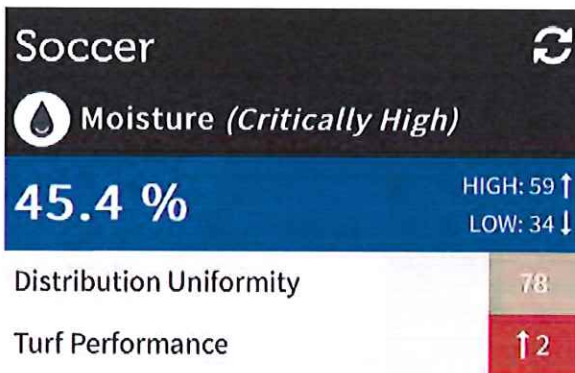
POGO+ Visual analysis of the Volumetric Water Content. Note the critically high reading. The field is at or near saturation. The Southern end is very wet. The irrigation was running in other fields after a significant rainfall event overnight and into the morning. Rain sensor likely not operational. Soccer field may have been irrigated prior to testing resulting in the saturated conditions.

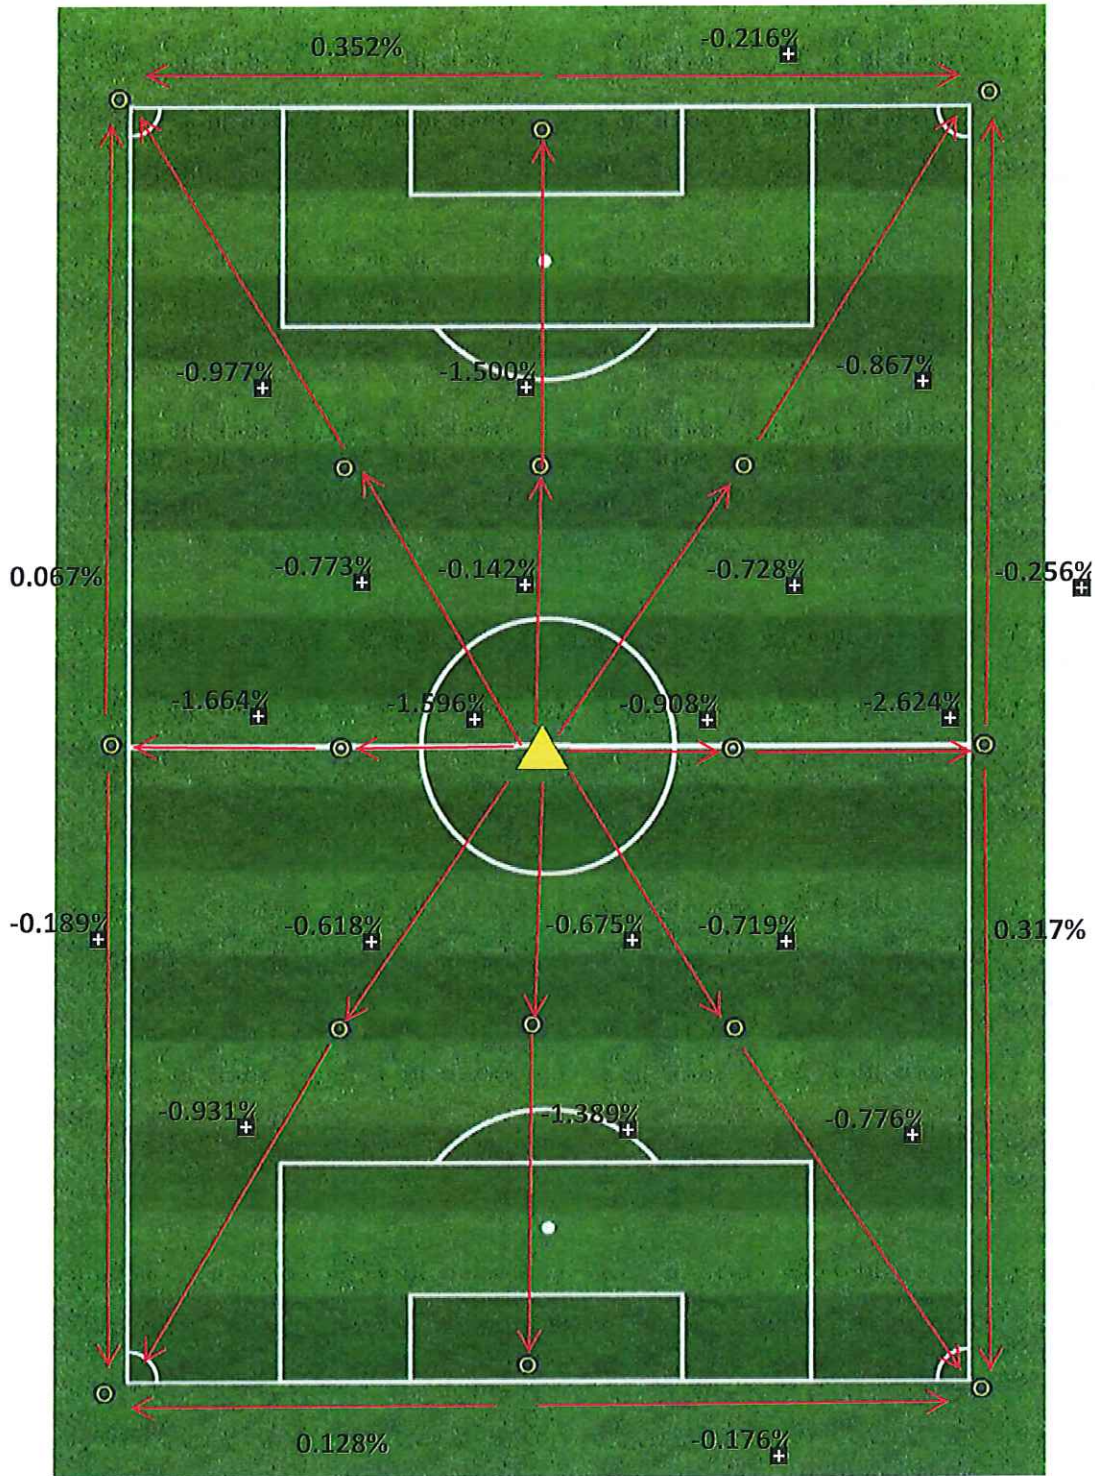
Field Gradients

The map on the previous page was generated by taking 24 elevation readings across the field to create a view of how surface water may drain across the field. Heights were determined using a laser level and distances were found using a laser range finder. Slopes were calculated between points to create the map. As you can see all the arrows are directed away from the datum at the midfield location, indicating the field is crowned. Water will likely move from the center of the field towards the edges where the drains are located.

- 1" rise identified between the Southeast intermediate and corner reading which may be contributing to the prolonged saturation issues Tucker had described.
- 1.5" depression along the centerline, approximately 20' to either side.
- 6" drop over the last 15' to the Northwest corner.
- These were just a few of many observed across the field.

- 1) The field should be re-graded to establish more uniform slopes across the field and subsequently, a more consistent growing environment. (Also see page 9 and point 1 of the recommendations)
