NEW ENGLAND ENVIRONMENTAL SERVICES

> RE: Hampton Village 37 South Main Street East Hampton, Connecticut

On April 12, 2023, I reviewed the wetland boundary and evaluated the wetlands on the proposed Hampton Village Subdivision.

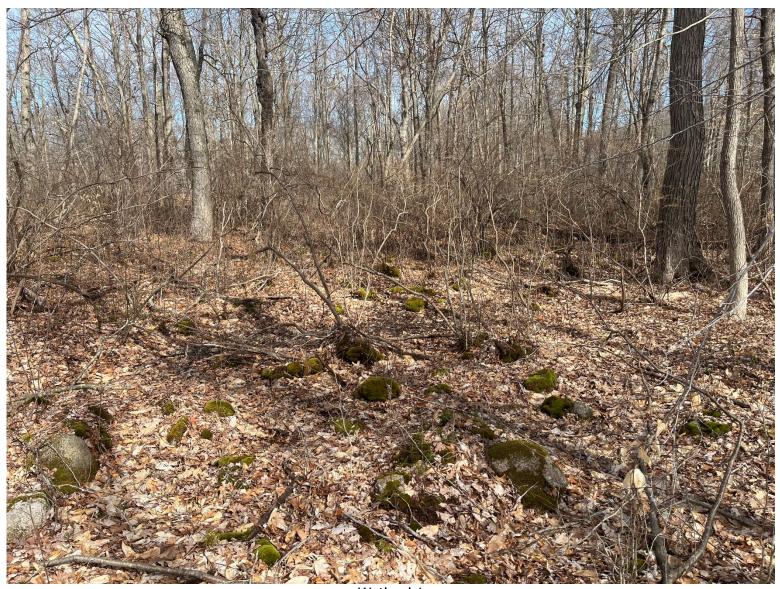
Wetland 1 April 12, 2023

Wetland 1 is a wooded wetland. The vegetation growing in the wetland includes Red Maple, American Beech, Yellow Birch, Winterberry, Pepperbush, Highbush Blueberry, Skunk Cabbage, Sedges, Violet, Cinnamon Fern, New York Fern, Fox Grape, and Catbrier. The soil type in the wetland is Leicester. Leicester is a poorly drained soil formed in glacial till. The topsoil and subsoil has a fine sandy loam texture. The substratum (unweathered glacial till) has a gravelly sandy loam texture. Two inches of pond water occurs at several locations in the wetland. No amphibian egg masses occur in the wetland. The wetland has a moderate function and value for flood storage, sediment trapping, pollutant renovation, and wildlife habitat because the wetland has no outlet and a diverse plant species, many of which has a high wildlife food value. The wetland is formed by groundwater discharge.

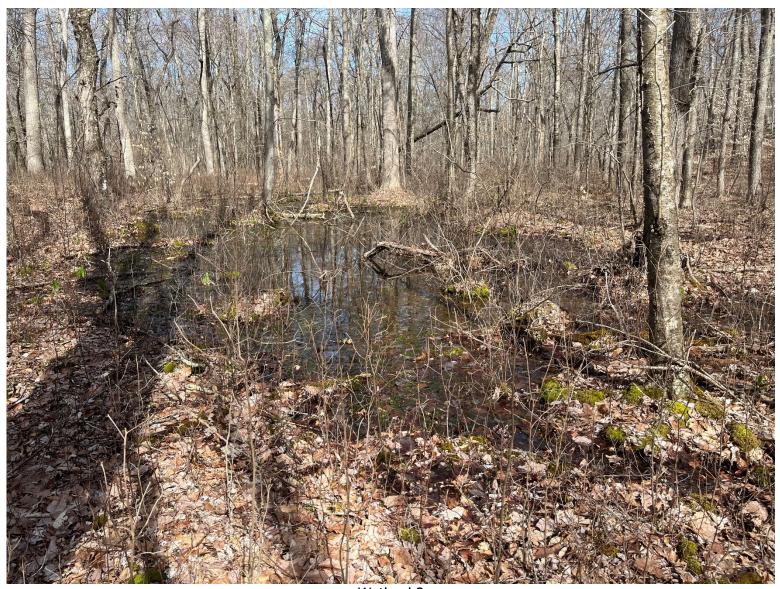
Wetland 2 April 12, 2023

Wetland 2 is a wooded wetland. The vegetation growing in the wetland includes Red Maple, Yellow Birch, Pepperbush, Highbush Blueberry, Princess Pine, Sedges, Winterberry, Cinnamon Fern, Violet, and Skunk Cabbage. The soil type in the wetland is Leicester. A vernal pool occurs in the wetland. Ten spotted salamander egg masses were counted in the pool. The depth of the water in the pool was 3 to 5 inches deep. The wetland has a high function and value for wildlife habitat due to the vernal pool. The wetland has a low flood storage capacity. The wetland has a moderate sediment trapping and pollutant renovation capacity due to the diverse plant species.

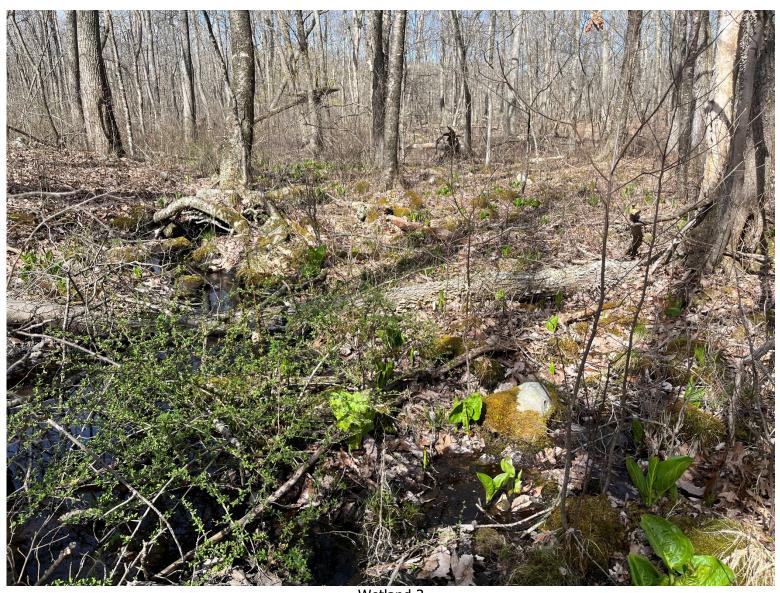
Wetland 3 April 12, 2023

Wetland 3 is a wooded wetland. The vegetation in the wetland includes Red Maple, Black Gum, Spicebush, Pepperbush, Highbush Blueberry, Shagbark, American Beech, Japanese Barberry, Tussock Sedge, Lurid Sedge, Cinnamon Fern, New York Fern, Violet, and Catbrier. The soil type in the wetland is Leicester. A 2 to 4-foot intermittent watercourse occurs in the wetland which flows in the westerly direction. No amphibian egg masses occur in the wetland. The wetland has a low value for flood storage. The wetland has a moderate value for sediment trapping, pollutant renovation, and wildlife habitat due to the plant species diversity.

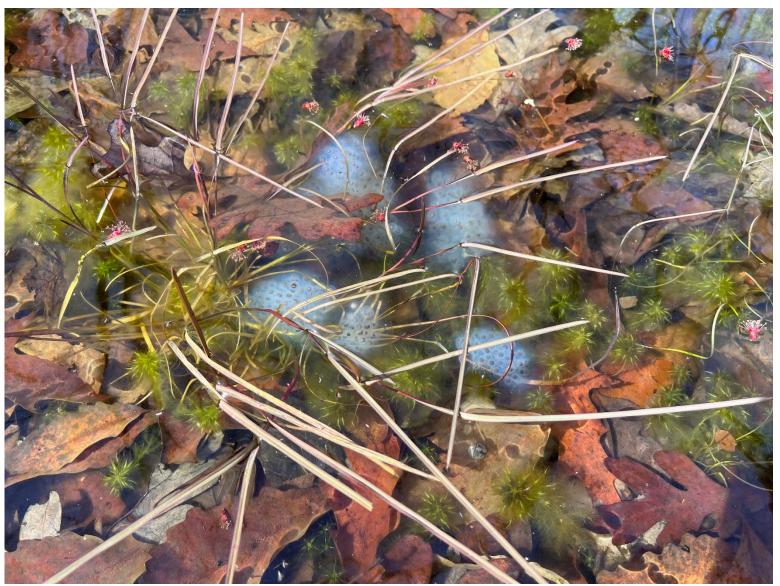
Spotted Salamander Egg Masses in Vernal Pool April 12, 2023
