RECEIVED
10.27.2021
East Hampton
Land Use Office

31 Bay Road
Sea Wall restoration
plan

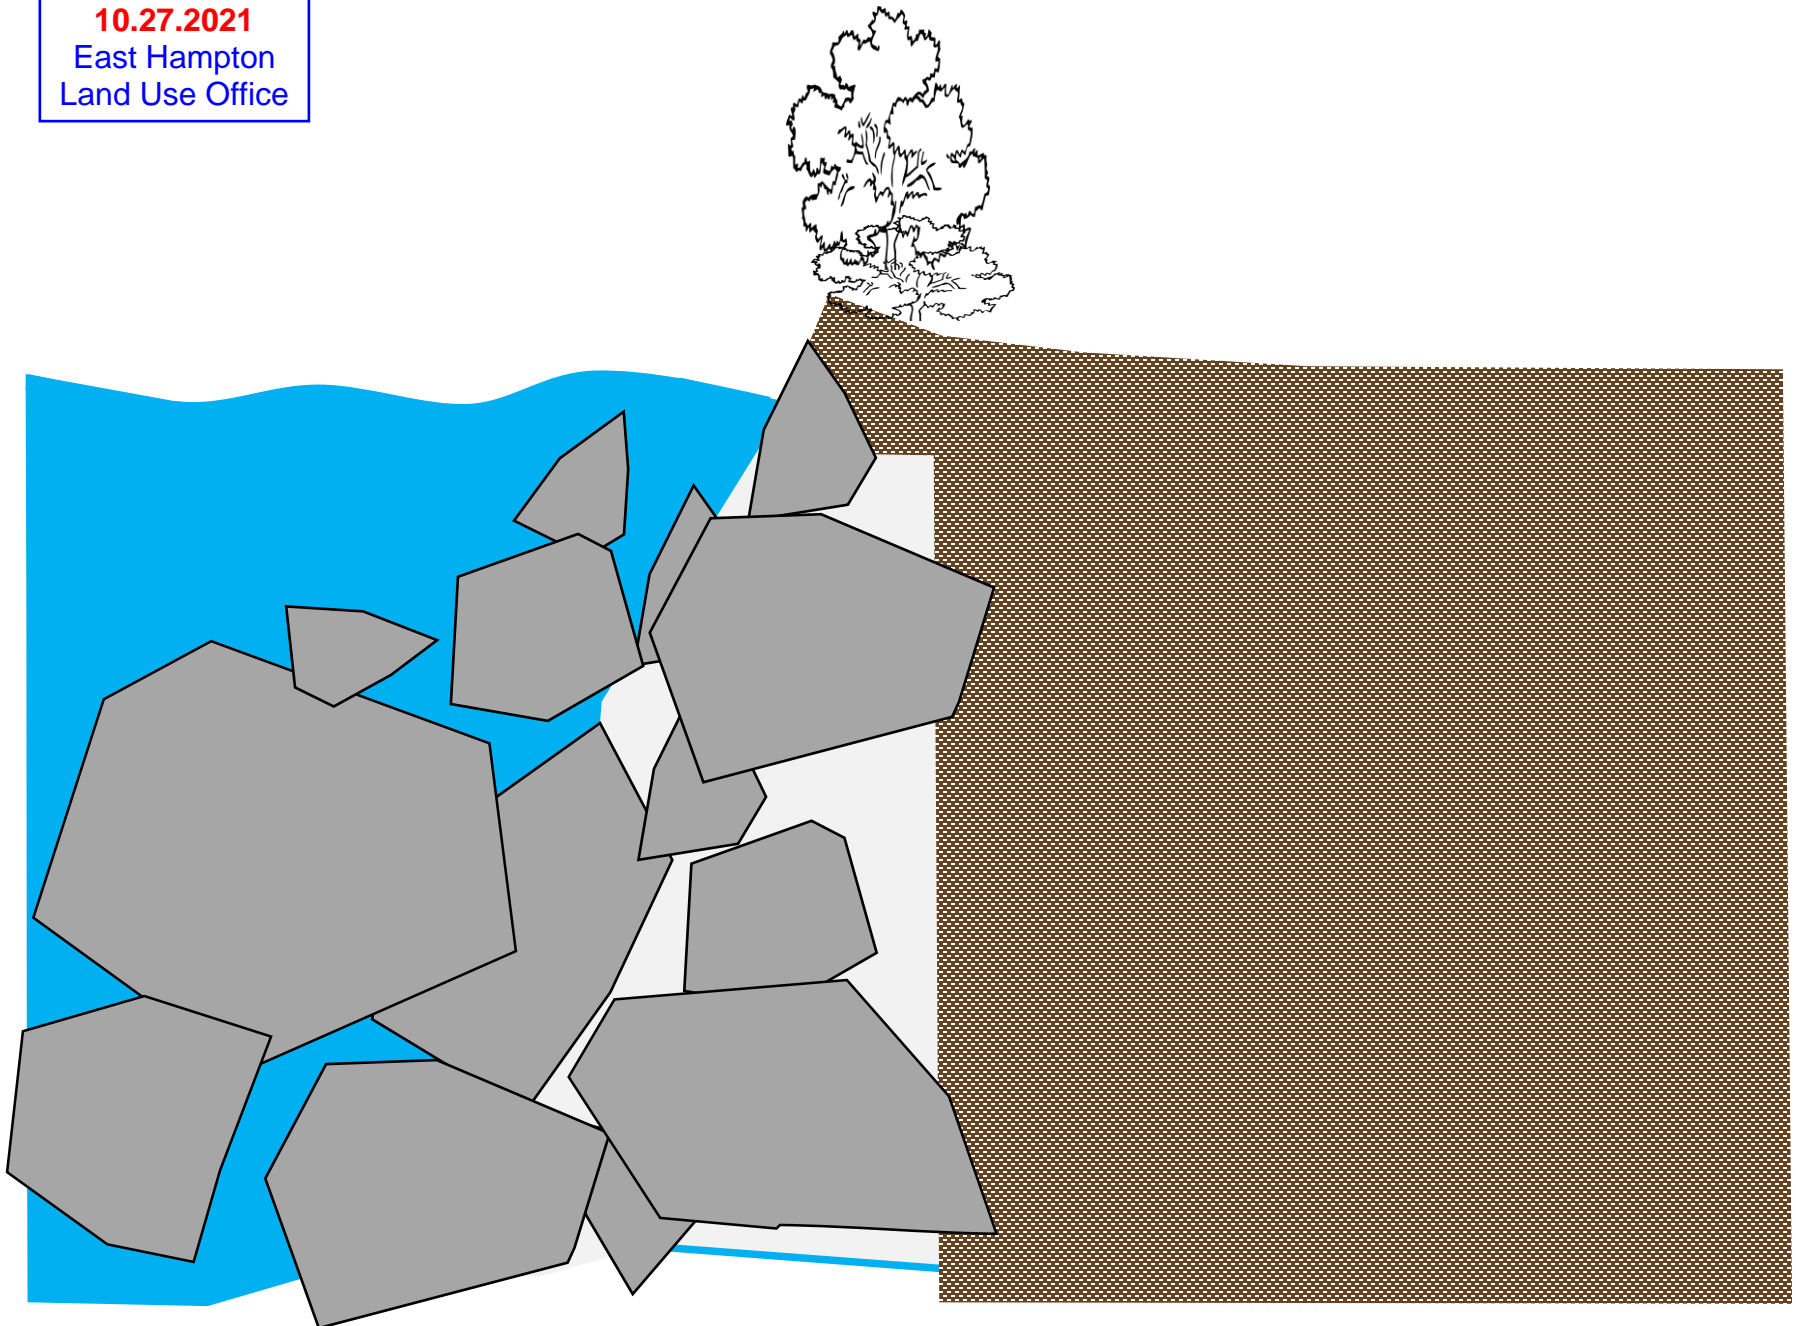
Existing View showing collapsed wall and existing plantings

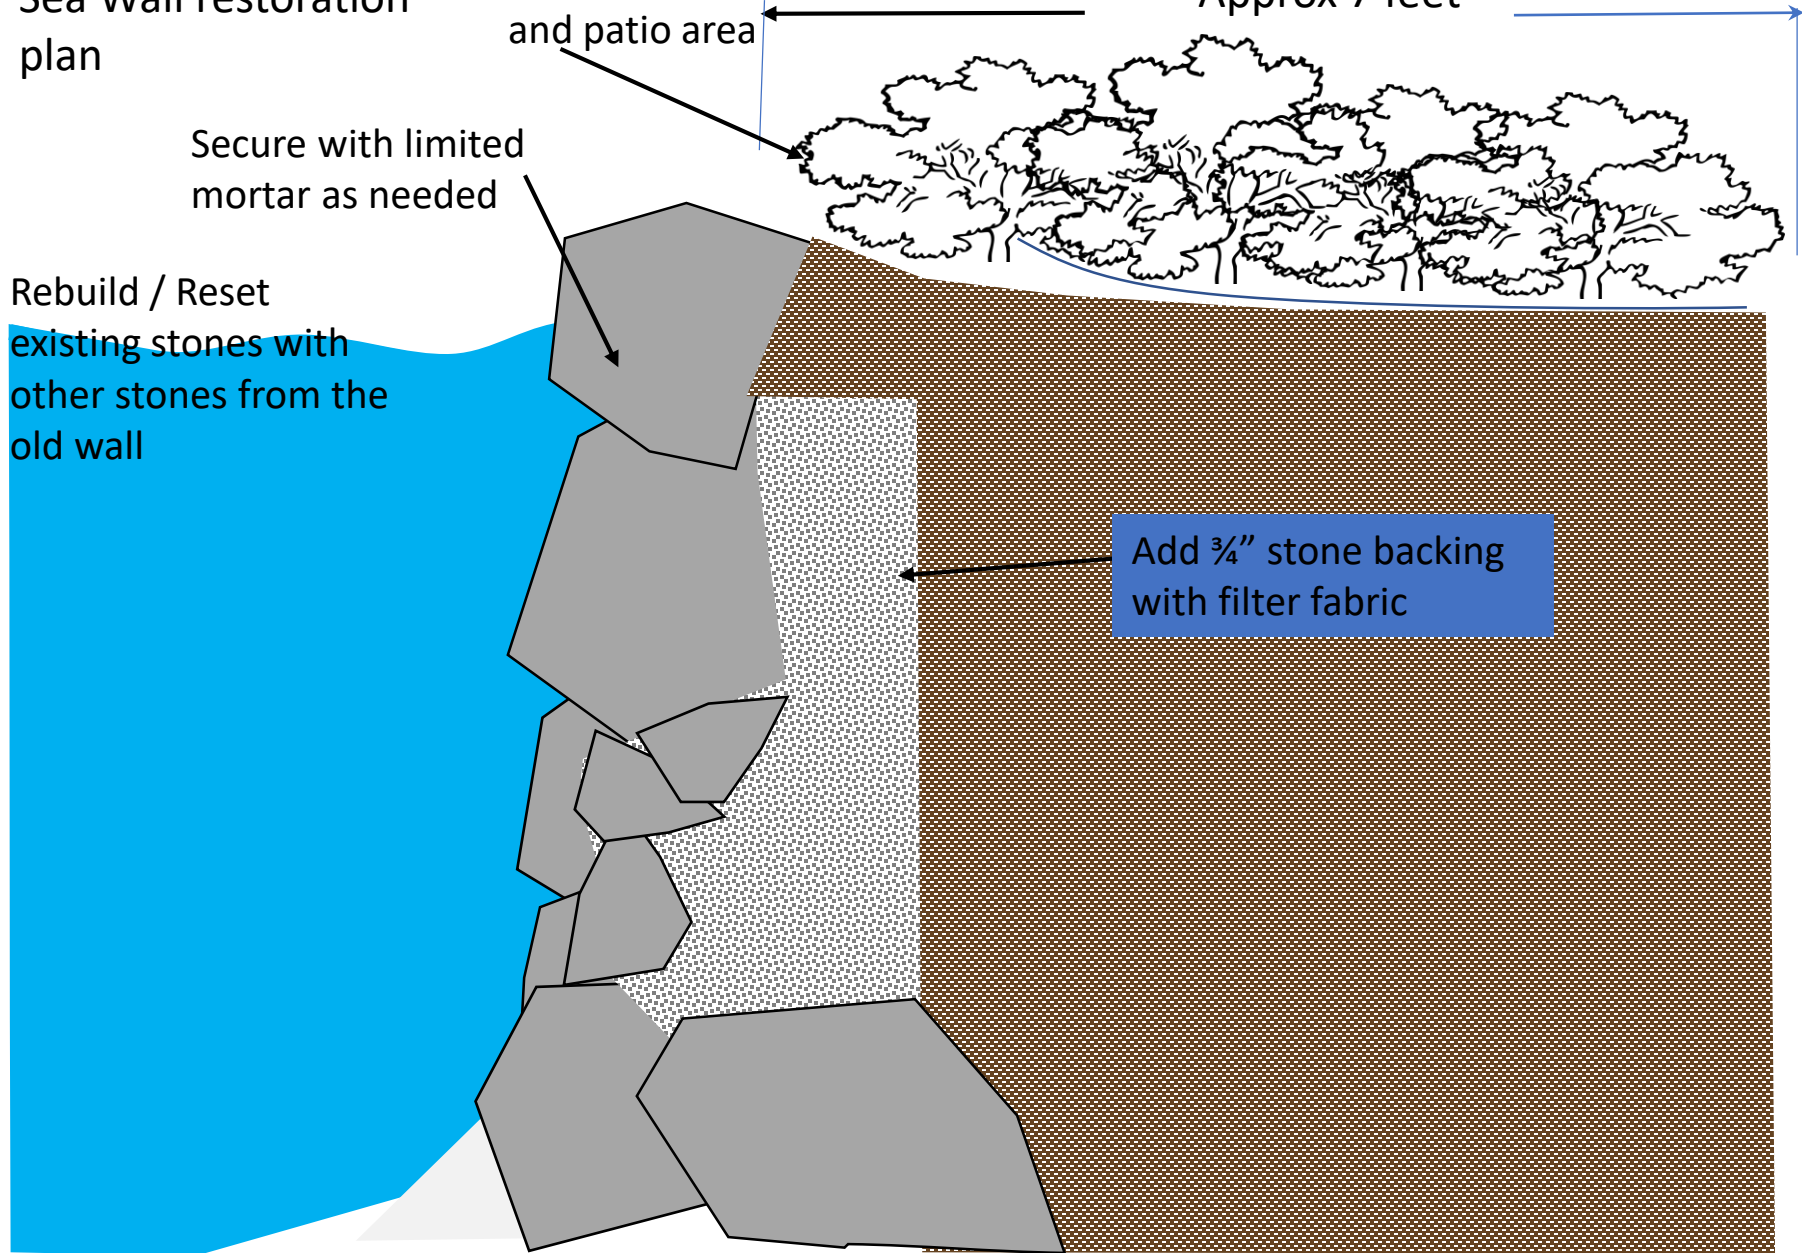
Approx 7 feet

Plant low shrubs and
plantings between wall
and patio area

Secure with limited
mortar as needed

Rebuild / Reset
existing stones with
other stones from the
old wall

Add ¾" stone backing
with filter fabric
