**Wetlands / Watercourse Assessment  
Proposed and Alternate Driveway Access Crossings  
11 Cone Road  
East Hampton, Connecticut**

**Revised Report**

**February 24, 2020**

**Project No. JE 19-16**

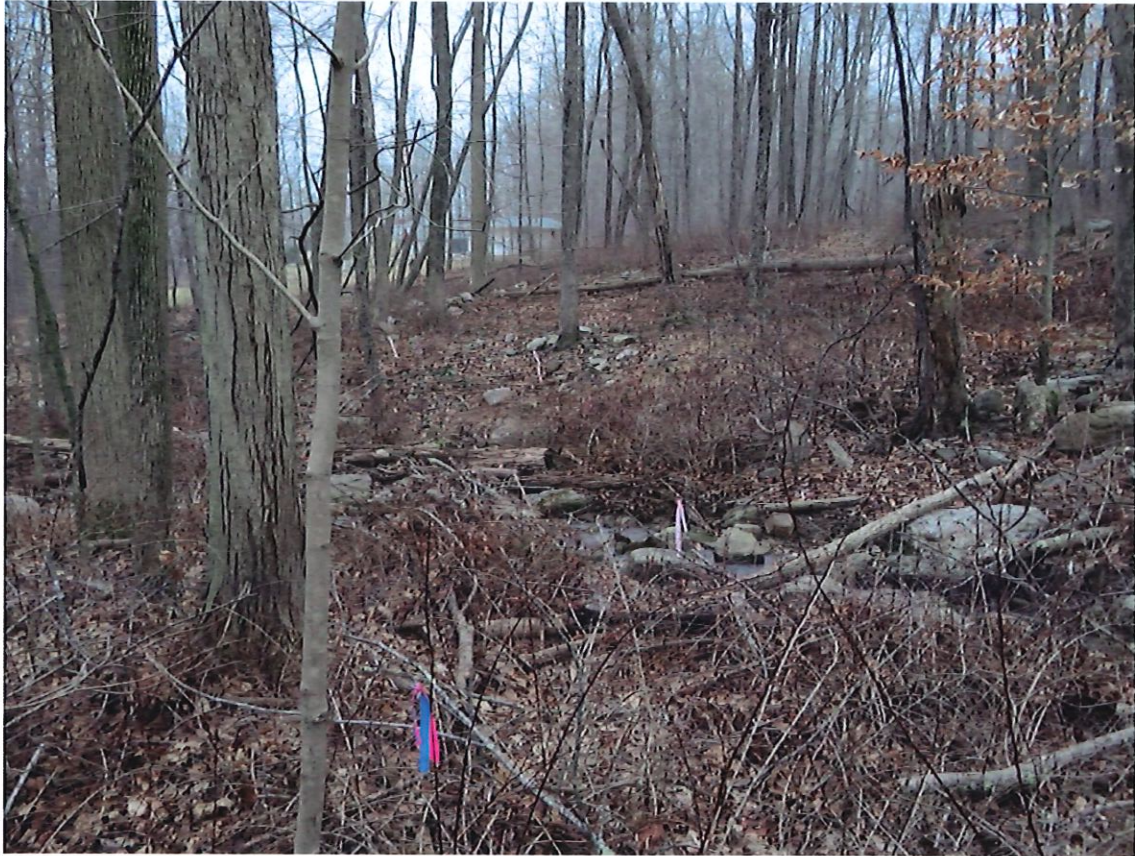
**Photo 1:** Watercourse in area of Crossing, Proposed Driveway Access

The watercourse is incised within a narrow channel; the channel gradient is at the proposed crossing is approximately 9-percent. The banks are composed of coarse sandy soils, cobbles and boulders. The primary functions of the watercourses are: groundwater recharge/discharge, the conveyance of surface water down-slope, and wildlife habitat. The watercourse was not flowing during the site visit on October 8, 2019. The watercourse has a narrow band (approximately 20-foot wide) of poorly-drained and/or alluvial soils immediately east of the channel. Dominant native forest vegetation observed in the vicinity of the proposed crossing included: sugar maple trees and saplings, shagbark hickory trees and saplings, American beech saplings, spice-bush shrubs, sassafras shrubs, spinulose wood fern, cinnamon fern, Christmas fern, Massachusetts fern, sensitive fern, smartweed and aster. The following invasive shrub species were also dominant: Japanese barberry, multi-flora rose and burning bush. Dense thickets of Japanese barberry were noted adjacent to the watercourse. The wetland soils bordering the watercourse likely serve to slow surface water runoff and provide habitat and a corridor for wildlife.

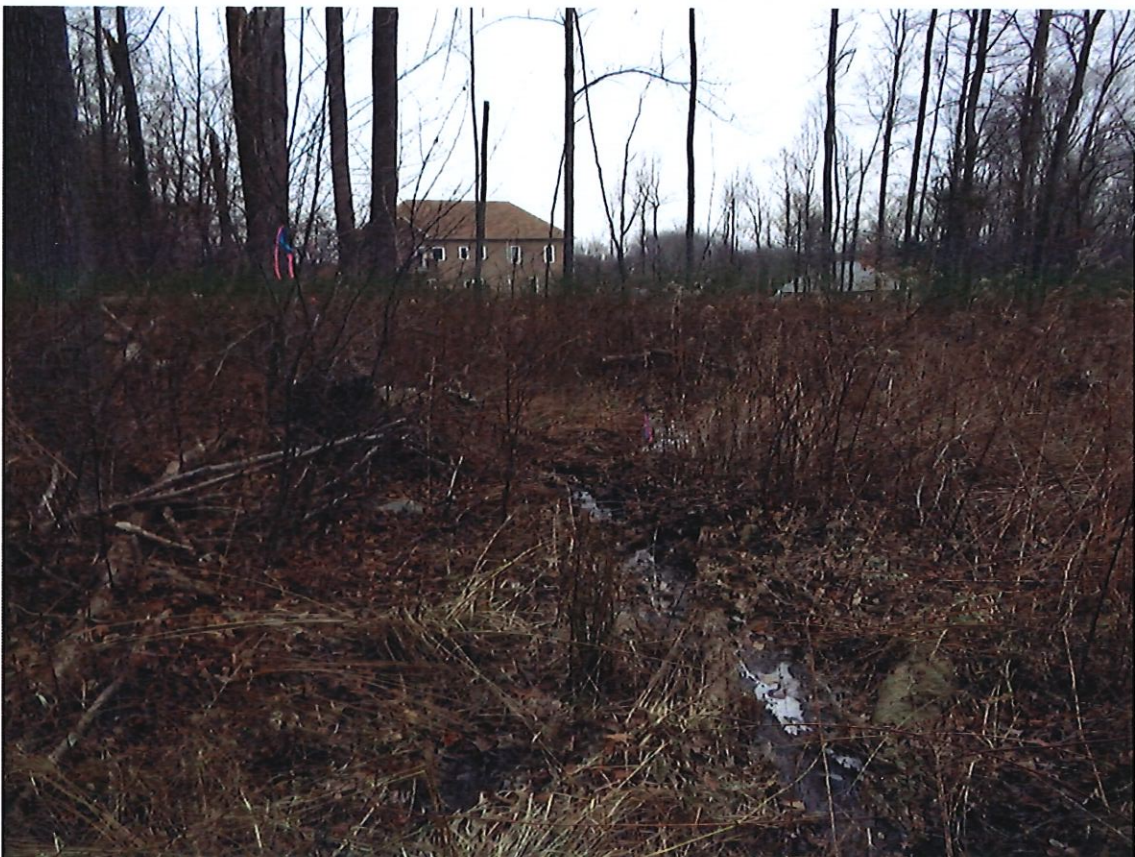
**Photo 2:** Watercourse in area of Crossing, Alternate Driveway Access

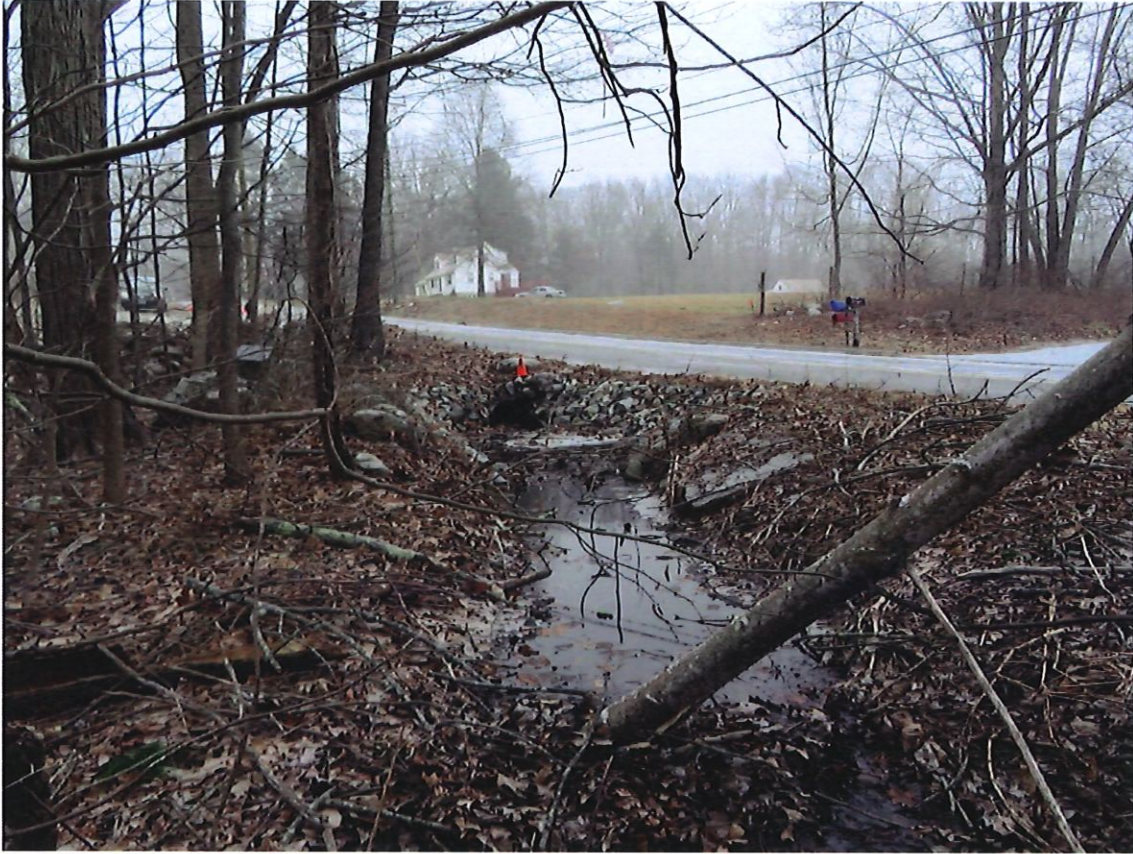
**Photo 3:** Stormwater Outfall & Associated Basin adjacent to Cone Road

The intermittent watercourse emanates from a stormwater drainage system outfall within Cone Road. An existing riprap-lined basin was constructed by the Town on 11 Cone Road immediately down-stream from the outfall. The alignment for the Proposed Access Driveway would require an approx. 780 square foot area of disturbance along 60 l.f. of the intermittent watercourse, adjacent to Cone Road, in order to construct the Proposed Access Driveway, associated drainage culvert, and a stilling basin south of a Access Driveway. A stilling basin is necessary to retain sediment-laden stormwater discharge from the stormwater drainage outfall in Cone Road. The existing riprap lined basin constructed immediately down-stream of the outfall has not been effective in preventing sedimentation within the intermittent watercourse located on the 11 Cone Road property.

Mitigation Measures – The proposed settling basin has been specified by the Engineer to retain sediment within stormwater the Cone Road drainage outfall. The Site Development & Erosion Control Plan shows a permanent scour-control structure and staked haybales downstream of the stilling basin location and a double-row of silt fencing bordering the limits of construction. The proposed stilling basin would enhance the intermittent watercourse by providing sediment retention and decreases in stormwater flow velocities down-stream.

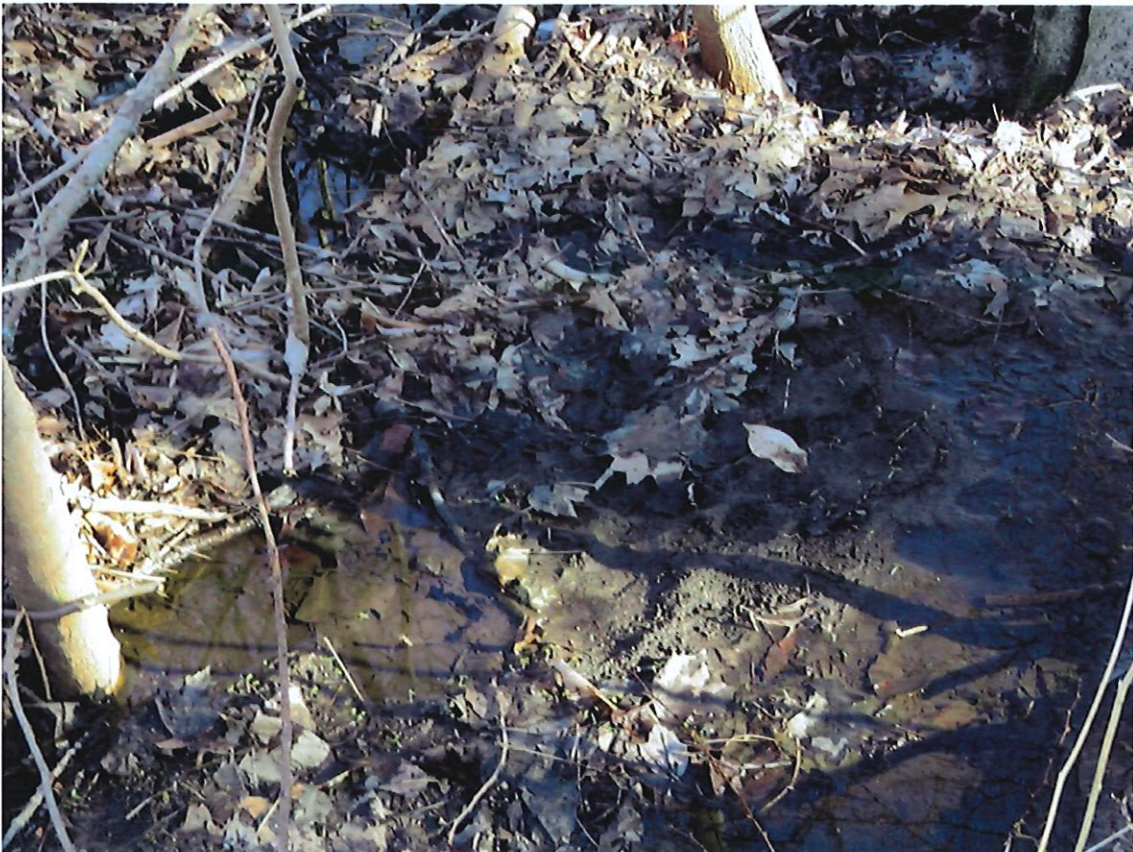
**Photo 4:** Sedimentation within Intermittent Watercourse adjacent to Cone Road

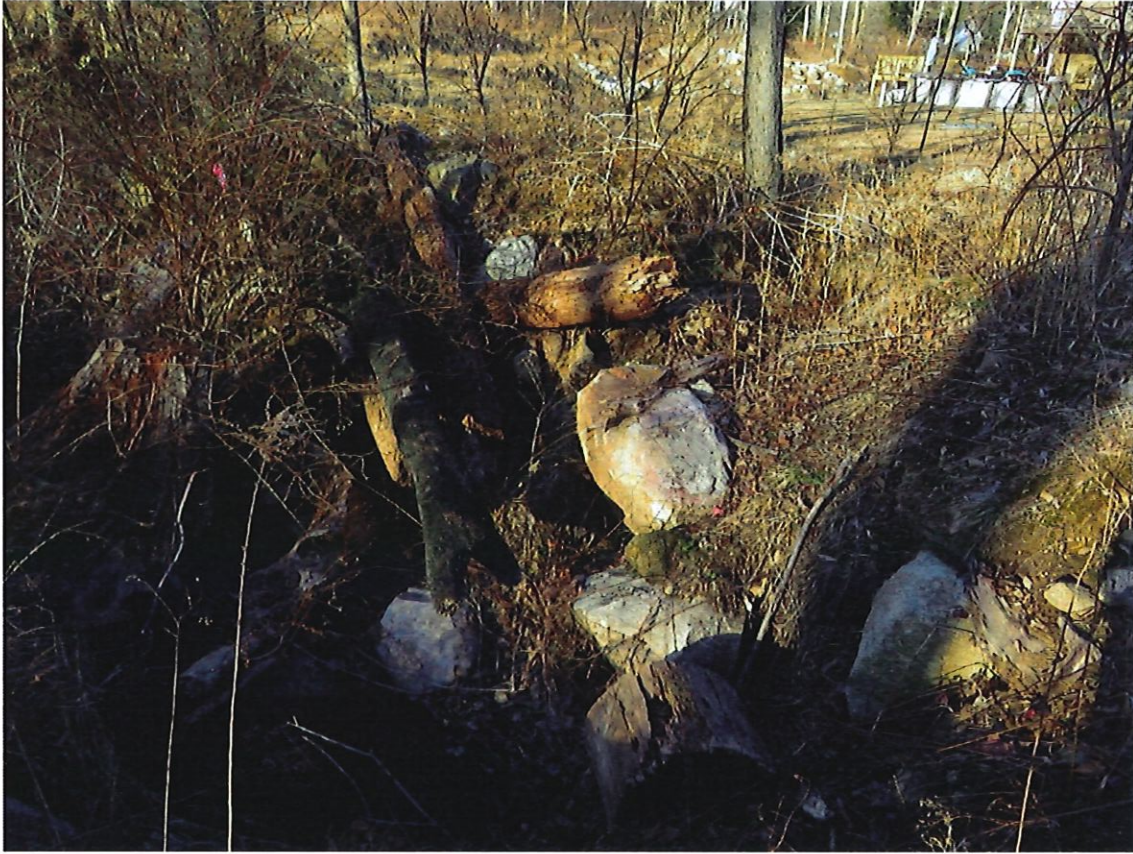
**Photo 5:** Watercourse Channel, East bank, at Existing Crossing from 15 Cone Road

And existing watercourse crossing has earthen fill and associated 12-in drainage pipe. The area of the existing crossing shown on the Site Plan is 1,025 s.f. The Town has requested the removal of this crossing and the restoration of the watercourse channel. This section of the watercourse was historically re-aligned and the channel in the area of the existing crossing was previously excavated.

The watercourse is incised approx. six vertical feet within a narrow channel. The banks are composed of sandy and loamy disturbed soils with boulder riprap. Vegetation includes red maple trees, yellow birch and staghorn sumac samplings, goldenrod and burning bush. The stream channel bottom contains a dense thicket composed of Japanese barberry and multiflora rose. The primary functions of the watercourses are: groundwater recharge/discharge, the conveyance of surface water down-slope, and wildlife habitat.

The Engineer proposes to remove the earthen fill and piping associated with the existing crossing and to stabilize the channel and side slopes with riprap.

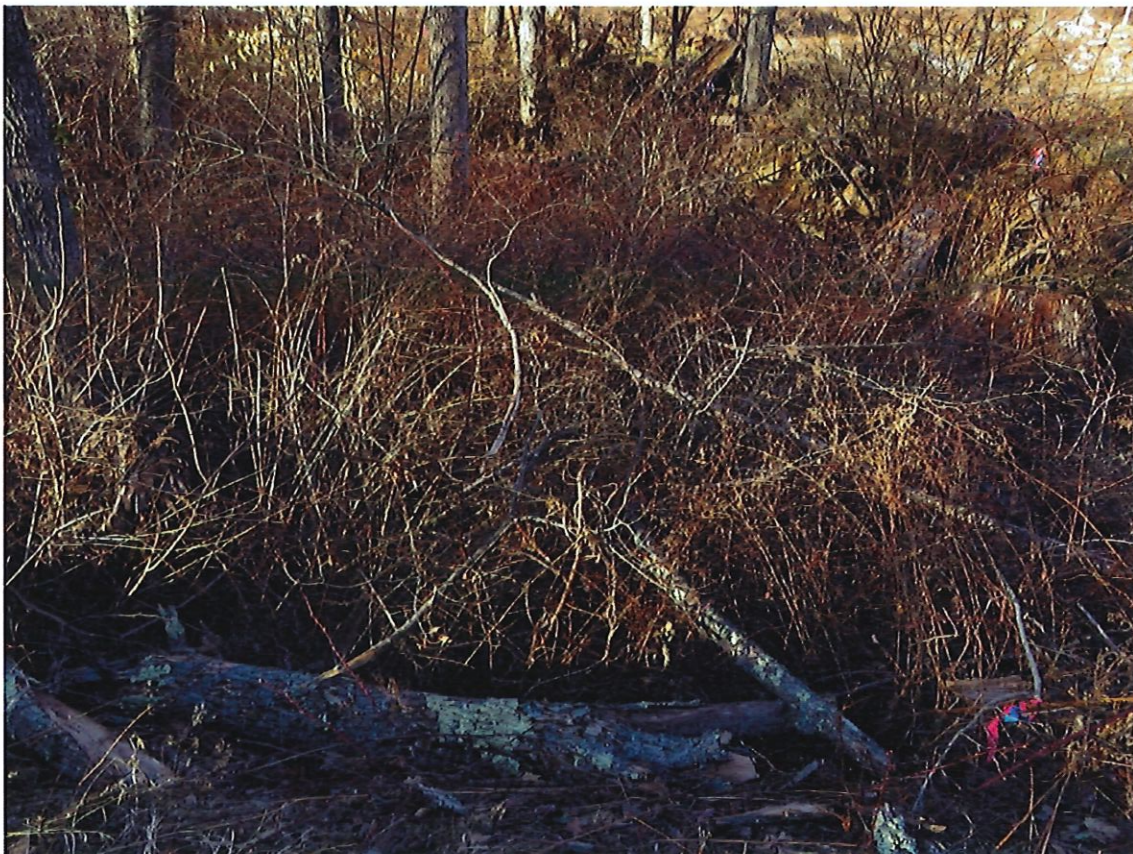
**Photo 6:** Watercourse Channel at Existing Crossing from 15 Cone Road, View North

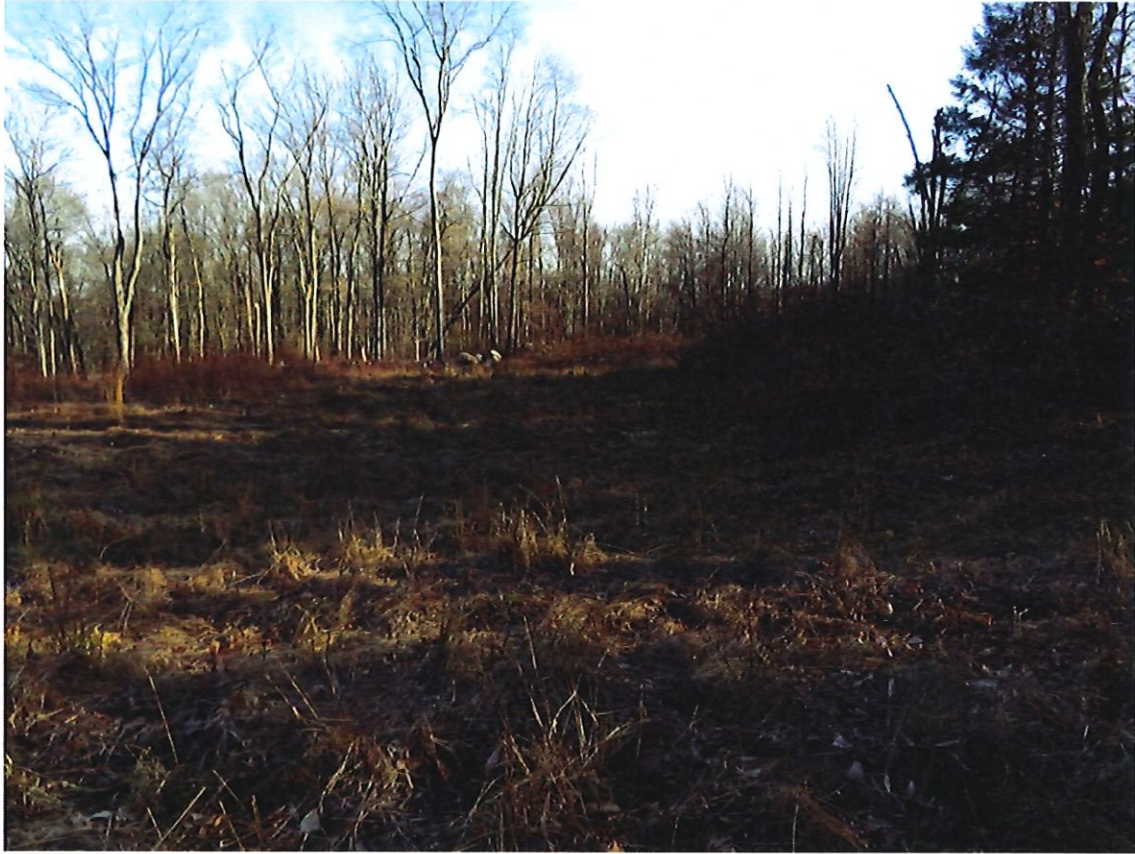
**Photo 7:** Emergent Wet Meadow, West Side of Proposed Conservation Easement, View South

Jackson Environmental understands that the property owner has agreed to set aside an area of land within a previously cleared area located adjacent to the northern property boundary and immediately west of 15 Cone Road. As noted in Table 2, the Proposed Driveway Access would allow approximately two-acres of previously cleared area for conservation and to protect an emergent wet meadow. As noted above in Section 1.2.1.4, the wet meadow contains herbaceous emergent vegetation. There is no direct activity (e.g., excavation or filling) proposed within this wetland area. A formal wetland/watercourse enhance plan that would include provision for inspections and management of invasive plant species (e.g., multiflora rose) and removal of woody debris within a conservation easement.

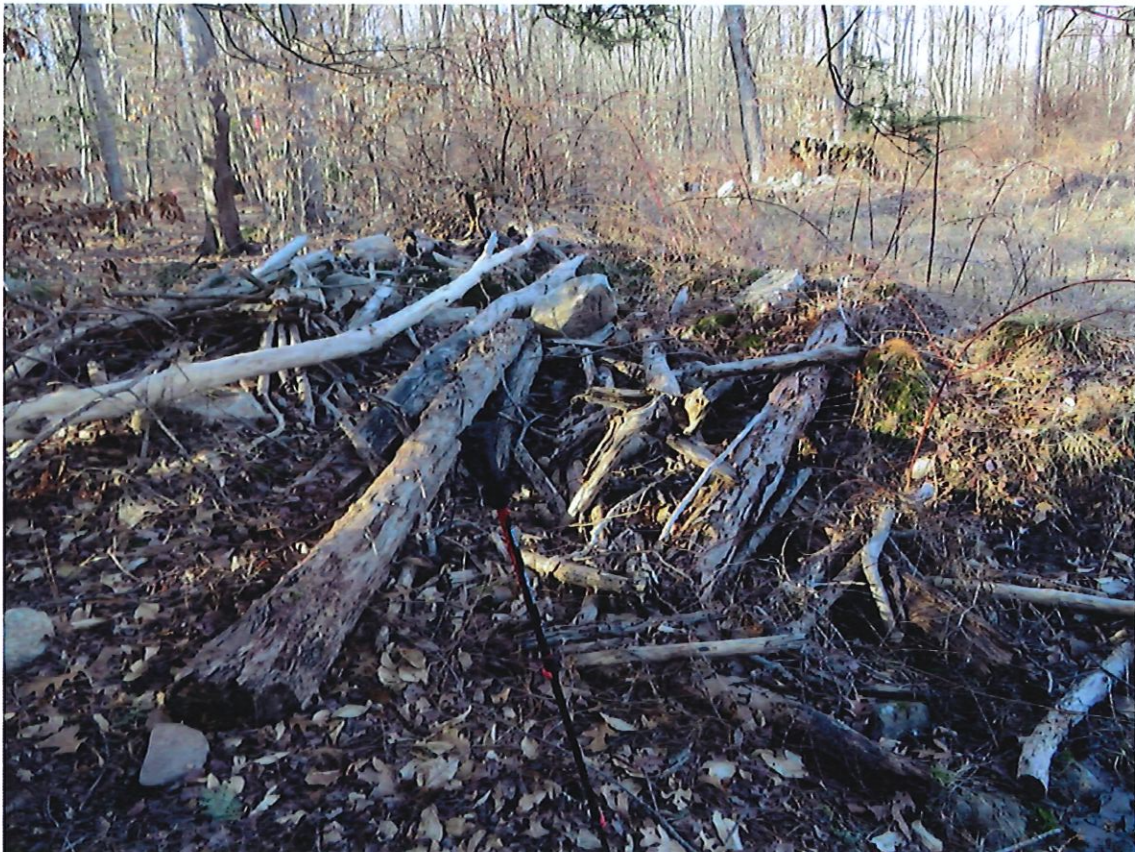
**Photo 8:** Woody Debris at Wetland Boundary, West Side of Proposed Conservation Easement
