**RE: Wetland and Watercourse Delineation
Proposed Bank Stabilization and Patio
49 Bay Road
East Hampton, Connecticut
MMI #141.17405.00001.0010**

WETLAND AND WATERCOURSE DELINEATION
 INLAND WETLAND PERMITTING ASSISTANCE
 HERRICK RESIDENCE
 49 BAY ROAD
 EAST HAMPTON, CONNECTICUT

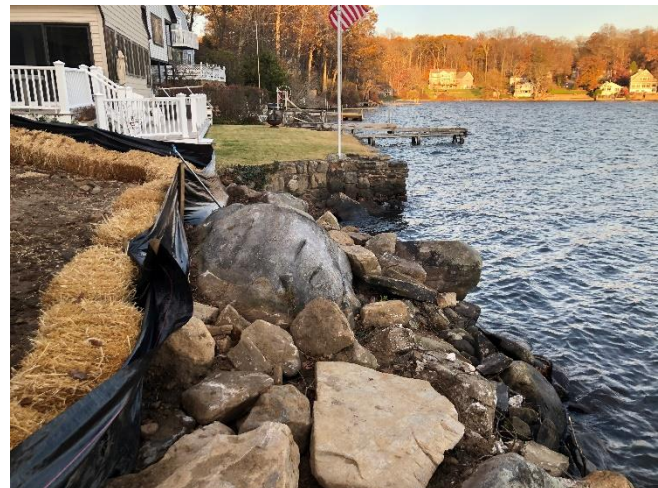
Bank stabilization at southern property boundary. Wetland boundary comprised of OHW line to Pocotopaug Lake.

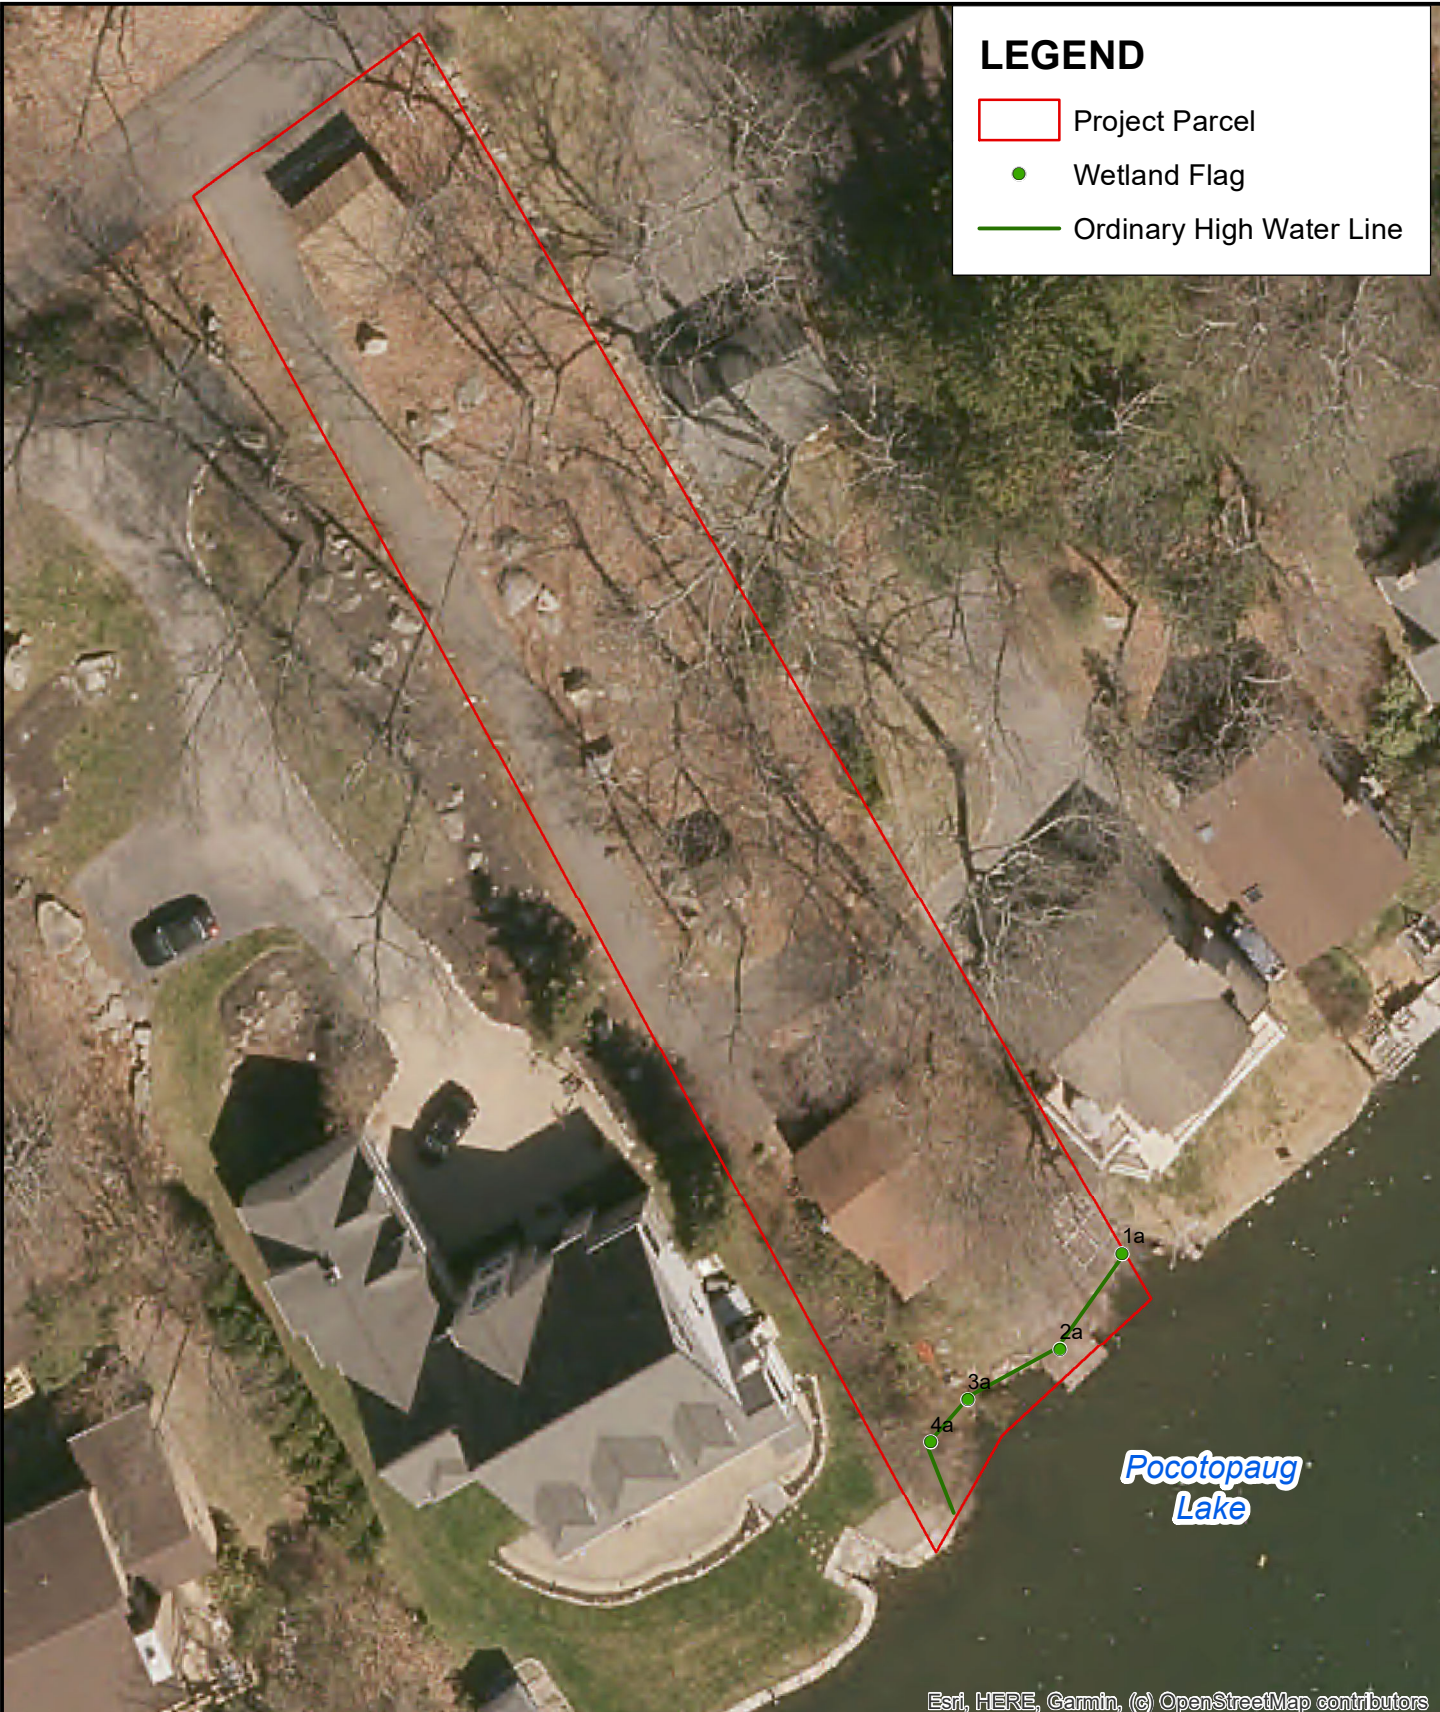
FIG. 2

Wetlands on the property consist of the OHW line to Pocotopaug Lake (Figure 2). Several feet of stones and small boulders currently stabilize the bank along the OHW line, and other sedimentation and erosion prevention measures are in place including a silt fence and straw bales to prevent soil loss from the unvegetated land upslope. The soils immediately adjacent to the lake behind the toe embankment were not poorly drained, very poorly drained, or alluvial, and no wetlands were delineated upslope of the lake.

Wetland boundaries along the OHW line of the lake were demarcated (flagged) with blue surveyor's tape (hung from vegetation) or small flags (on wire stakes) that are generally spaced a maximum of every 50 feet. Complete boundaries are located along the lines that connect these sequentially numbered flags. The wetland boundaries are subject to change until adopted by local, state, or federal regulatory agencies. Wetland boundaries are depicted by flag series 1a through 4a.

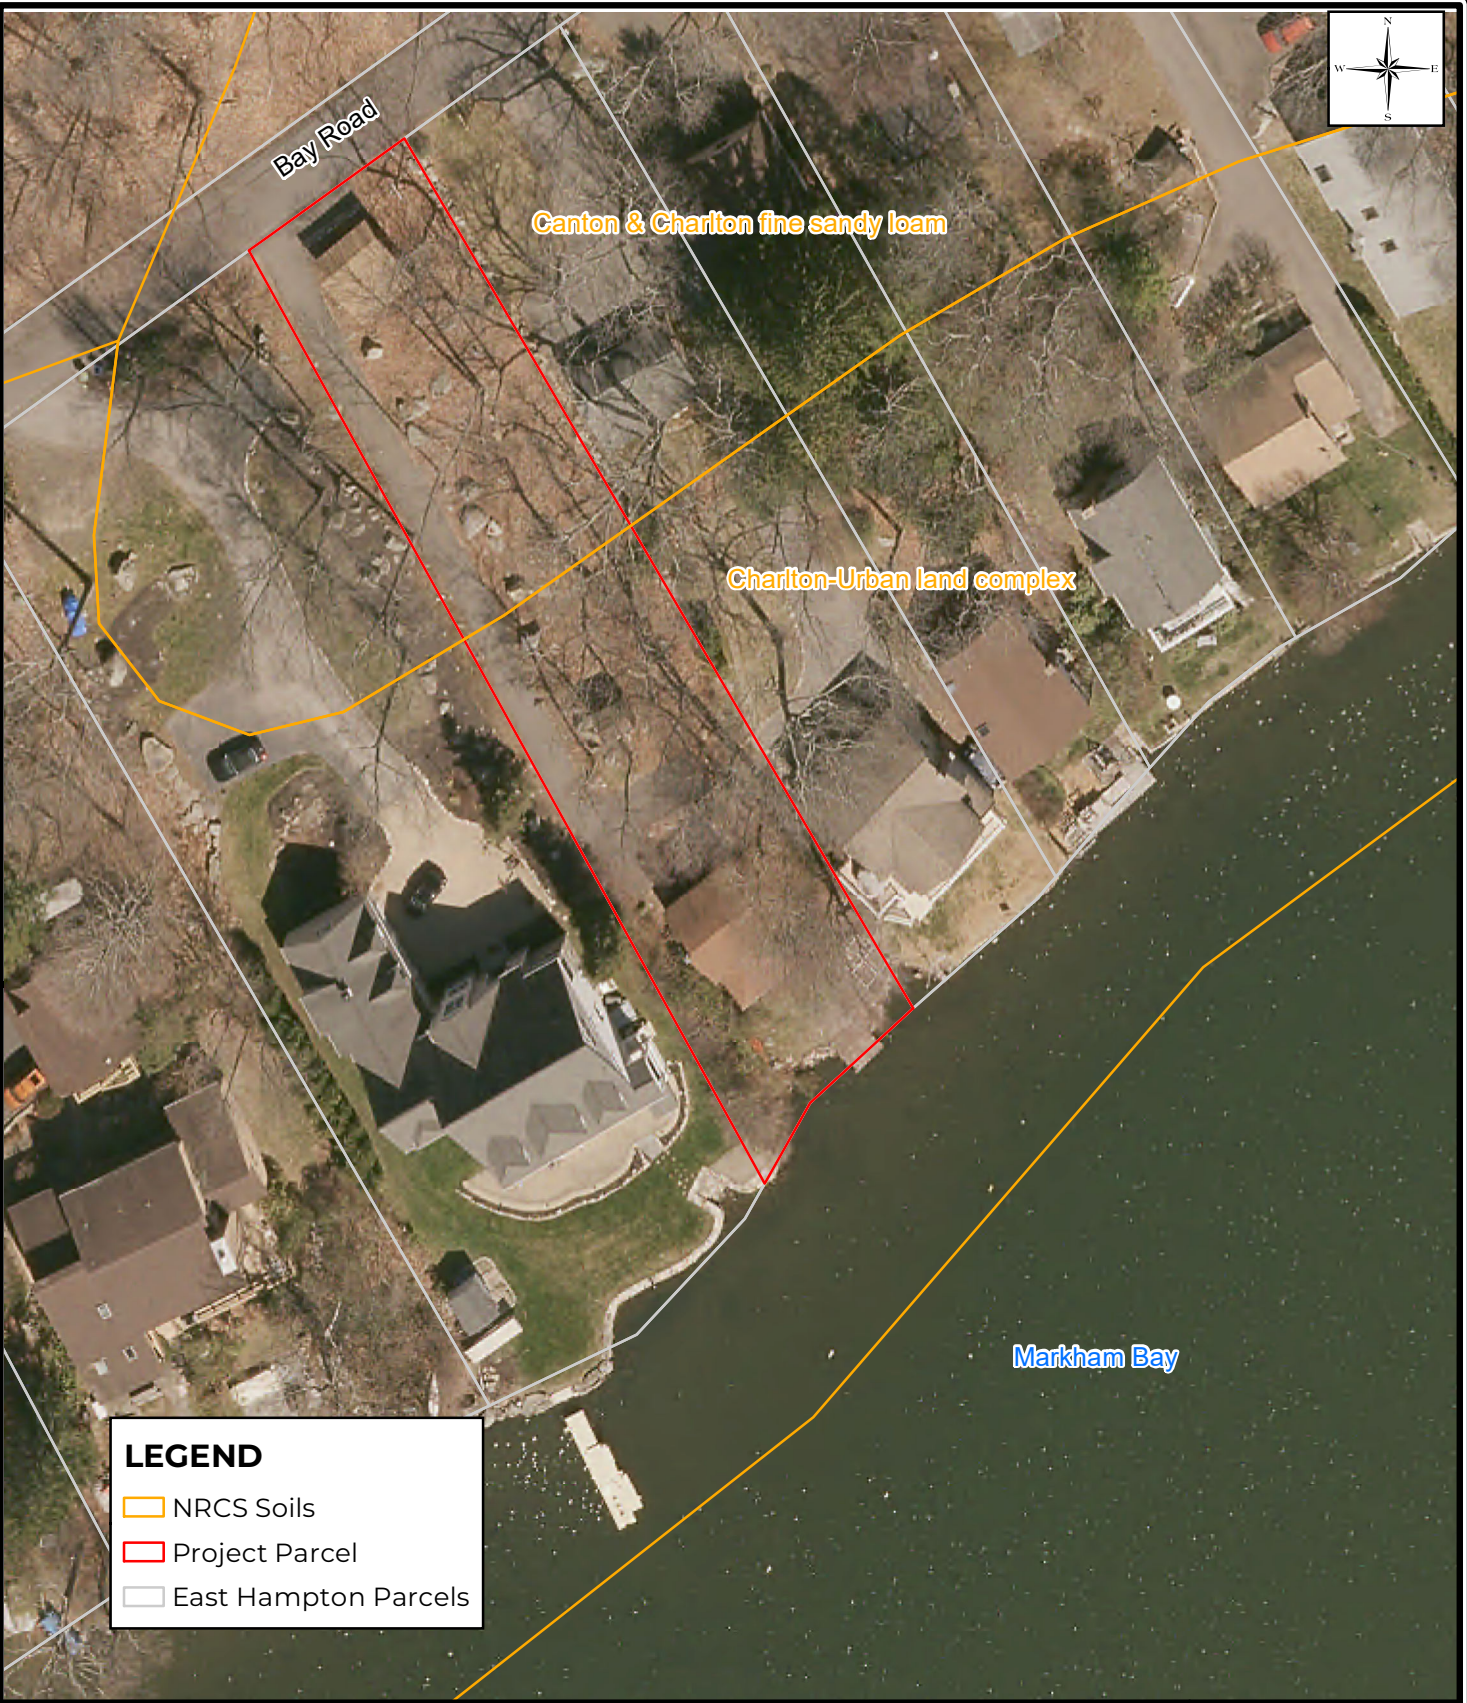
DRAWING NAME:
FIG. 3

To identify soils within the project area, a Natural Resources Conservation Service (NRCS) soil survey was conducted (Figure 3). Two upland soil map units were identified on the property, Canton and Charlton fine sandy loams (62C) and Charlton-Urban land complex (260D). Each map unit represents a specific area on the landscape and consists of one or more soils for which the unit is named. Other soils (inclusions that are generally too small to be delineated separately) may account for 10 to 15 percent of each map unit. The mapped units are by name, symbol, and typical characteristics (parent material, drainage class, high water table, depth to bedrock, and slope) (Table 1). These characteristics are generally the primary characteristics to be considered in land use planning and management. A description of each characteristic and its land use implications follows the table. A complete description of each soil map unit can be found in the *Soil Survey of the State of Connecticut* (USDA, 2005) and at <http://soils.usda.gov>.

NRCS SOIL MAP
 INLAND WETLAND PERMITTING ASSISTANCE
 HERRICK RESIDENCE
 49 BAY ROAD
 EAST HAMPTON, CONNECTICUT
 SOURCE: 2004 AERIAL PHOTO, CTDEEP, 2006
