**Wetlands / Watercourse Assessment  
Proposed and Alternate Driveway Access Crossings  
11 Cone Road  
East Hampton, Connecticut**

**January 28, 2020**

**Project No. JE 19-16**

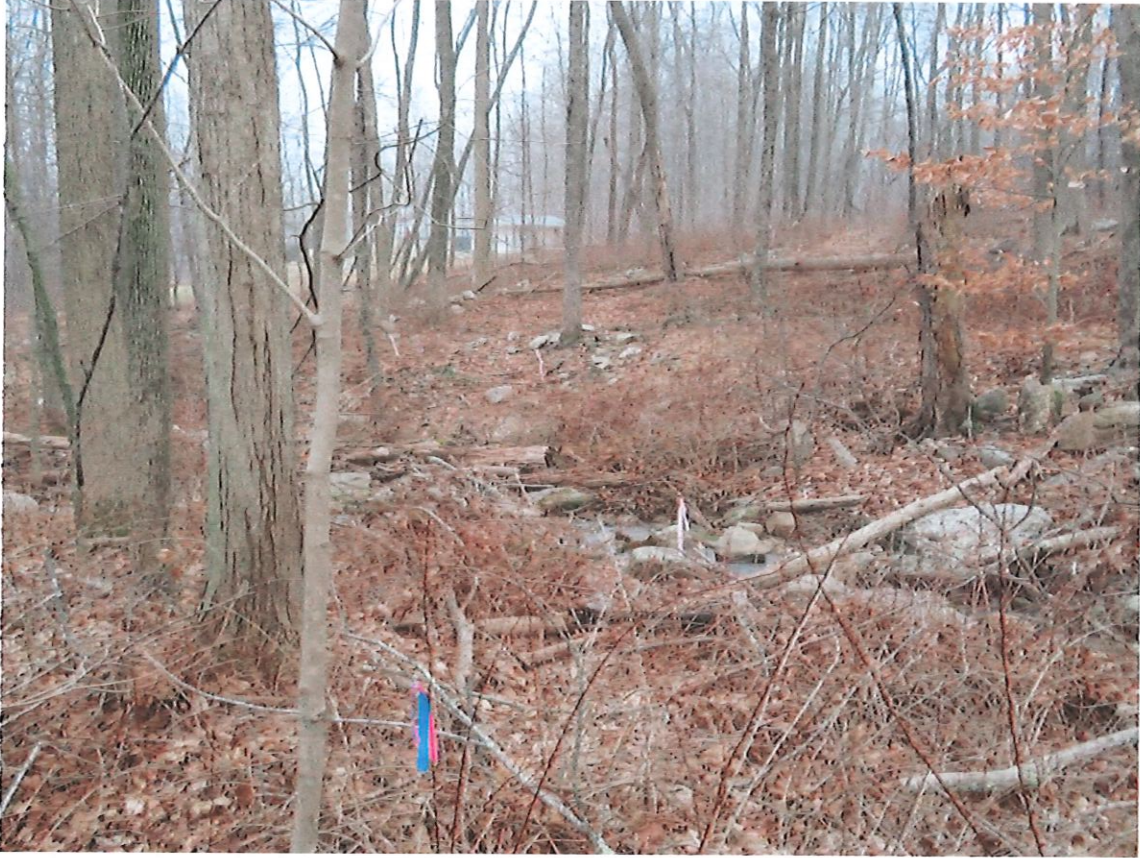
**Photo 1:** Watercourse in area of Crossing, Proposed Driveway Access

The Proposed Driveway Access would cross the perennial watercourse in the vicinity of wetland / watercourse delineation flags B-5, B-6 and B-7. A photograph of area of Proposed Driveway Access crossing (Photograph #1) is attached. Dominant native forest vegetation observed included: sugar maple trees and saplings, shagbark hickory trees and saplings, American beech saplings, spice-bush shrubs, sassafras shrubs, spinulose wood fern, cinnamon fern, Christmas fern, Massachusetts fern, sensitive fern, smartweed and aster. The following invasive shrub species were dominant: Japanese barberry, multi-flora rose and burning bush.

According to the submitted specifications, the proposed watercourse crossing structure for both the Proposed and Alternate Driveway Access alignments would be a 13-foot wide by 3-foot high "Aluminum Box Culvert, Structure #21" manufactured by Contech Construction Products, Inc. According to Mr. Magnotta, this is a "bottomless arch culvert" design and will not directly impact the existing stream-bed within the watercourse channel at the proposed crossing. This is one of the preferred crossing structures identified in CT DEEP's Stream Crossing Guidelines.

- an approx. 400 square foot area of wetland located between the watercourse channel and wetland delineation flag B-6; and,
- an approx. 180 square foot area within the intermittent watercourse, adjacent to Cone Road, in order to construct a stilling basin south of a proposed culvert beneath the access driveway.

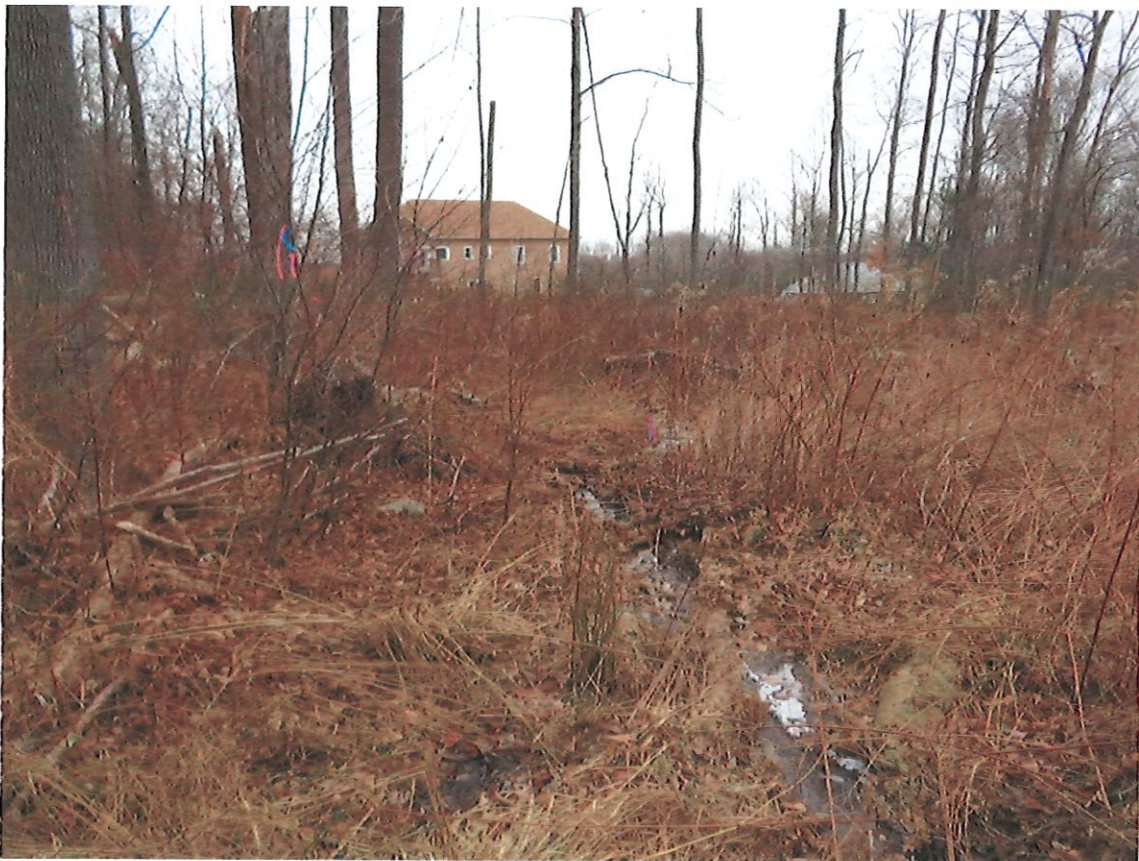
**Photo 2:** Watercourse in area of Crossing, Alternate Driveway Access

The Alternate Driveway Access would cross the watercourse in the vicinity of wetland / watercourse delineation flags 1B-8, 1B-9 and 1B-10. A photograph of area of Alternate Driveway Access crossing (Photograph #2) is attached. Dominant native vegetation observed included: shagbark hickory, red-maple saplings and goldenrod. The following invasive shrub species were noted: multi-flora rose and burning bush.
