Northeast Aquatic Research, LLC

RE: Results from June 19 & 22, 2020 Aeration System Water Quality Monitoring Visits

Oakwood Station (41.59758, -72.50849)

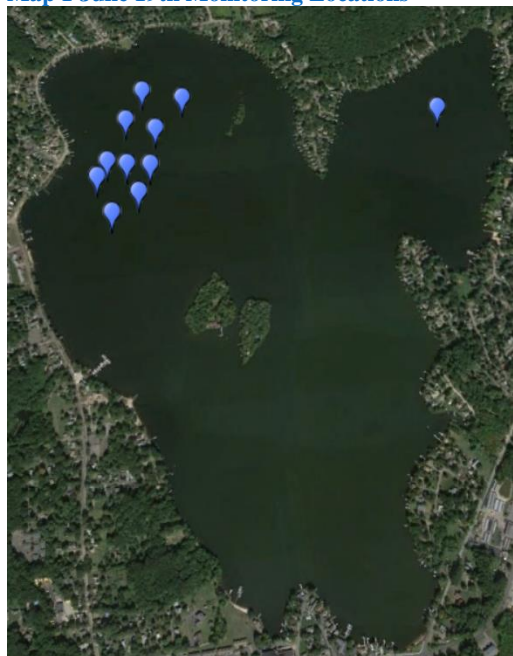
Map 1 June 19th Monitoring Locations

In addition to monitoring at the regular Oakwood bay station, an additional 18 water column profiles of temperature and dissolved oxygen were measured at 1m intervals on June 19th, next to and at varied distances from the aerators, across ten monitoring locations in Oakwood bay. These profiles were taken to document water column conditions before, during, and 3hrs-after the turning on of the destratification aeration system. The full results will be available in the year-end water quality report.

One of the key findings of the many temperature and dissolved oxygen profile measurements is that the area of anoxic water seems to be shrinking, in addition to the reduction in the height of the anoxic boundary. These are positive results. For instance, the northernmost monitoring locations in Oakwood bay, which are both roughly 21ft deep, had a meter and a half of anoxic bottom water on the 19th and no anoxic water on the 22nd. We hope that the aeration system will continue to effectively shrink the area of bottom sediment that is capable of releasing iron-bound phosphorus (nutrients) into the water column.

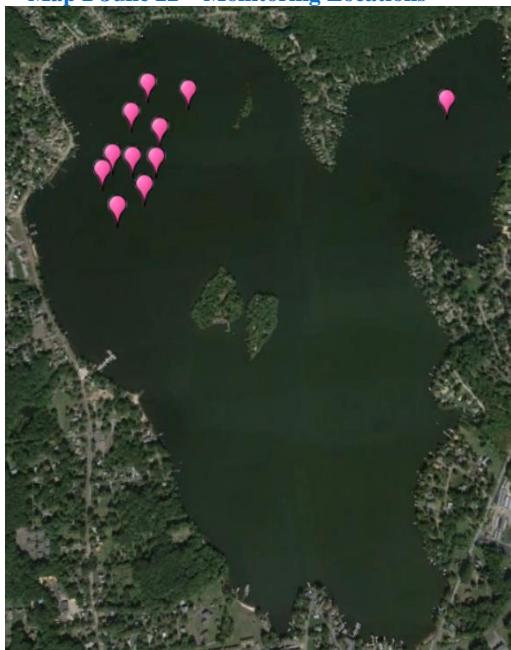
Map 2 June 22nd Monitoring Locations

On June 22nd, an additional 10 temperature and oxygen profiles were measured, including both the Markham and Oakwood bays, and the same locations as measured on June 19th.
