**Town of East Hampton**

Department of Energy & Environmental Protection  
Lake Pocotopaug Watershed Water Quality Improvements

Project # - 17-07b

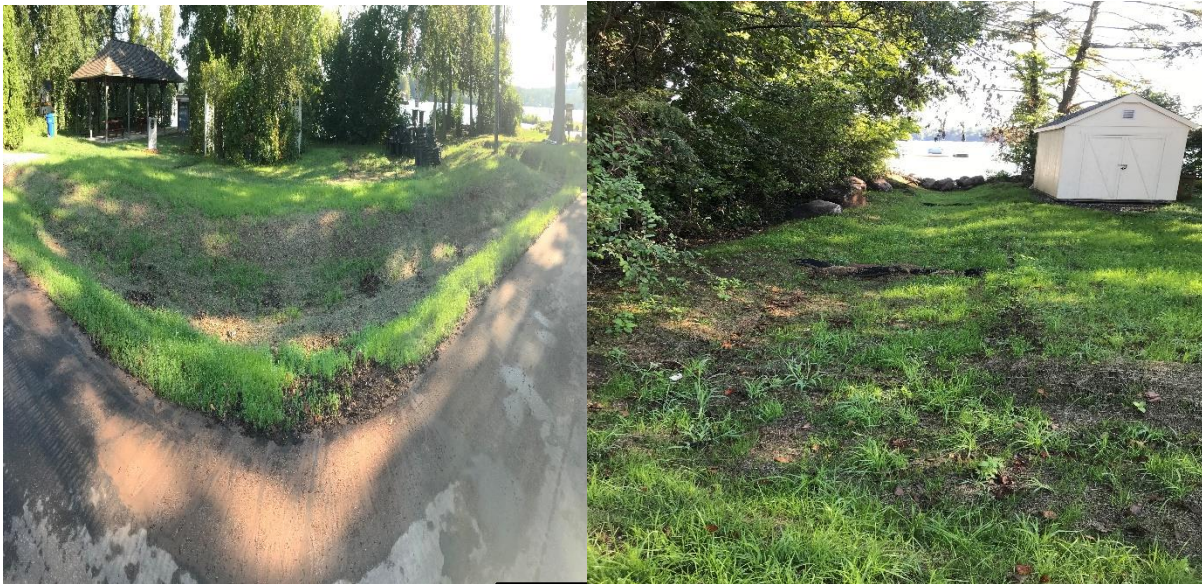
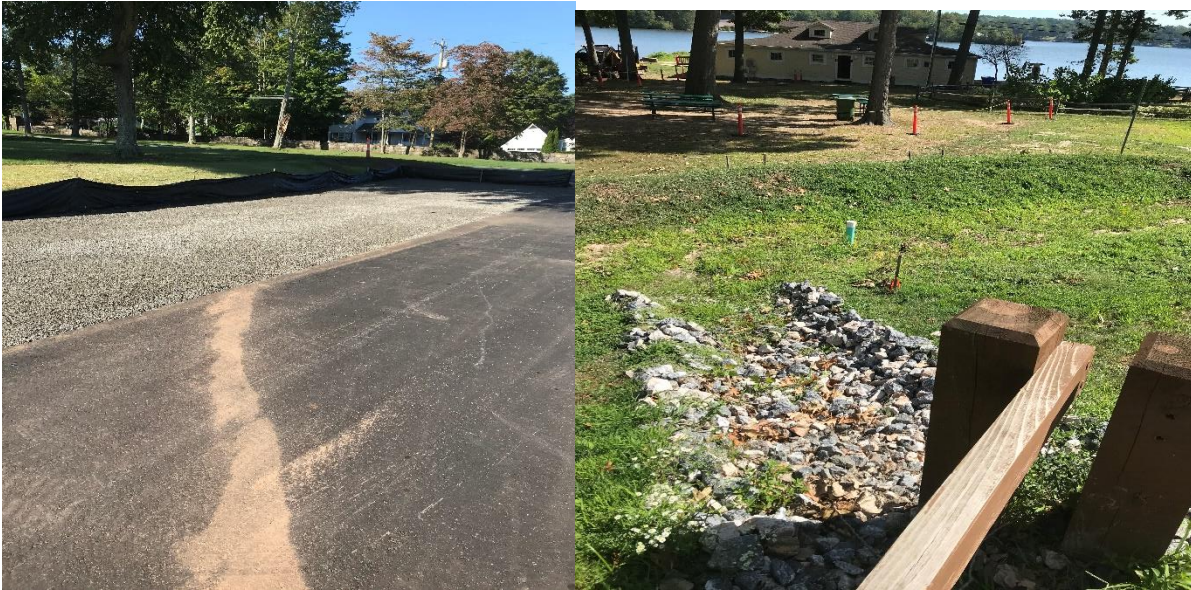
- Sears Park: Lat 41.5911 Long -72.5076

1. **Sears Park:** prior to the BMP's being installed Sears park featured very little sediment control measures and the result of storm water events allowed water to flow from SE in a NW direction of the park eventually draining directly into Lake Pocotopaug at a high rate of velocity. BMP's installed: Construction of a bioswale at the bottom of the new parking lot which will intercept overland flows from the pavement. At the north and south ends of the bioswale, we constructed a grass swale to direct any runoff going to the lake to pass into the bioswale for infiltration. At the entrance we constructed PVC pavers with pea gravel over a gravel base to direct runoff and infiltrate into the underlying swales. Modifications were made to the existing swale near the property line of 64 North Main Street to provide better removal of suspended solids, and the uptake of dissolved nutrients by vegetation. We also modified the existing rain garden to more efficiently manage the runoff from the tennis courts. This included a parking lot regrade to better direct runoff to one of the two existing catch basins and retention systems from Task 1.b.iii.1. Finally, we paved the parking area and constructed a final bioretention system at the base of the fill slope to the north of the parking area. Runoff from the paved parking area and driveway will be directed to this system.

These projects presented us with many challenges throughout the course of the spring and summer months. Sears Park was most definitely our largest challenge, during construction we unearthed electrical conduit, sewer pipes and an old abandon well. Changing the topography was most certainly a struggle as we took out 3' in some areas of material. Pertaining to the bio retention systems we had to overcome a one-day storm that dropped 2" of rainfall on us and washed out the lower basin and part of the upper basin prior to seed germination. Sears Place started out as a Vegetative Swale but the velocity coming off Sears Place proved to much and even with seed germination washout was prevalent. The end result was a changeover to Rip Rap Swale instead of a vegetative swale. In the end the projects were completed, and additional LID measures were established to help reinforce the initial plan.

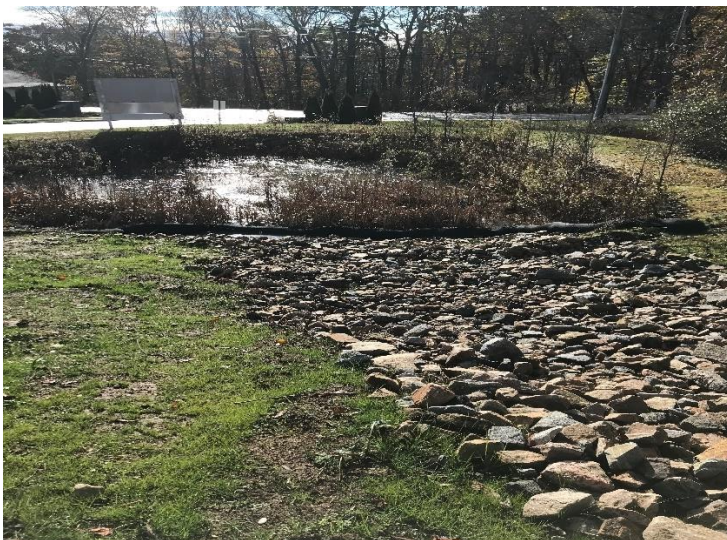
- Skyline Estates: Lat 41.5957 Long -72.5200

2. **Skyline Estates:** The former property consisted of a shallow bioretention system that was not adequate for holding water and infiltration of nutrients prior to its discharge into nearby

storm drain which inevitably identified high levels of TP and TN from this site as a result of the large housing development on site. We constructed a wet swale with riprap that includes reconstruction a forebay, swale and level spreader system to optimize the function and slow down the flow of water to allow for infiltration prior to it reaching the storm drains.

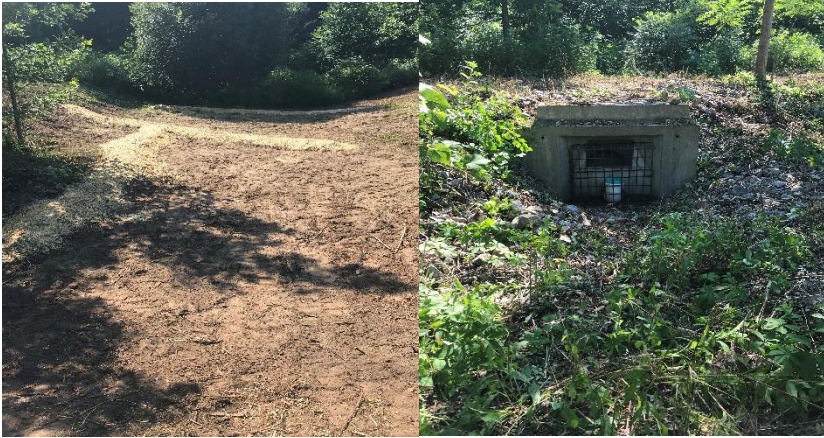
- Seven Hills Estates Lat 41.6042 Long -72.5055

3. **Seven Hills Estates:** As is the case with Skyline Estates this particular BMP operated relatively the same with an open detention pond that did not allow for the necessary contact time for adequate infiltration which resulted in TP and TN entering the storm drains at a higher rate thus adding more nutrient loading into Lake Pocotopaug. This property which is responsible for a 120-housing development is the prime location for storm drain discharge. Due to the amount of storm water discharge we felt it necessary to construct and retrofit a dry detention basin by adding earthen berms to increase the flow path and increase the depth of the retention pond.

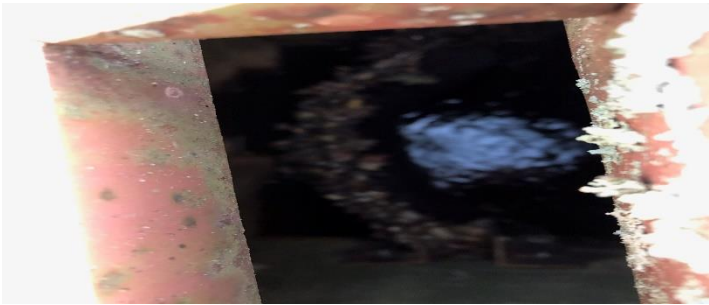
- Hawthorne Road Lat 41.5946 Long -72.4935

4. **Hawthorne Road:** At this location we identified a catch basin which assumes a majority of storm drains which meet up at one location prior to discharging into Lake Pocotopaug. The runoff from the surrounding catch basins is coming from Route 66 and surrounding properties of the Town Hall building and multi-unit housing developments. This location was sited a few times in previous years with fine course sediments reaching the lake front. As a result, we isolated this storm drain to create a retrofit that consisted of a weir like structure inside the catch basin that consisted of Filter Sox built up 4 feet in length. Once the water reaches this catch basin the attempt is to pond the water for a short duration and filter all nutrients through the filter sox eliminating a large amount of TP and TN prior to it reaching the waterfront.

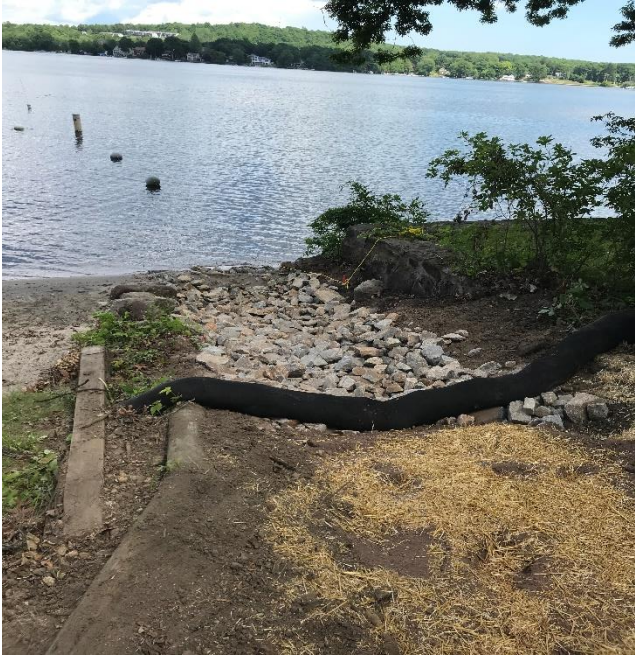
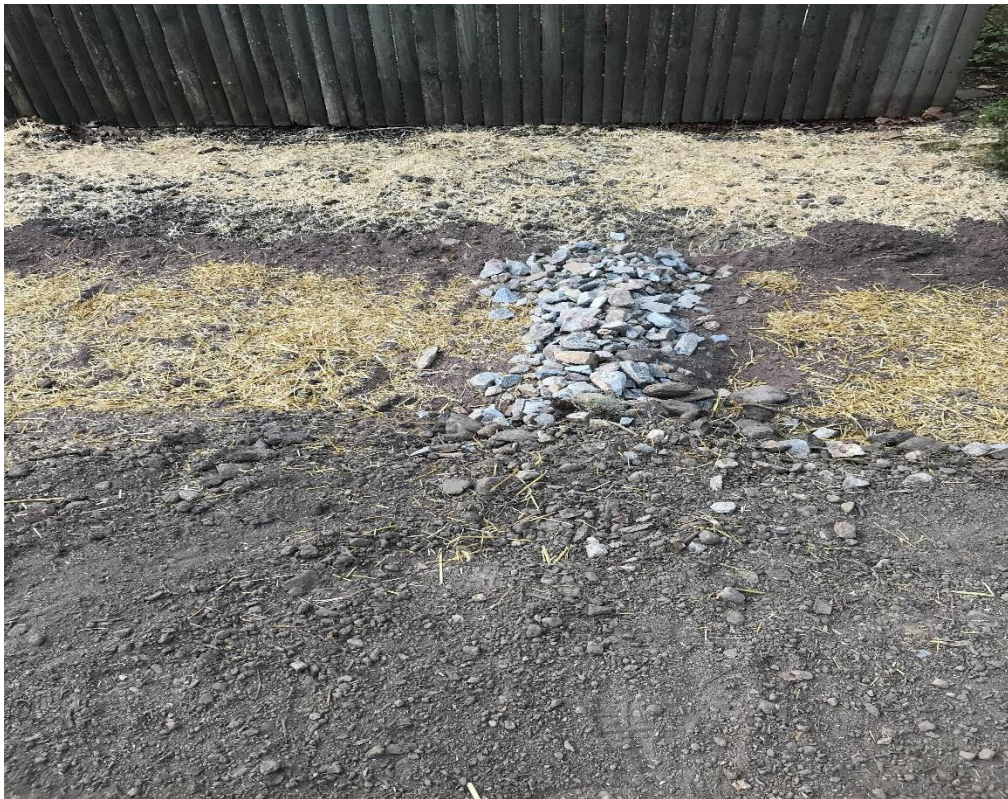
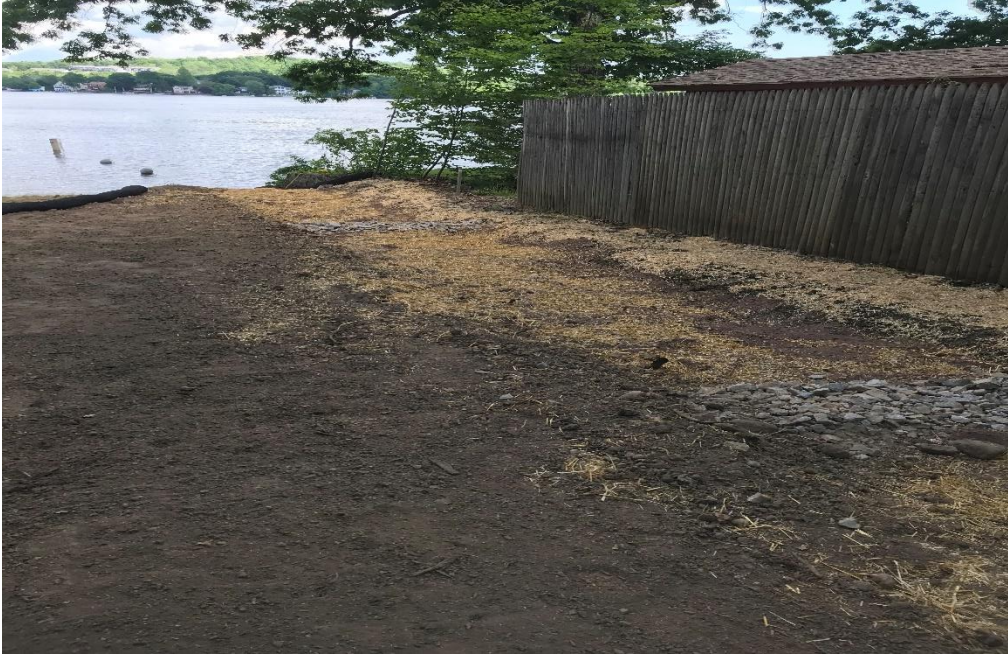
- Sears Place Lat 41.5889 Long -72.5058

5. **Sears Place Beach Association:** The current location at the end of Sears Place provided little to no BMP's for collecting nutrients prior to its discharge of storm water in the lake. The existing topography shows a 5% grade from the North Main Street entrance down the long stretch of road (approximately 100 feet) where it was intercepted at the bottom of the road by a paved curbing, the paved curbing proved to be unsuccessful at redirecting the water to the side lot on the south end of the Beach Association property where it could infiltrate into dense vegetation. As a result we manipulated the paved curbing and increase the height to 6" rather than 4" and redirected the water to the south side of the beach property where we constructed a rip rap swale with a series of check dams every 6' apart. This allowed for the concentration of storm water to slow down the velocity before reaching the lake front and infiltration of sediment was controlled by the rip rap and check dams.

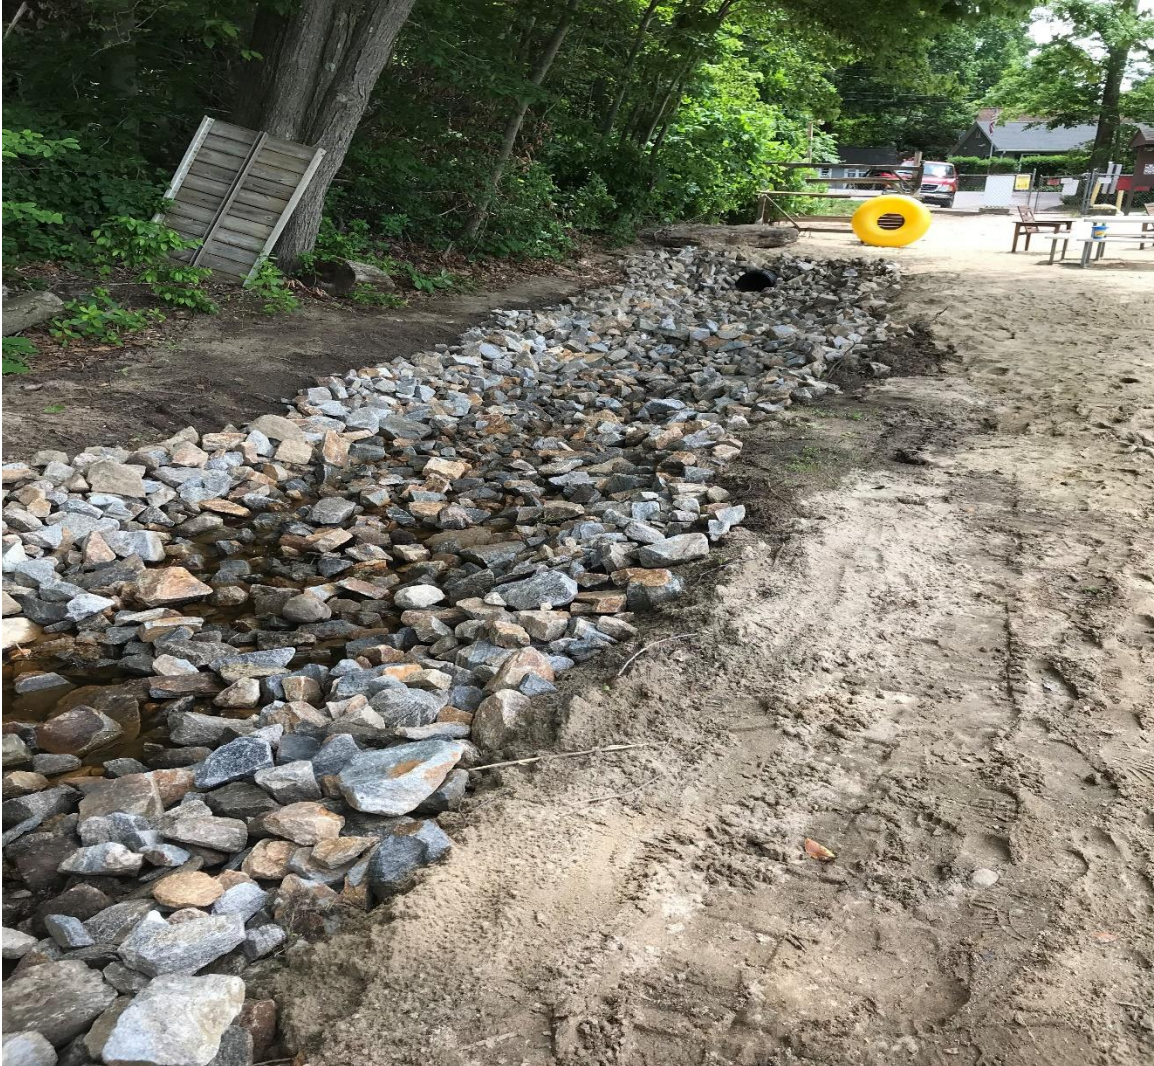
- Wangonk South Beach Lat 41.5982 Long -72.4919

6. **Wangonk South and North Beach:** the preexisting conditions prior to BMP's had no way of controlling storm water runoff prior to it reaching Lake Pocotopaug. The land on South beach was the final stop for storm water as the road to the beach saw a rapid decline in topography with no BMP's prior to collection into storm drain and the eventual discharge to Lake

Pocotopaug. The same is true with the North Beach as water collected from several storm drains from adjacent streets and collected in one final storm draining before discharging at the beach location into lake Pocotopaug. Each discharge point had a paved culvert which provided no infiltration at each site location. The project consisted of rip rap swales at each location at the point of discharge to infiltrate storm water following discharge from the primary catch basin. Additionally, seed was added to help with the overflow of storm drains and normal run off at each property location.
