## 45 Meeks Point Rd Project Narrative

### Structural and Foundation Repairs

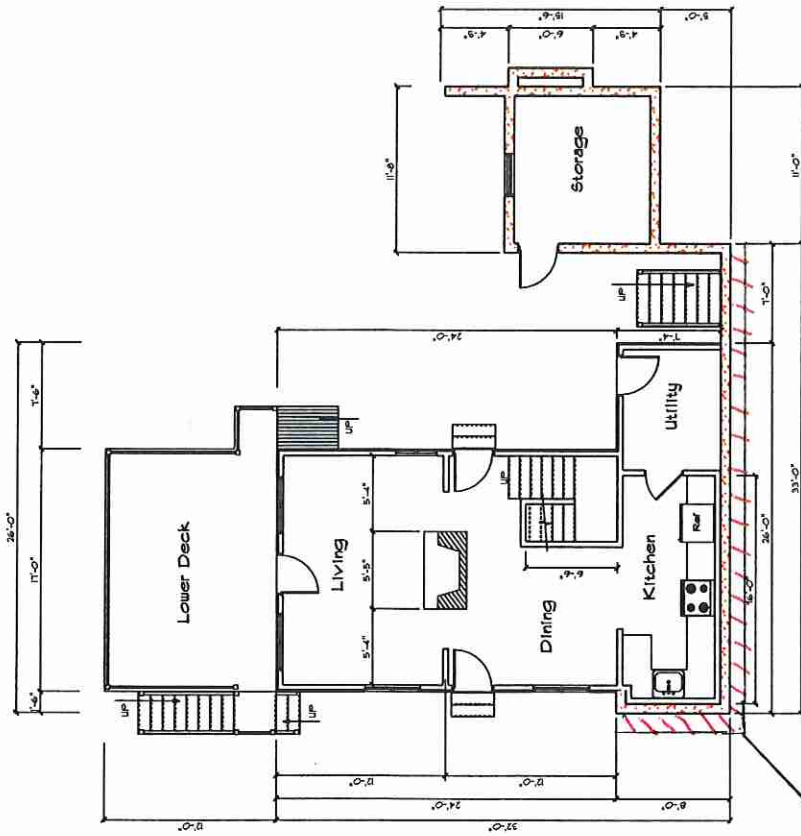
### Existing Lower Level Plan

material to be removed

1. Work Scope: Replace failing wooden I-beam that's sits on two concrete footings with steel I-beam. Raise home replace I-beam and level home. No excavation needed to make repair only replacement of existing beam. This portion of work will have no impact on surface water runoff. Hail bails will be below work zone in case of run off.
2. Excavate forty-one feet (41') by four (4') for 164 sqft around original homes foundation for remediation of water infiltration. Repair and water seal old foundation. Any unused excavated material will be transported away. Silt fences and hail bays will be used as indicated on site plan, two buffers for added protection.
